# Technical Service Bulletin

## 94 Moisture accumulation in headlamps

94 13 01 2028277/5 January 2, 2013. Supersedes Technical Service Bulletin Group 94 number 12-98 dated November 21, 2012 for reasons listed below.

Model(s)	Year	VIN Range	Vehicle-Specific Equipment
Q7	2010-2014	All	Not Applicable

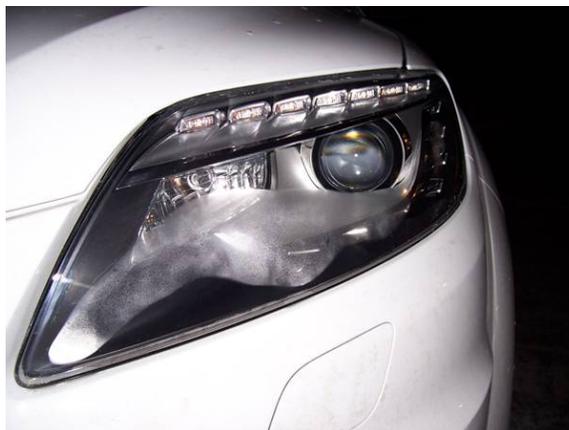
- Considerable moisture present in headlamp.
- The moisture disappears only after extended drives (greater than 10 minutes).

*Figure 1. Moisture in headlamp.*

Humid air settles on the inside of the glass, causing moisture to appear on the inside of the headlamp lens. Because of the headlamp circulation system, outside air is allowed to flow through the headlamps. The open, water-protected ventilation system (needed for pressure compensation) creates different “ climate zones” inside the headlamp, where the lens is either warmed up by the light or cooled down by passing air.

When high air humidity and temperature differences exist between the inside of the headlamps and the outside, condensation can form on the inside of the lens, especially in cold and wet weather. The moisture in the headlamps can be compared with condensation on the windshield, which is cleared by the "defroster vent". This moisture buildup can happen for example: after a car wash, after steam cleaning of the engine or the front end, or after overnight temperature changes.

1. Remove the headlamps and dry the inside using compressed air or hot air blower.

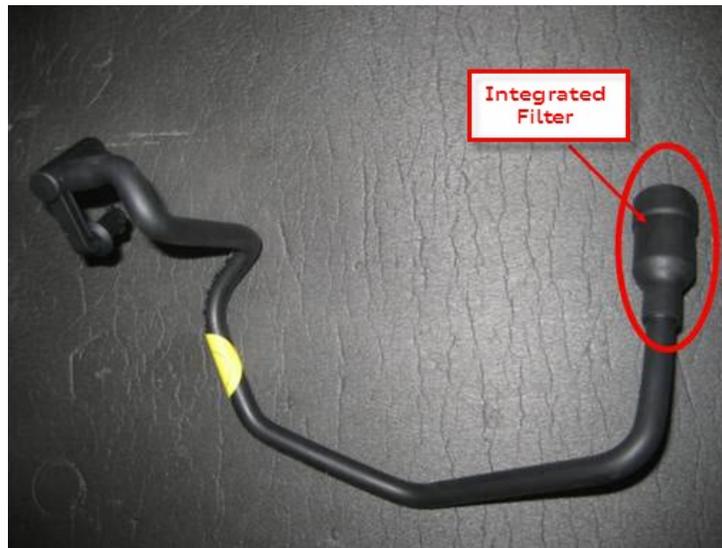
*Figure 2. Updated ventilation hose with integrated filter.*

2. If vehicle's build is prior to VIN # \*CD004736, replace the headlamp ventilation hose for each headlamp with the new part number to help reduce any further humidity ingress into the headlamps (see Part information table below). Otherwise, move to step 3.

The updated ventilation hose can be recognized by the integrated filter (Figure 2).

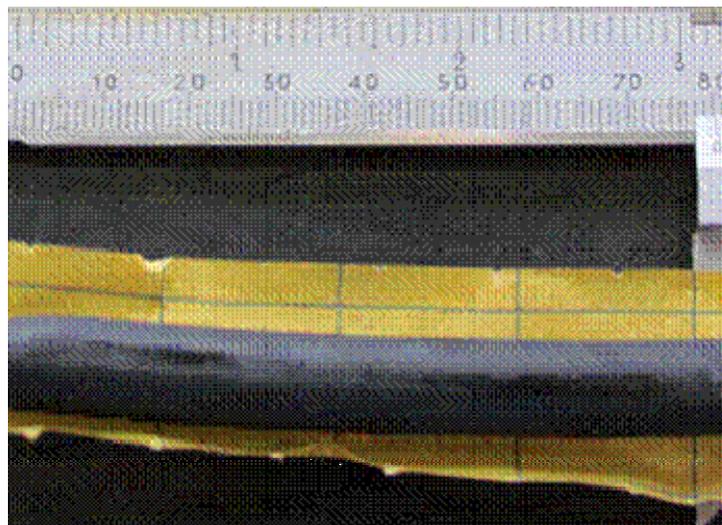
*Figure 3. Butyl cord sealant, 10mm diameter.*

3. Cut two sections of butyl cord sealant, 8cm long each (Figure 3).

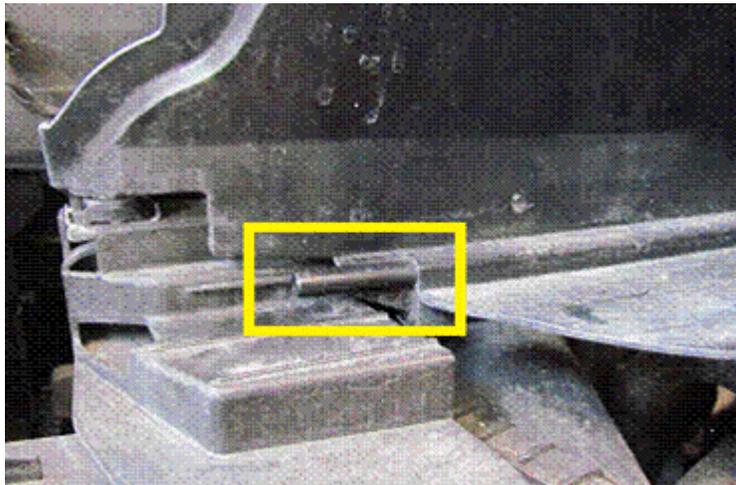
*Figure 4. Headlamp ventilation guide tube.*

4. Each headlight ventilation guide tube must be sealed to protect against further moisture ingress (Figure 4).

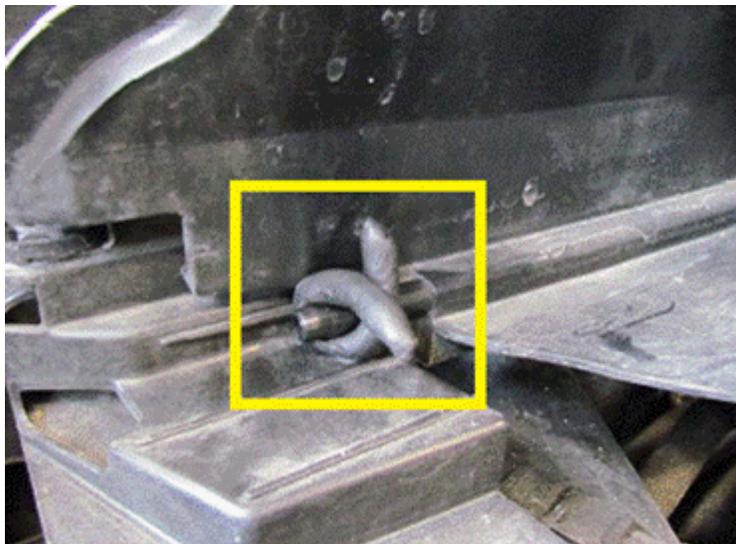
*Figure 5. Initial butyl cord shown on guide tube.*

5. Wrap butyl cord sealant around the left and right ventilation tubes, taking care not to block the air passage tube (Figure 5).

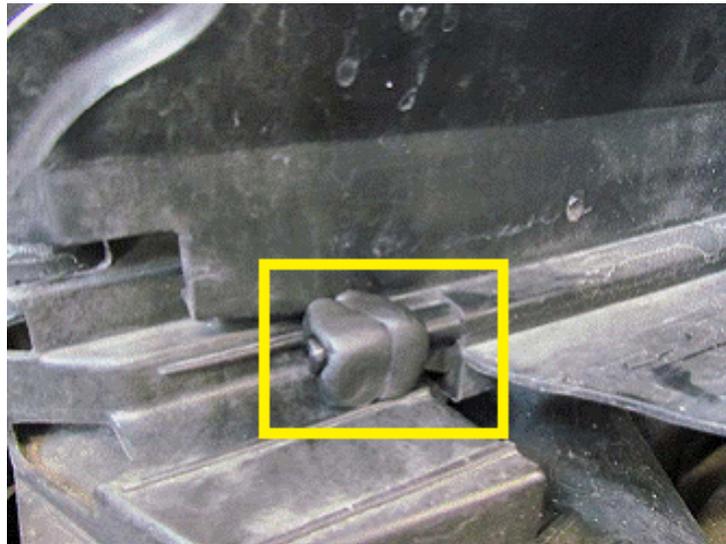
*Figure 6. Butyl cord kneaded in place.*

6. Knead the butyl cord sealant in place. The butyl sealant must be excessive enough so that the headlamp housing squeezes it and creates a robust seal at the housing (Figure 6).

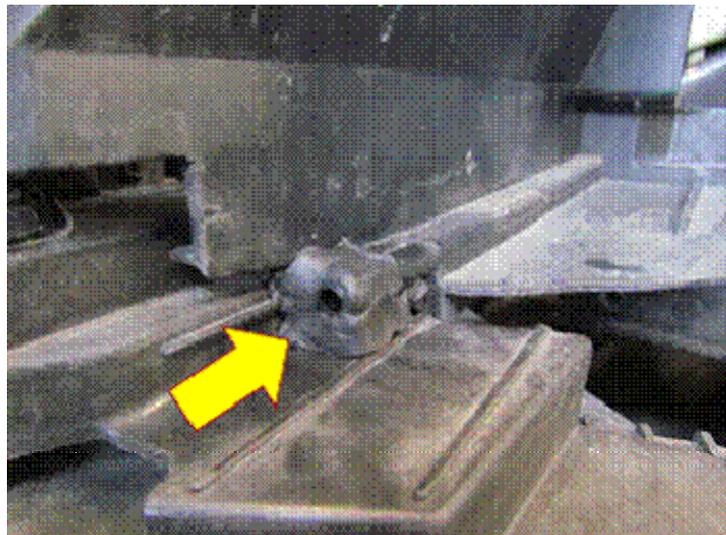
*Figure 7. View of direction of headlamp engagement, with appropriate butyl cord application.*

7. Leave an uncovered section of the air tube so that there is no chance the sealant will clog the air passage tube (Figure 7).

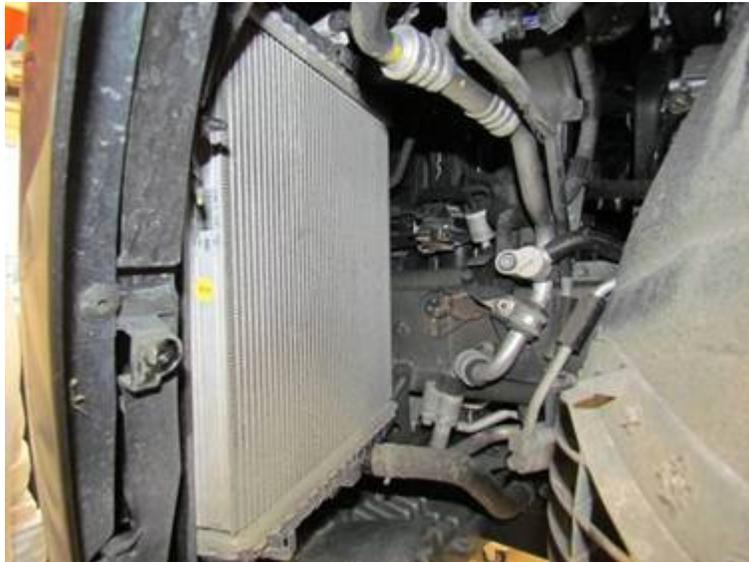
*Figure 8. View of charge air cooler with wheel well liner removed*

9. Check vehicle for left and right air ducting for exiting air behind charge air coolers. Vehicles built from June 2010 will not have these exit air ducts installed. Check vehicle regardless of build date. If air ducts are not installed, follow instructions below.
10. Remove front wheels and wheel housing liners. The rear of the charge air coolers will be exposed (Figure 8).

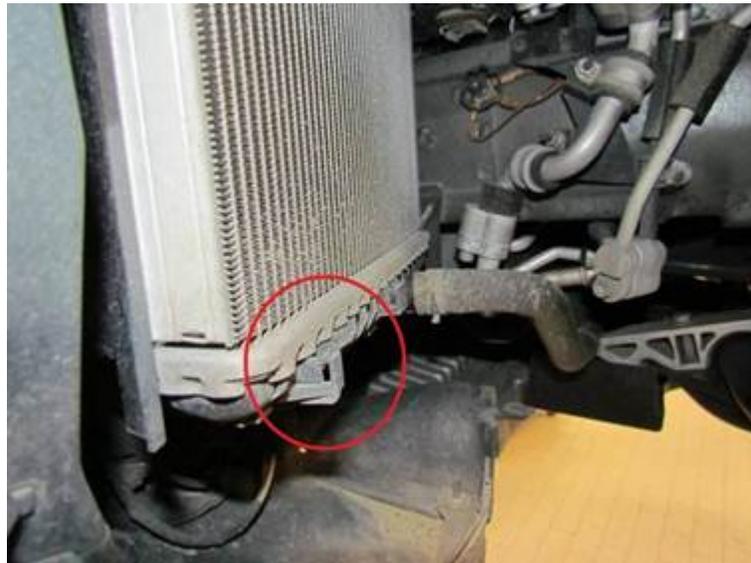
*Figure 9. Lower exit air duct attachment point to charge air cooler.*

11. Locate exit air duct attachment hooks on the left and right charge air coolers (Figure 9 and 10).

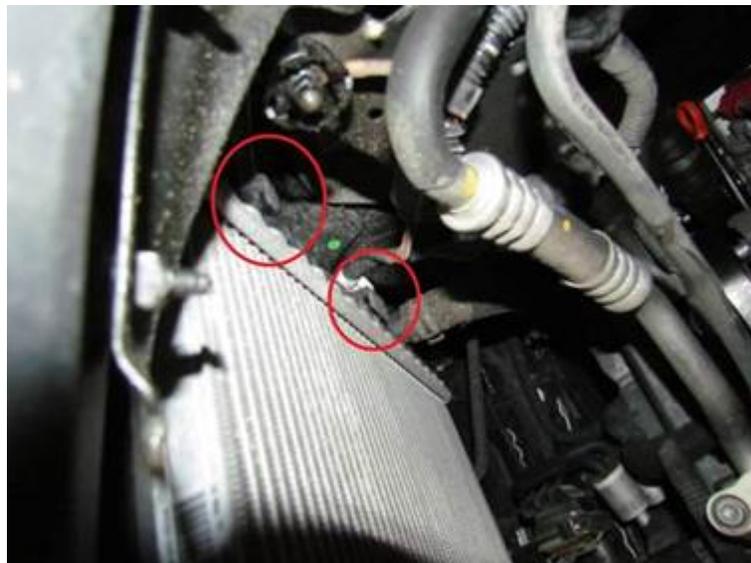
*Figure 10. Upper exit air duct attachment points to charge air cooler.*

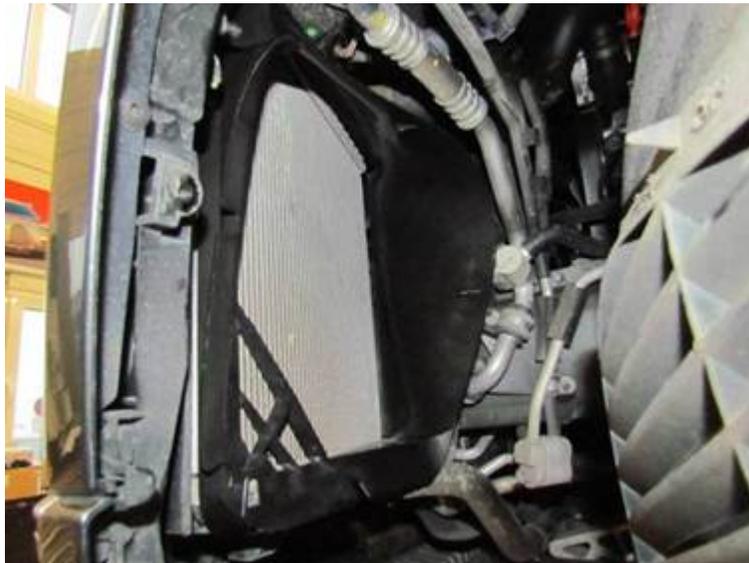
*Figure 11. Charge air cooler exit air duct installed.*

12. Affix left and right exit air ducts over the rear of the charge air coolers (Figure 11).

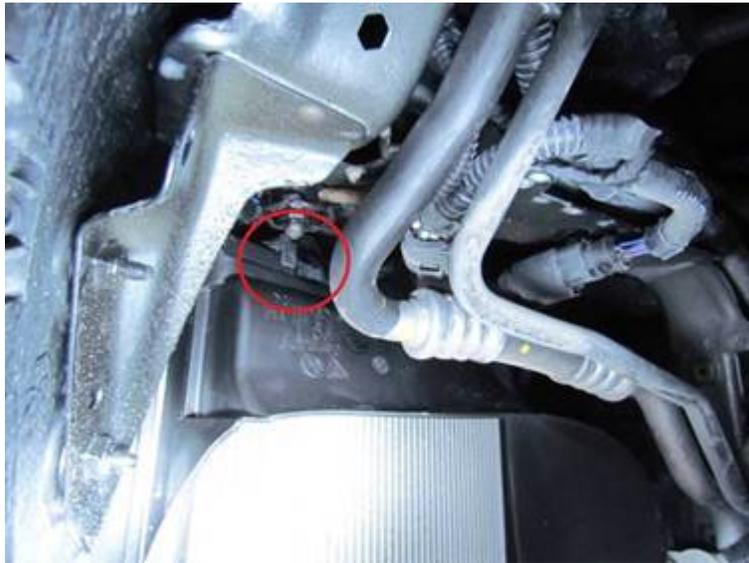
*Figure 12. View of exit air duct affixed to mounting hook.*

13. Inspect exit air duct attachment points to be sure ducts are engaged properly over charge air cooler hooks (Figure 12).
