NUMBER: 02-001-13
GROUP: Front Suspension
DATE: March 06, 2013

Noise From Front Of Vehicle Over Bumps Or When Turning

2012-2013 (JC) Journey

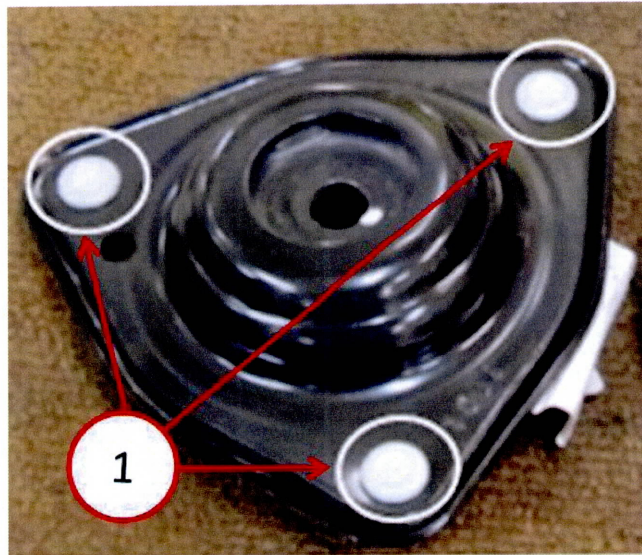
Fig. 1 Front upper Strut Bracket

1 - Stud Heads

NOTE: Assemble the upper front mount strut bracket (**Fig. 1**) to the upper front strut bearing (**Fig. 2**) by aligning the stud heads on the strut bracket to the 3 notches on the strut bearing.
