NUMBER: 08-017-13

Flash: Vehicle Theft Alarm Intermittently Sounds

2011 - 2012 (WK) Grand Cherokee (International only)

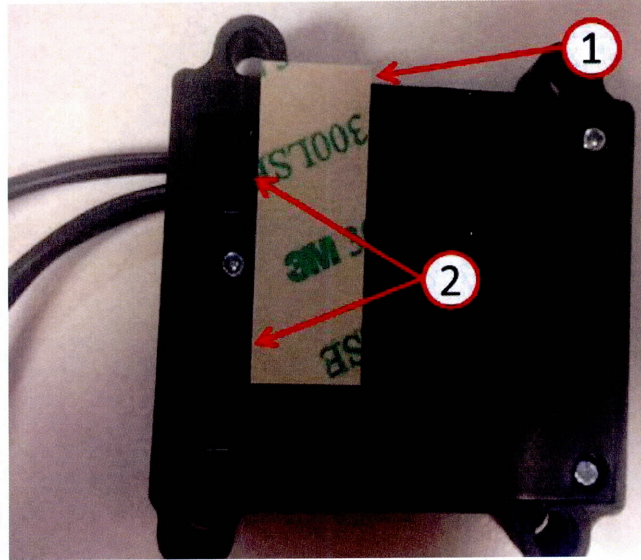
Fig. 1 Module and Tape Placement Location

This could be caused by the overhead console not retaining the intrusion module in place as well as it should. With the module not properly secured and with temperature changes, the wiring stiffens and relaxes moving the module. This set's off the alarm. Reprogramming the module is to improve sensor stability that makes it less sensitive to movement. Adding tape to the module prevents movement.

- 1 - Leave a tab at this location.
- 2 - Line up the tape along these indents.

- 6. Reinstall the module, putting slight pressure on the module to seat the tape.
- 7. Install the overhead console, follow procedure in TechCIONNECT, 23 - Body/Interior/CONSOLE, Overhead/Installation.
