NUMBER: 23-012-13

Squeak Coming From Under Front Passenger Seat Storage Bin

2012 - 2013	(JC)	Journey
2012 - 2013	(JF)	Journey (Export)

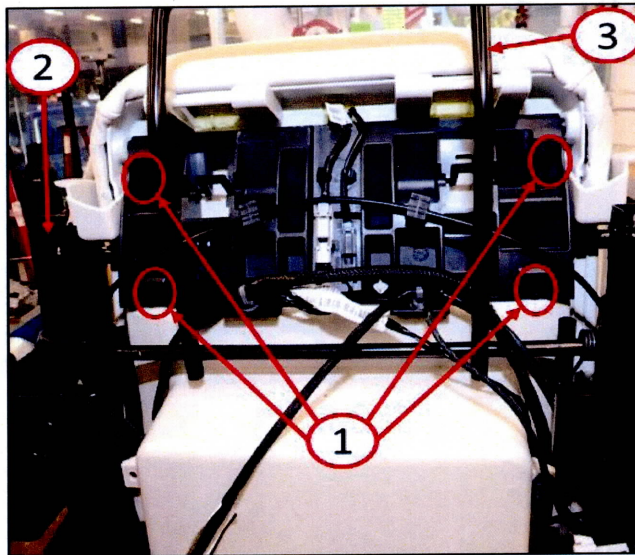
Fig. 1 Remove Storage Bin

The seat storage bin is sitting on and rubbing against the seat track cross frame bar at the front of the passenger seat bottom. If the customer describes the symptom, perform the Repair Procedure.

2. Remove the four fasteners (1) and disconnect any retaining clips or connectors in order to remove the seat bottom/storage lid assembly (Fig. 1).
