NUMBER: 19-001-13 REV. A

GROUP: Steering

Rattle From Driver Side Of Instrument Panel Or Steering Wheel Over Rough Roads Or When Turning

2014 (WK) Grand Cherokee (Includes SRT8)

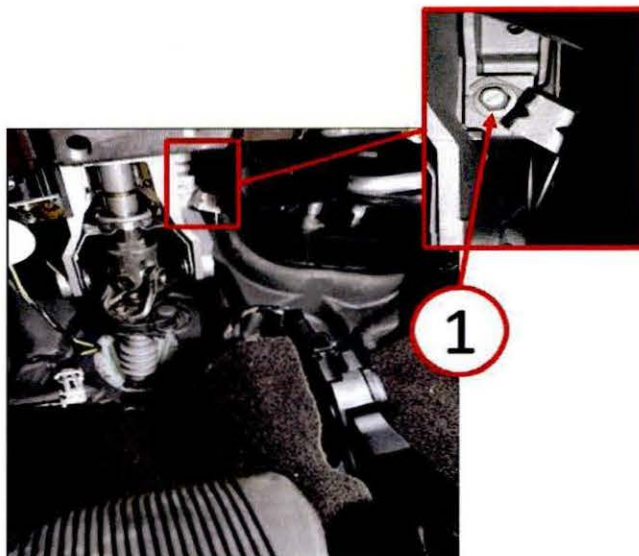
Fig. 1 Steering Column Bracket

1. **Inspect the vehicle for the steering column lock control module wiring harness bracket (Fig. 1). Is the steering column lock control module wiring harness bracket installed?
 - a. Yes>>> Proceed to [Step #2](#).
 - b. No>>> Return the vehicle to the customer or dealer inventory. **

1 - Steering Column Lock Control Module Wiring Harness Bracket Fastener

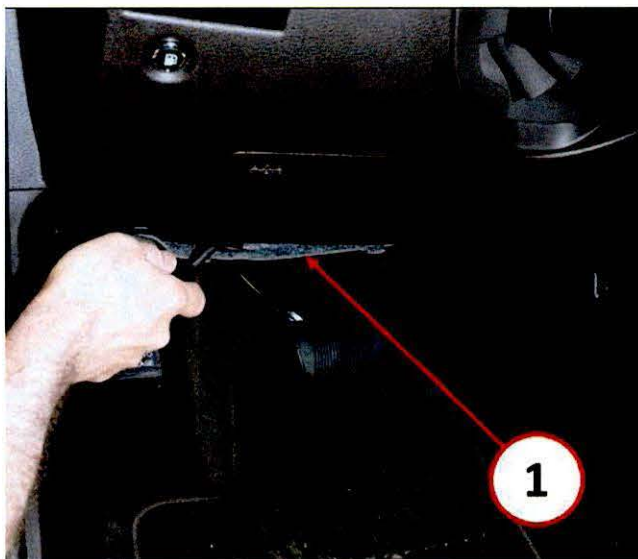
Fig. 2 Left Instrument Panel Closeout

1 - Left Instrument Panel Closeout

-
2. Release the fasteners securing the driver side instrument panel closeout (1) to the instrument panel ([Fig. 2](#)).

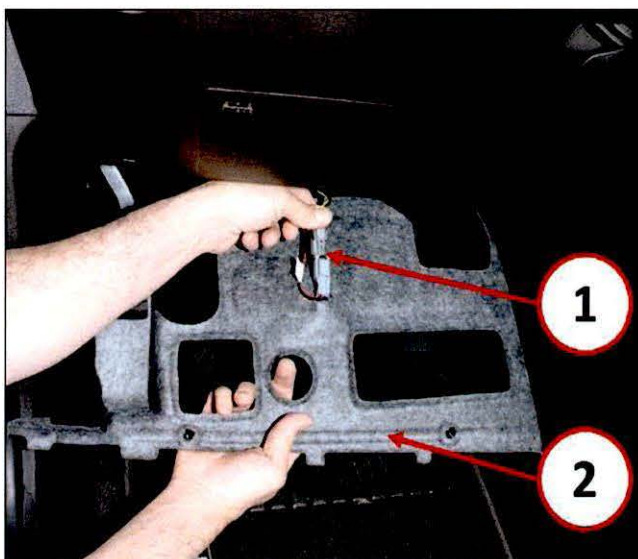
Fig. 3 Instrument Panel Closeout Removal

1- Courtesy Lamp Harness

2- Left Instrument Panel Closeout

-
3. Disconnect the courtesy lamp electrical harness (1) from the driver side instrument panel closeout (2) (Fig. 3).
 4. Remove the driver side instrument panel closeout (2) from the vehicle (Fig. 3).

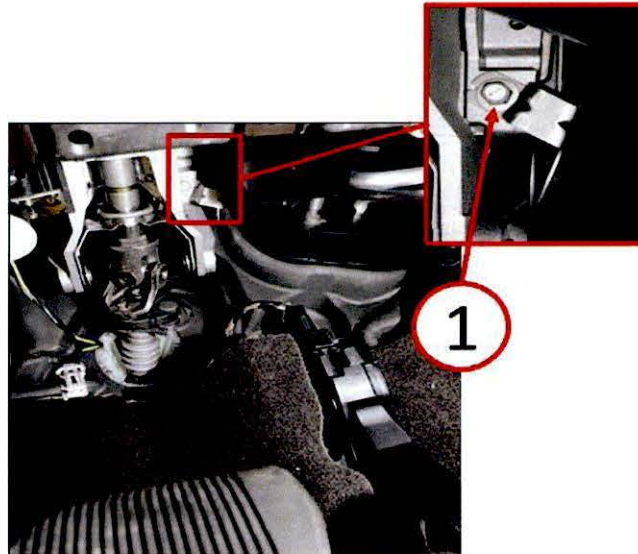
Fig. 4 Steering Column Bracket

1 - Steering Column Lock Control Module Wiring Harness Bracket Fastener

5. Remove the fastener (1) securing the steering column lock control module wiring harness bracket to the steering column and discard the steering column lock control module wiring harness bracket (Fig. 4).

6. Reinstall the fastener that secured the steering column lock control module wiring harness bracket to the steering column and torque to 27 N-m (20 ft-lbs).
7. Connect the courtesy lamp electrical harness (1) to the driver side instrument panel closeout (2) (Fig. 3).
8. Install the driver side instrument panel closeout (2) to the vehicle (Fig. 2).
