SERVICE BULLETIN

APPLICABILITY: 2013-14MY BRZ

NUMBER: 12-156-13

SUBJECT: Rattling Sound from Seat Belt Buckle

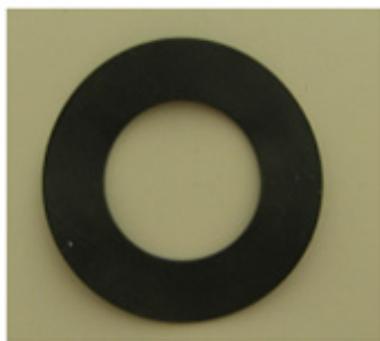
NEW p.n. 64168CA200, Spring Wave Washer

- Remove the buckle assembly from the seat then remove the toothed washer from the shouldered mounting stud. Photos of the new spring wave washer and the old toothed washer are provided for reference below.

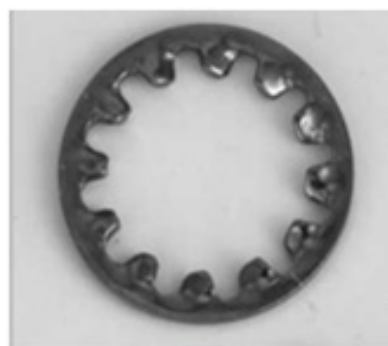
This bulletin provides a repair procedure to address customer concerns of a rattling sound coming from the point where the seat belt buckle is attached to the seat frame. The sound may be heard from either seat on acceleration, deceleration or going over bumps. The sound is more prevalent when the seat belt is buckled but in rare cases, can occur when the belt is unbuckled. The service procedure involves removal of a toothed washer and replacing it with a spring wave washer.

OLD toothed washer

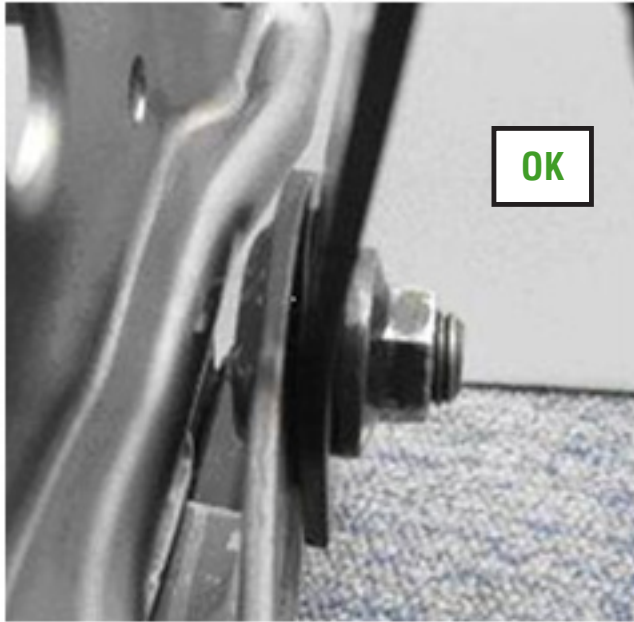
- Put the new spring wave washer onto the shoulder of the mounting stud in place of the removed toothed washer.
- Re-install the buckle assembly onto the mounting stud making sure the spring wave washer stays on the shoulder properly as shown in the photo below, left. The photo below, right shows the spring wave washer unseated from the mounting stud shoulder.

- Install the retaining nut and torque to 42 +/- 8.4 Nm (31 +/- 6.2 ft. lbs.).
- Reinstall the seat assembly.
- Road test the vehicle to confirm the rattling sound has been repaired.
