**NUMBER:** 02-146-13

## SERVICE BULLETIN

APPLICABILITY: 2012-13MY Impreza 2.0L

**SUBJECT:** Revised Valve Train Parts to Reduce a Warm Engine

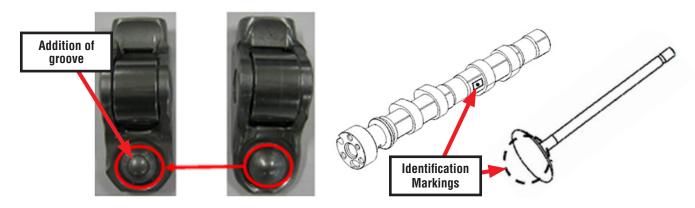
The illustrations below show additional information about the changes to the valve rockers, camshafts and valves to help readily distinguish them from the previous version parts.
