Technical Service Bulletin

94 Moisture accumulation in headlights

94 13 11 2028277/6 March 6, 2013. Supersedes Technical Service Bulletin Group 94 number 13-01 dated January 2, 2013 for reasons listed below.

Model(s)	Year	VIN Range	Vehicle-Specific Equipment
Q7	2010	All	Not Applicable
	2011	All	
	2012	All	
	2013	All	
	2014	All

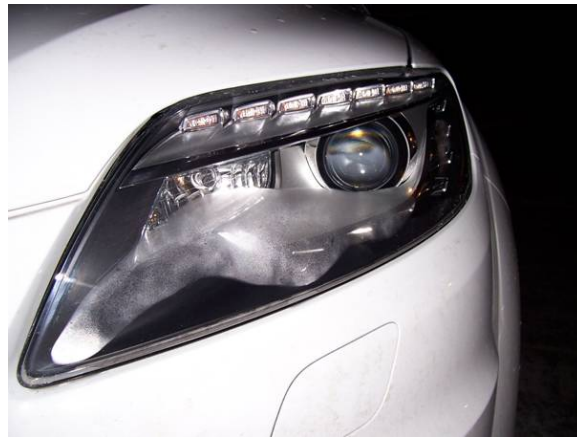
- There is considerable moisture present in the headlamp (Figure 1).
- The moisture disappears only after extended drives (greater than 10 minutes).
- There is no external damage to the headlamp which could introduce moisture.

Figure 1. Moisture in headlamp.

Humid air settles on the inside of the glass, causing moisture to appear on the inside of the headlamp lens.

When high air humidity and temperature differences exist between the inside of the headlamps and the outside, condensation can form on the inside of the lens, especially in cold and wet weather. This moisture buildup can happen, for example, after a car wash, after steam cleaning of the engine or the front end, or after overnight temperature changes.

1. Remove the headlamps and dry the inside using compressed air or a hot air blower. Check for any loose caps, loose or unsealed control modules, or cracks in the headlamp housing(s) as the culprit of moisture exposure.
2. If the vehicle's build is prior to VIN # *CD004736 and the updated ventilation hoses are not currently installed, replace the headlamp ventilation hose for each headlamp with the new part number to help reduce any further humidity ingress into the headlamps (see *Required Parts and Tools*, below). Otherwise, proceed to step 3.

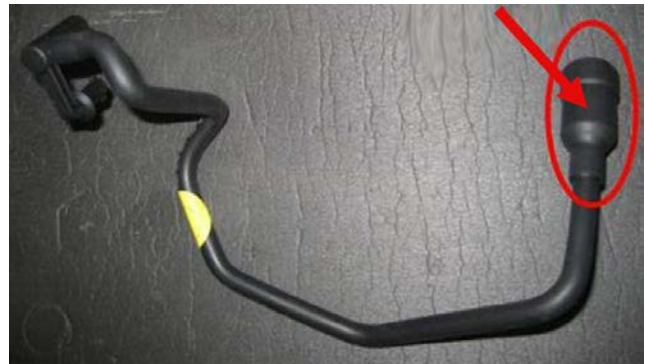
Figure 2. Updated ventilation hose with integrated filter.

**Tip:** The updated ventilation hose can be recognized by the integrated filter (Figure 2, arrow).

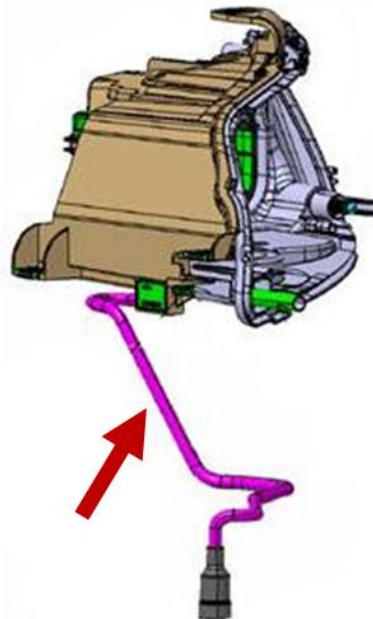
Figure 3. Mounting of updated ventilation hose.

**Tip:** The updated ventilation hose is not connected directly to the headlamp housing. The hose routes downward from the headlamp carrier and between the radiator and bumper (Figure 3, arrow).

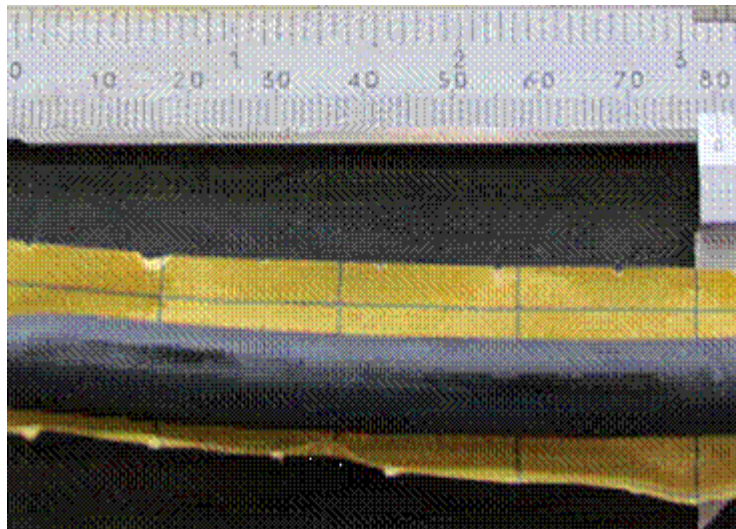
Figure 4. Butyl cord sealant, 10mm diameter

3. Cut two sections of butyl cord sealant, each 8cm long (Figure 4).

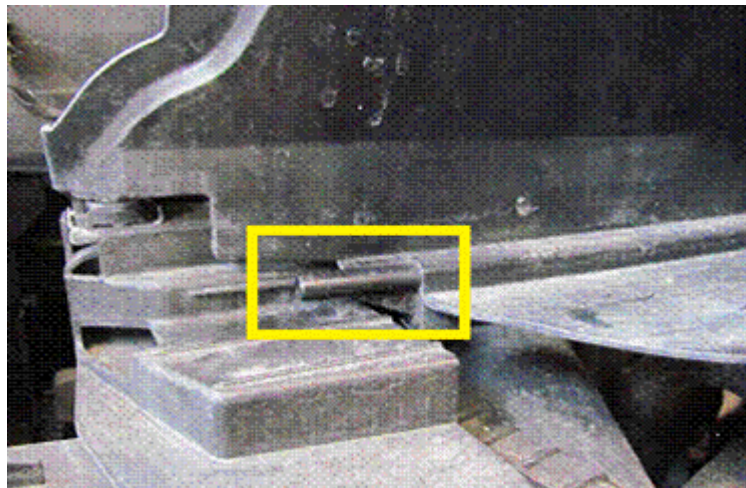
Figure 5. Headlamp ventilation guide tube.

4. Each headlight ventilation guide tube must be sealed to protect against further moisture ingress (Figure 5).

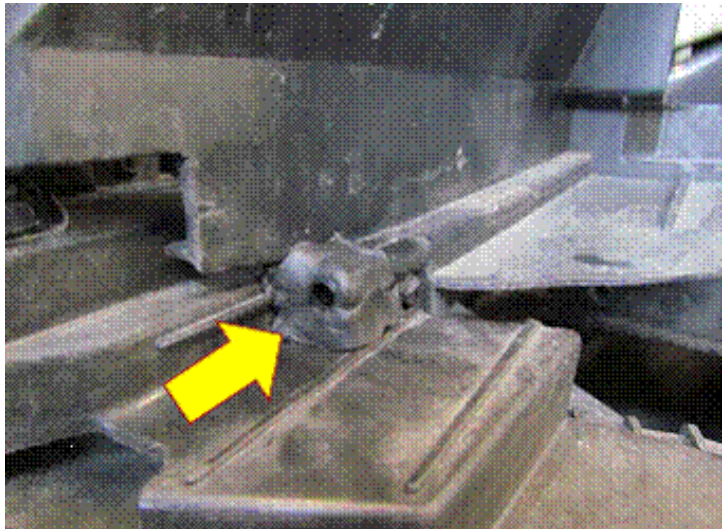
Figure 8. View of direction of headlamp engagement, with appropriate butyl cord application.

7. Leave an uncovered section of the air tube so that there is no chance the sealant will clog the air passage tube (Figure 8).

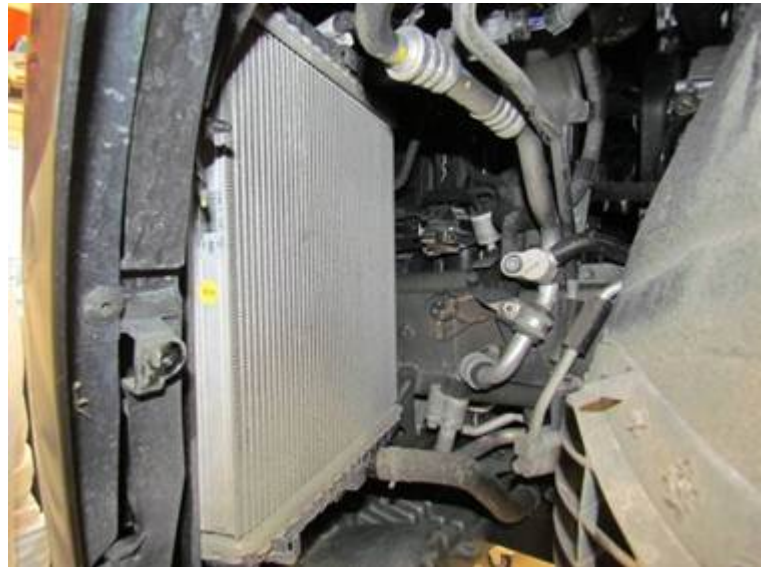
Figure 9. View of charge air cooler with wheel well liner removed.

10. Remove front wheels and wheel housing liners. The rear of the charge air coolers will be exposed (Figure 9).

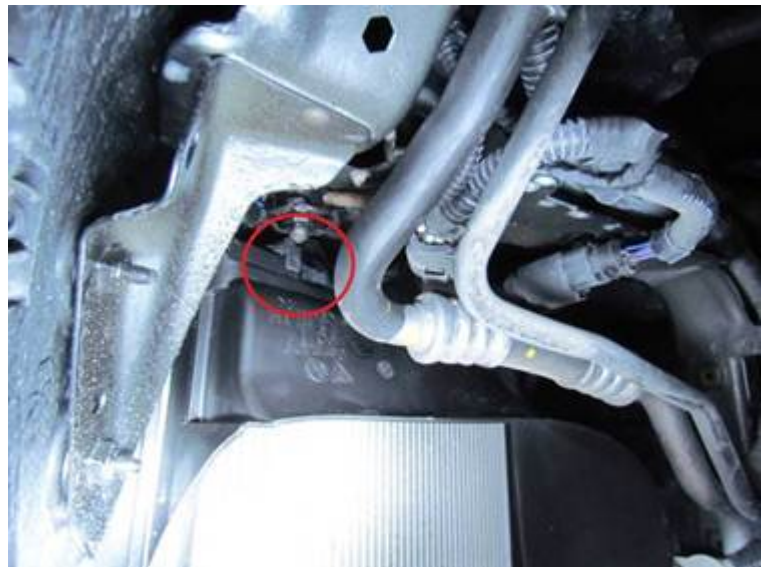
Figure 13. View of exit air duct affixed to mounting hook.

13. Inspect exit air duct attachment points to be sure that ducts are engaged properly over charge air cooler hooks (Figure 13).
