# Technical Service Bulletin

## 94 Bugs or debris found in rear lid taillight housing

94 13 15 2027755/2 April 19, 2013. Supersedes Technical Service Bulletin Group 94 number 11-59 dated December 7, 2011 for reasons listed below.

Model(s)	Year	VIN Range	Vehicle-Specific Equipment
Q7	2010	All	Not applicable
Q7	2011	All	Not applicable
Q7	2012	000001 - 010780	Not applicable

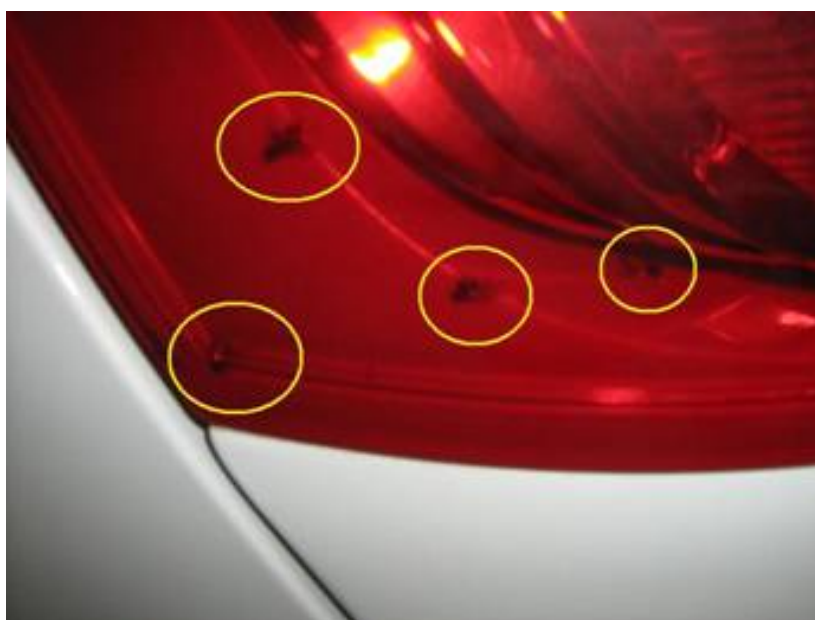
Bugs can be seen inside the housing, and there are no external markings indicating the taillight has been hit or has been previously damaged due to outside influence (Figure 1).

Figure 1. Bugs found inside the lid taillight housing.

Bugs are able to enter the taillight housing because the seal around the housing is not tight enough.

1. Clear out bugs and debris from taillight housing (this can be done with dry compressed air).
2. Replace the seal on the taillight housing with the new optimized seal (**4L0945191B**). The new seal can be used with either the right or left taillight housing.
