Technical Service Bulletin

94 Rear lid tail lamp lighting does not switch over to bumper (DTC 03073)

94 13 16 2033675/1 April 29, 2013.

Model(s)	Year	VIN Range	Vehicle-Specific Equipment
Q5	2009-2014	All	NA
Q7	2007-2014	All	NA

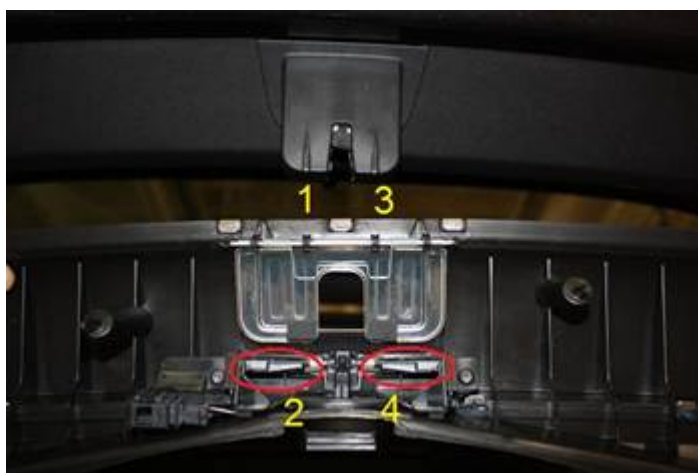
In order for the taillight lighting to switch between the rear lid and the bumper when the lid is operated, the paddle switches on the rear sill trim must contact the opposing lid latch points uniformly.

- Paddle switch G526 (Figure 1, 2) must contact lid latch point 1 (Figure 1, 1), as shown in the image at right.
- Paddle switch G525 (Figure 1, 4) must contact lid latch point 3 (Figure 1, 3), as shown in the image at right.

Figure 1. Inside vehicle view of rear lid latch showing location of G526 (2) and G525 (4) on rear sill trim, and contact points (1 and 3).

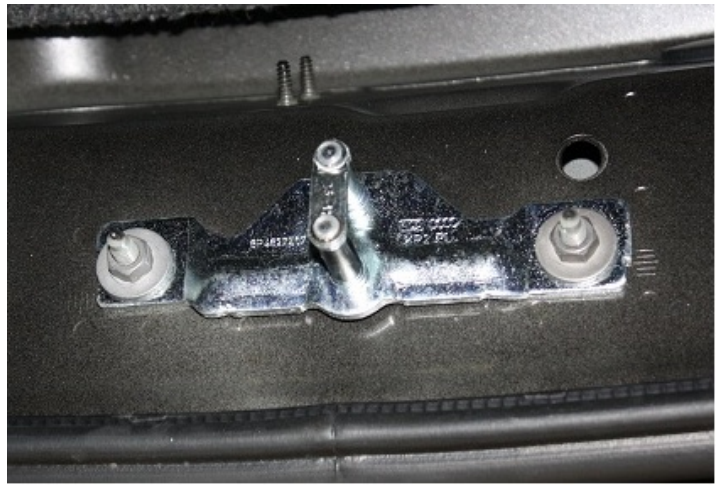
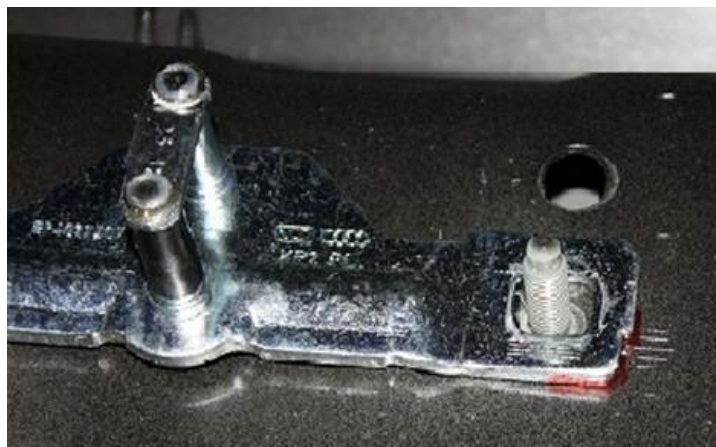
Figure 3. Power lid's motorized striker plate bolted mounting.

Figure 4. Power lid's motorized striker plate adjustability and serrated indicators.

Figure 5. Manual lid style striker plate studded mounting.

Figure 6. Manual lid style striker plate adjustability and serrated indicators.

2. Note the current position of the striker plate by using the serrated lines surrounding the bolt or surrounding the nut's integrated washer (Figure 3 - Figure 6).

Tip: Use a permanent marker to mark original position.
