Technical Service Bulletin

94 Rear lid tail lamp lighting does not switch over to bumper (DTC 03073)

94 13 17 2033675/2 May 22, 2013. Supersedes Technical Service Bulletin Group 94 number 13-16 dated April 29, 2013 for reasons listed below.

Model(s)	Year	VIN Range	Vehicle-Specific Equipment
Q5	2009-2014	All	NA
Q7	2007-2014	All	NA

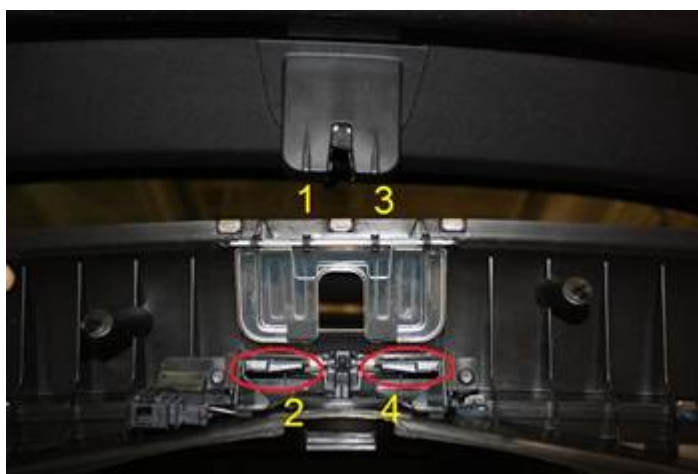
In order for the taillight lighting to switch between the rear lid and the bumper when the lid is operated, the paddle switches on the rear sill trim must contact the opposing lid latch points uniformly.

- Paddle switch G526 (Figure 1, 2) must contact lid latch point 1 (Figure 1, 1), as shown in the image at right.
- Paddle switch G525 (Figure 1, 4) must contact lid latch point 3 (Figure 1, 3), as shown in the image at right.

Figure 1. Inside vehicle view of rear lid latch showing location of G526 (2) and G525 (4) on rear sill trim, and contact points (1 and 3).

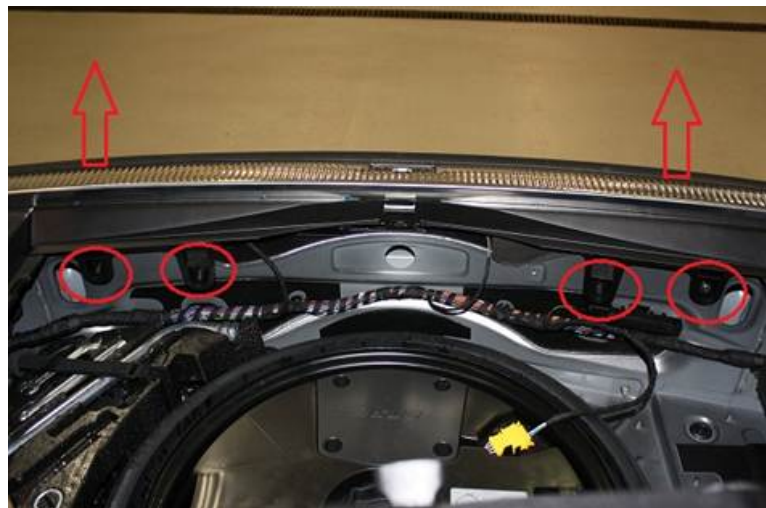
Figure 2. Rear cargo area trim plate removal in the Audi Q7. The T25 Torx® screws to be removed are circled in red.

- In the Audi Q7: Remove the four T25 Torx® screws (Figure 2), then carefully pull up on the plate.
- In the Audi Q5: The plate is not held by screws. Carefully lift the plate straight up, noting the four clips retained in the trim.

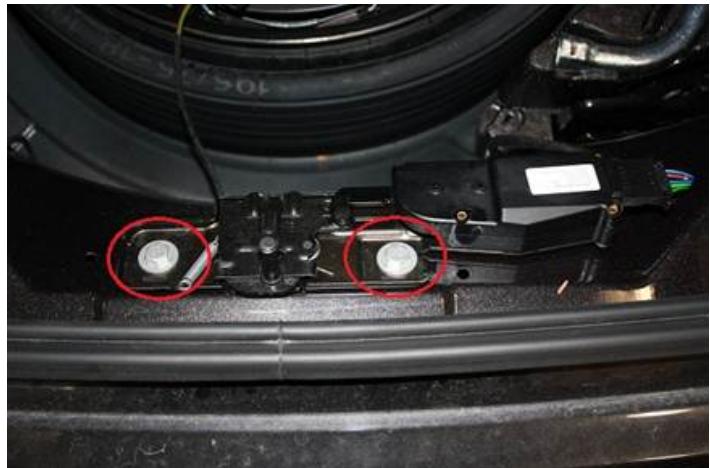
Figure 3. Power lid's motorized striker plate bolted mounting.

2. Note the current position of the striker plate by using the serrated lines surrounding the bolt or surrounding the nut's integrated washer (Figure 3 - Figure 6).

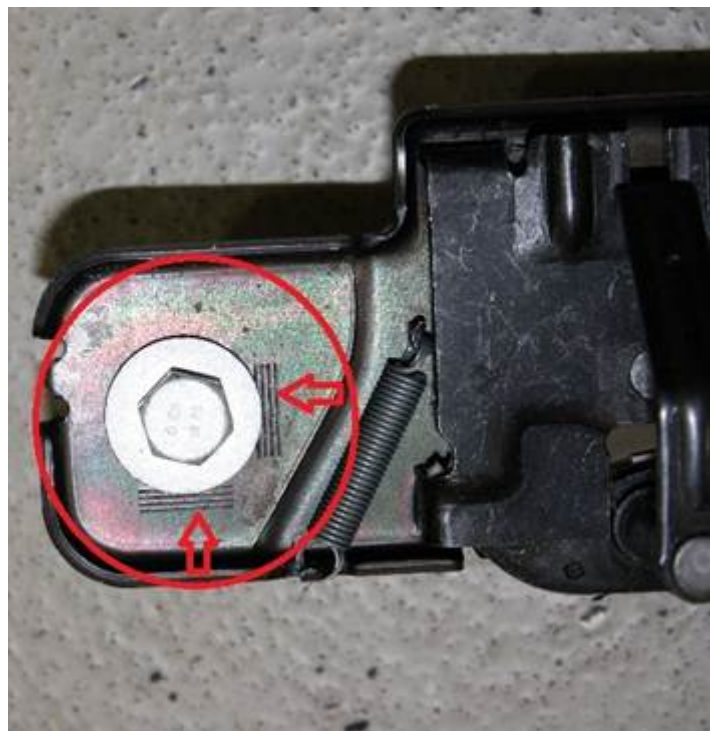
Figure 4. Power lid's motorized striker plate adjustability and serrated indicators.

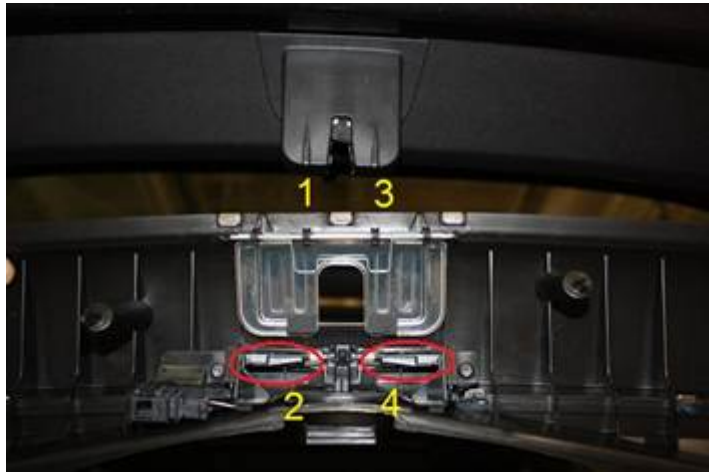
Figure 7. Inside vehicle view of rear lid latch showing location of G526 (2) and G525 (4) on rear sill trim, and contact points (1 and 3).

3. Adjust the striker plate until the lid latch is evenly drawn in to actuate the G526 and G525 paddle switches (Figure 7, 2 and 4). Center the striker plate latch to the lid latch.

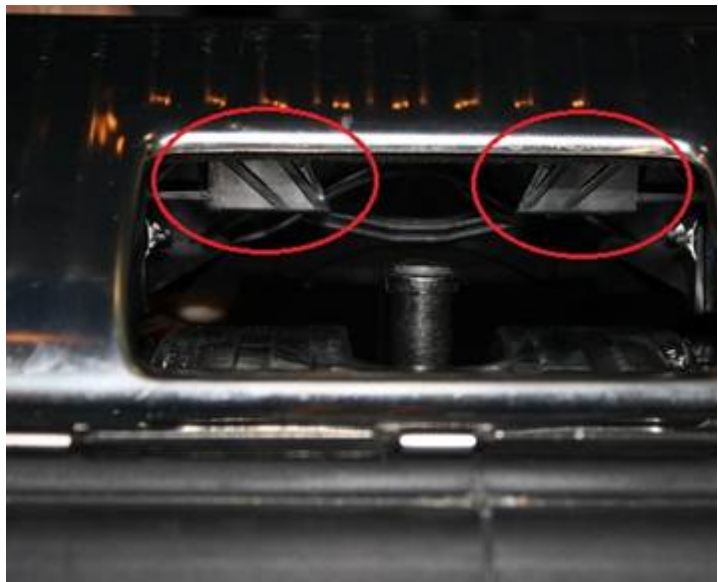
Figure 8. Overhead view of paddles contacted by rear lid latch.

Tip: Moving the striker plate latch towards the front of the vehicle will bring the lid latch closer to actuating the paddle switches (Figure 8).
