# Technical Service Bulletin

## 55 Rear Lid Switch (DTC 03073 - Closed Rear Lid Sensor - Incorrect Signal)

94 13 23 2033675/3 July 12, 2013. Supersedes Technical Service Bulletin Group 94 number 13-17 dated May 22, 2013 for reasons listed below.

Model(s)	Year	VIN Range	Vehicle-Specific Equipment
Q7	2007-2014	All	NA

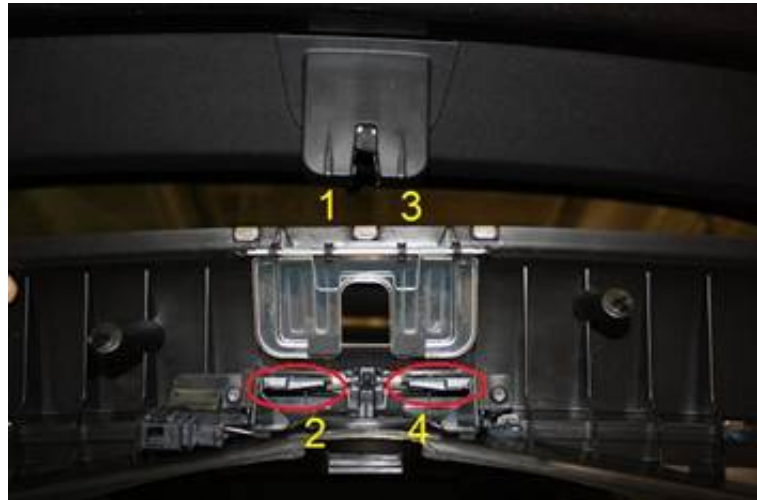
In order for the vehicle to receive a proper rear lid status signal when the lid is operated, the paddle switches on the rear sill trim must contact the opposing lid latch points uniformly.

- Paddle switch G526 (Figure 1, 2) must contact lid latch point 1 (Figure 1, 1), as shown in the image at right.
- Paddle switch G525 (Figure 1, 4) must contact lid latch point 3 (Figure 1, 3), as shown in the image at right.

**Figure 1.** Inside vehicle view of rear lid latch showing location of G526 (2) and G525 (4) on rear sill trim, and contact points (1 and 3).

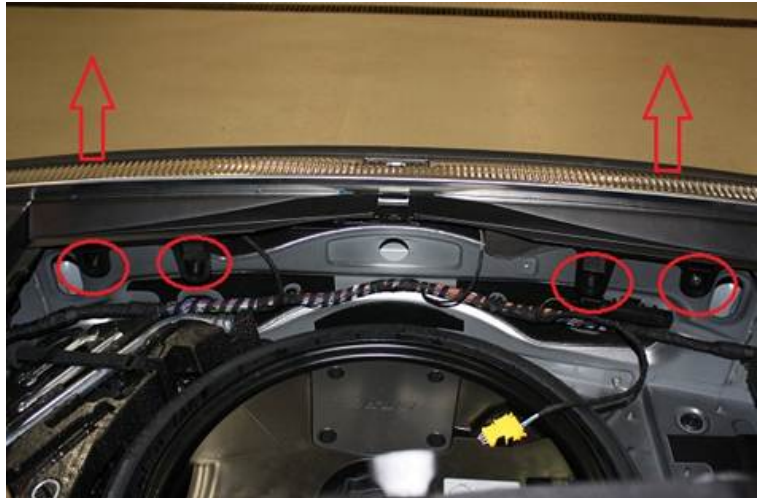
**Figure 2.** Rear cargo area trim plate removal. The T25 Torx® screws to be removed are circled in red.

1. Remove the rear trim plate by first removing the four T25 Torx® screws (Figure 2), then carefully pulling up on the plate.

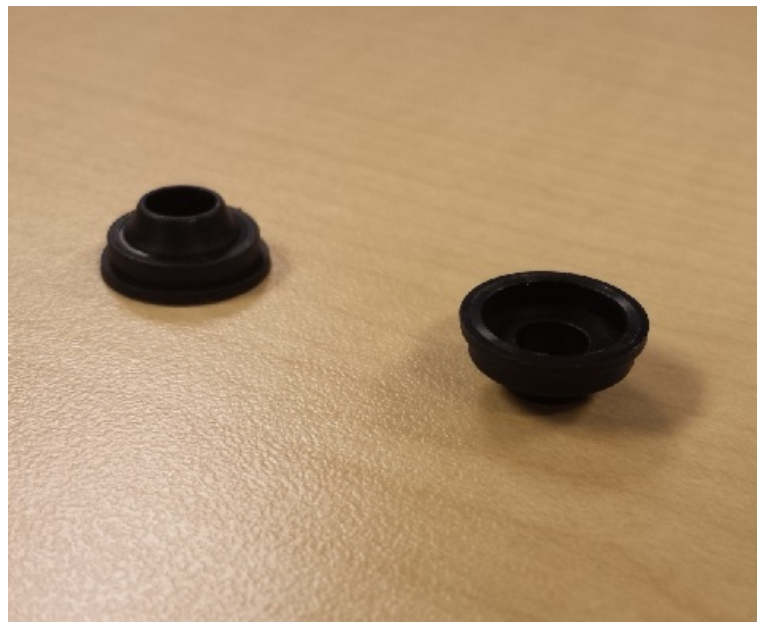
**Figure 3.** Spacers for underneath paddle switch assembly.

2. Remove the two T20 Torx® screws that hold down the paddle switch assembly. Install spacers (**4L0863191A 4PK**) (Figure 3) between the paddle switch and the trim. The large diameter faces the switch and small diameter faces the mounting.

**Tip:** If factory service parts are not available, improvise by using spacers with dimensions of no less than 5.5mm I.D., no greater than 13mm O.D., and no thicker than 5.6mm.

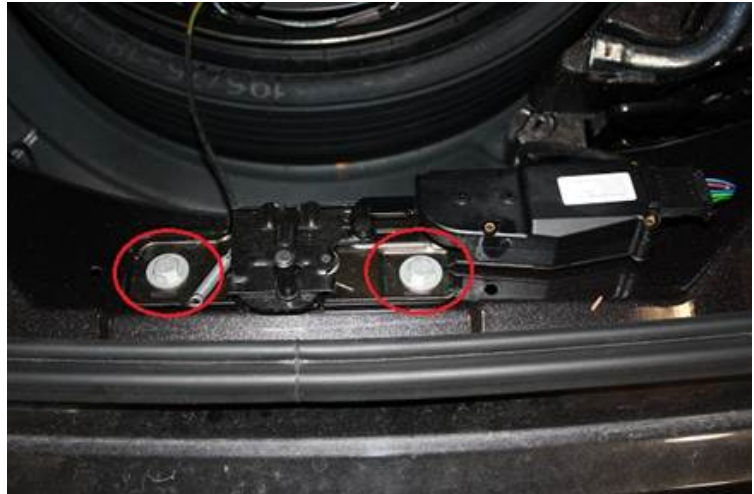
**Figure 4.** Power lid's motorized striker plate bolted mounting.

Note the current position of the striker plate by using the serrated lines surrounding the bolt or surrounding the nut's integrated washer (Figure 4 and Figure 5).

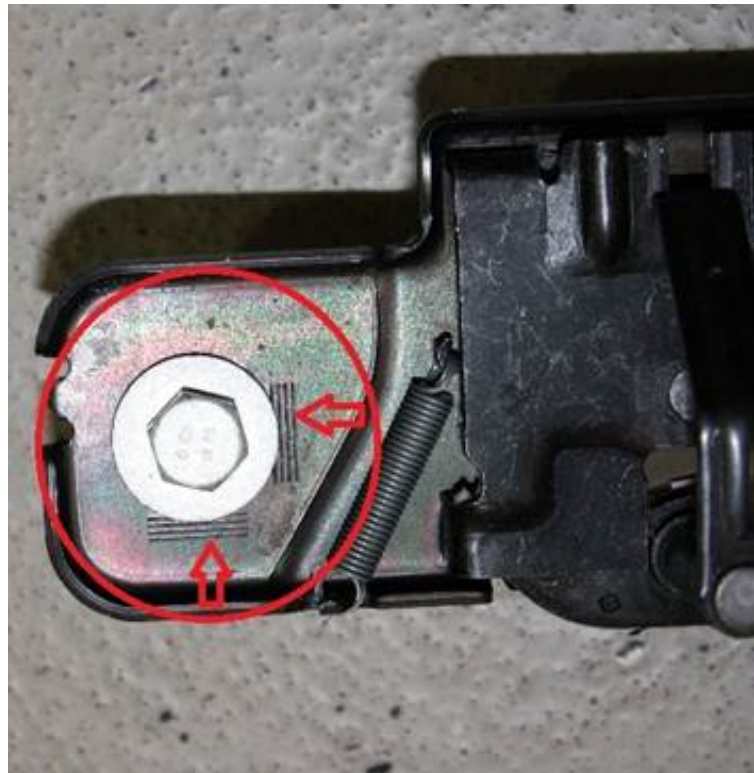
**Figure 5.** Power lid's motorized striker plate adjustability and serrated indicators.

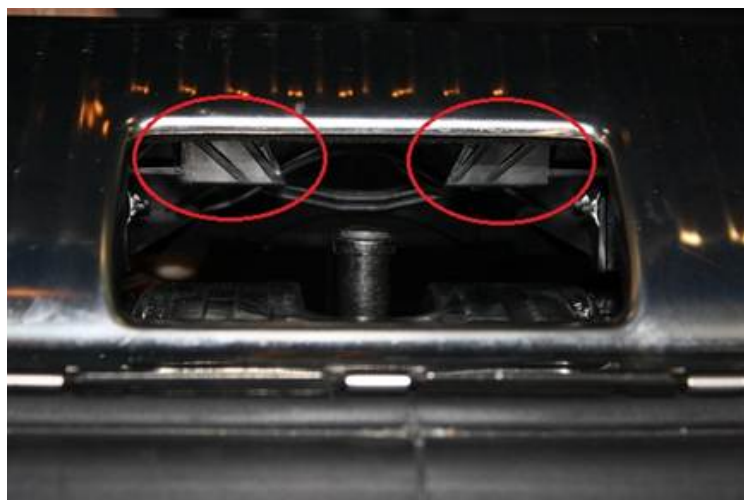
**Figure 6.** Overhead view of paddles contacted by rear lid latch.

**Tip:** Moving the striker plate latch towards the front of the vehicle will bring the lid latch closer to actuating the paddle switches (Figure 6). Do not move the latch forward too far to ensure that the lid is not pulled in with greater force than necessary.
