Technical Service Bulletin

94 Moisture accumulation in headlamps

94 13 24 2028277/8 July 18, 2013. Supersedes Technical Service Bulletin Group 94 number 13-20 dated July 3, 2013 for reasons listed below.

Model(s)	Year	VIN Range	Vehicle-Specific Equipment
Q7	2010 - 2014	All	Not Applicable

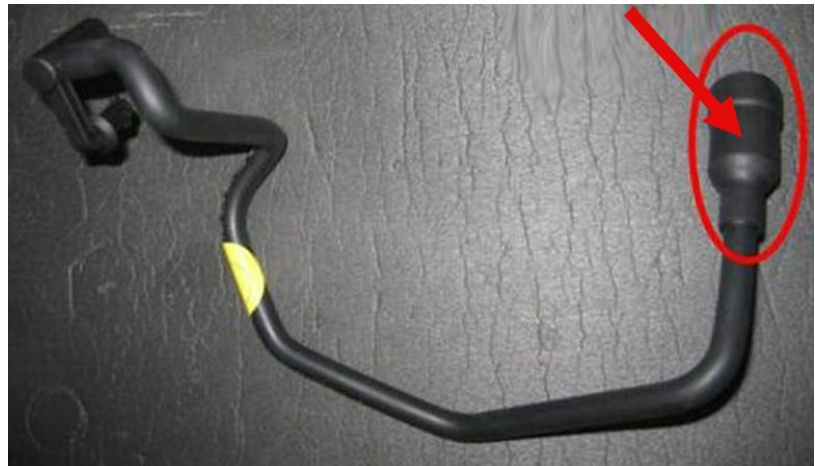
Tip: The updated ventilation hose can be recognized by the integrated filter (Figure 2, arrow).

Figure 2. Updated ventilation hose with integrated filter.

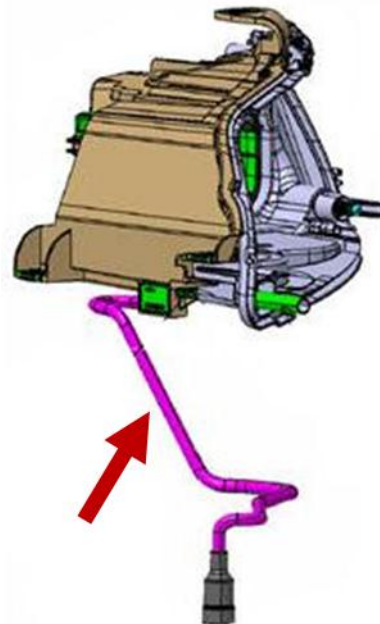
i **Tip:** The updated ventilation hose is not connected directly to the headlamp housing. The hose routes downward from the headlamp carrier and between the radiator and bumper (Figure 3, arrow).

Figure 3. Mounting of updated ventilation hose.
