Technical Service Bulletin

94 Moisture accumulation in headlamps

94 13 30 2028277/10 December 20, 2013. Supersedes Technical Service Bulletin Group 94 number 13-28 dated August 13, 2013 for reasons listed below.

Model(s)	Year	VIN Range	Vehicle-Specific Equipment
Q7	2010 - 2014	All	Not Applicable

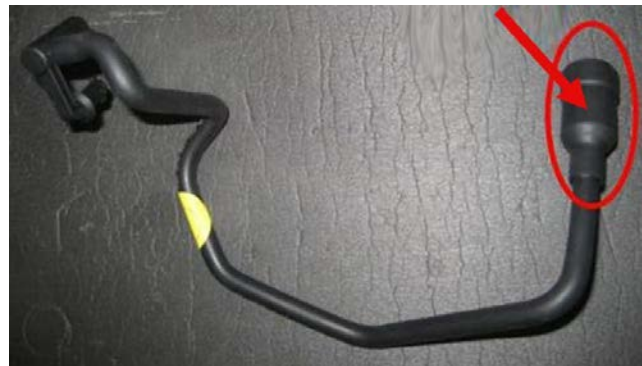
Figure 2. Updated ventilation hose with integrated filter.

**Tip:** The updated ventilation hose can be recognized by the integrated filter (Figure 2, arrow).

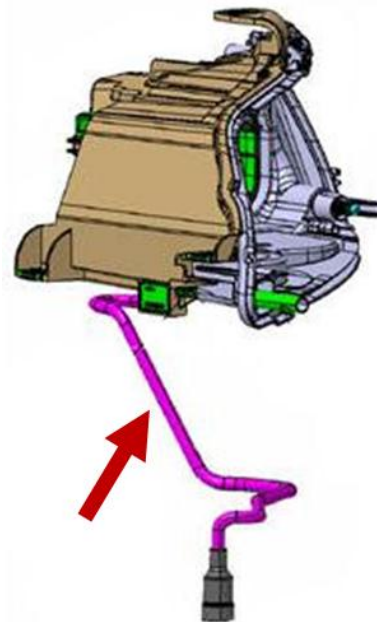
Figure 3. Mounting of updated ventilation hose.

**Tip:** The updated ventilation hose is not connected directly to the headlamp housing. The hose routes downward from the headlamp carrier and between the radiator and bumper (Figure 3, arrow).

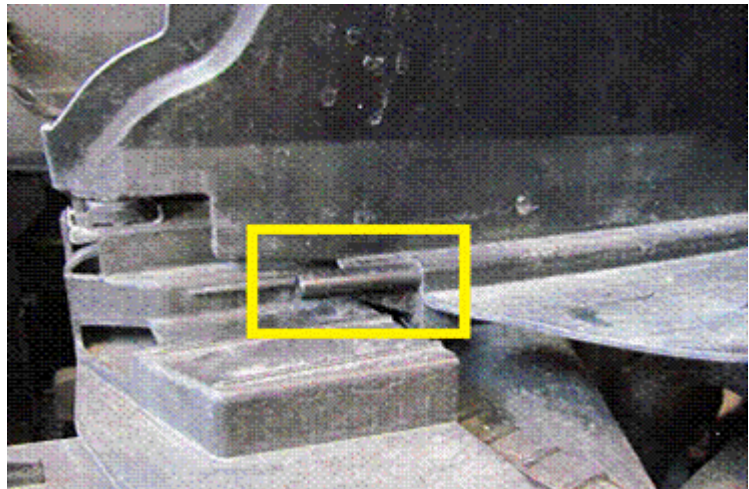
Figure 4. Headlamp ventilation guide tube.

- Each headlamp air ventilation tube must be sealed to protect against further moisture ingress (Figure 4).

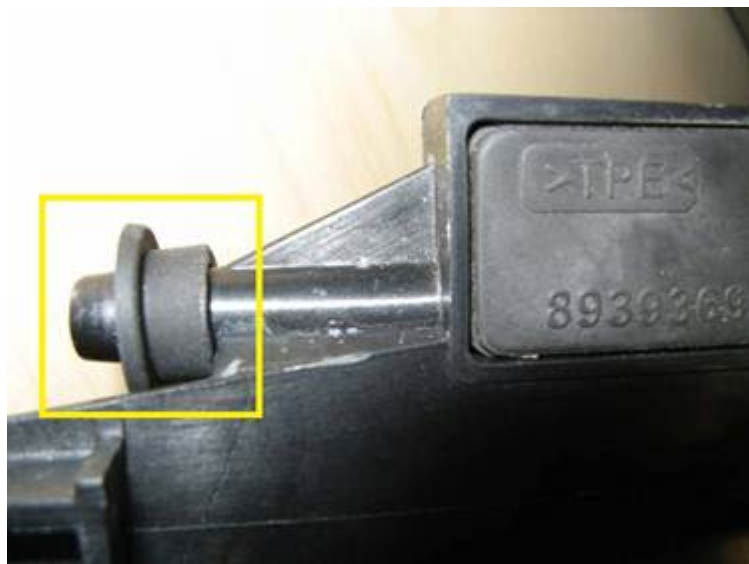
Figure 5. Ring seal installed on headlamp air tube.

- Install ring seal on headlamp air ventilation tube (Figure 5). The larger diameter of the seal faces the headlamp.

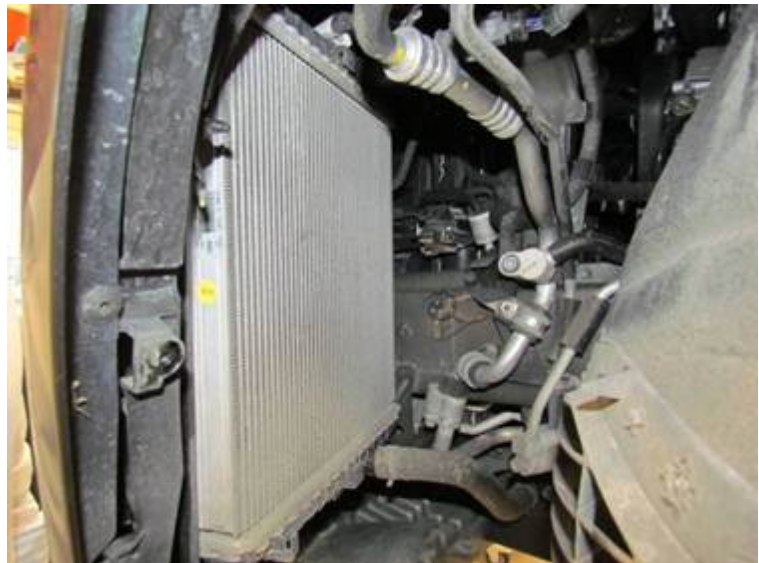
Figure 6. View of additional radiator with wheel well liner removed.

7. Remove front wheels and wheel housing liners. The rear of the charge air coolers or additional radiators will be exposed (Figure 6).

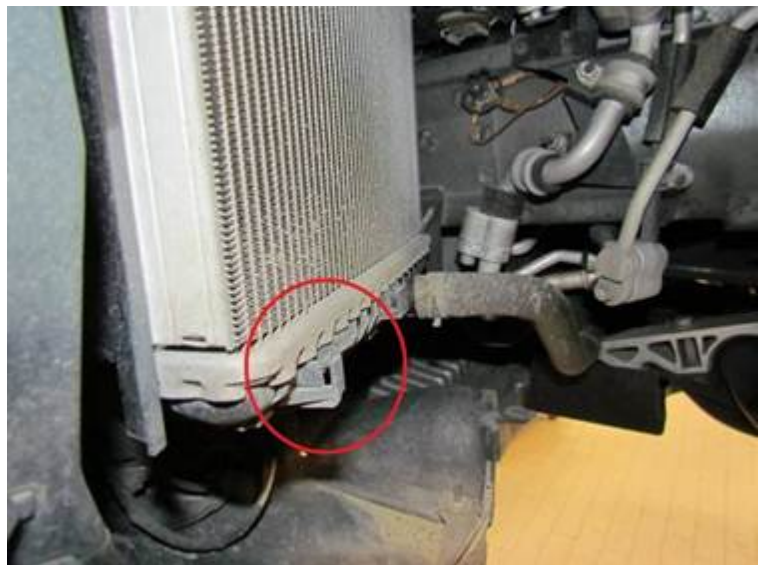
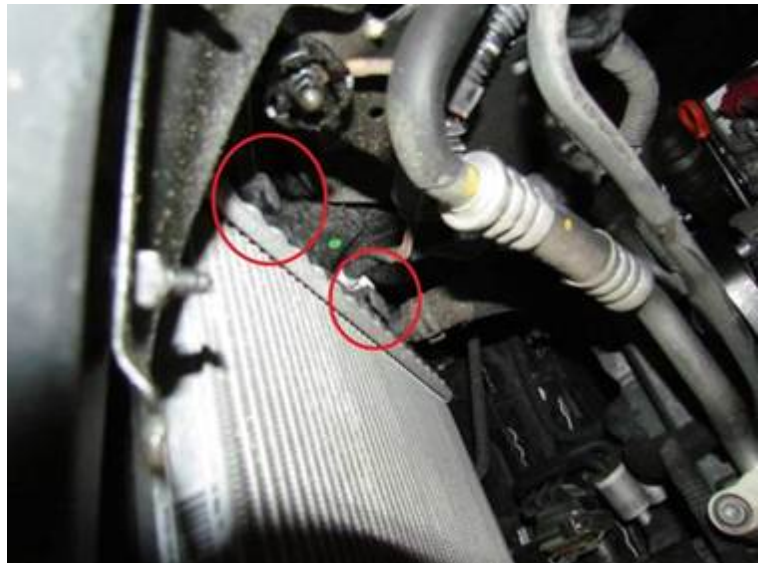
Figure 7. Lower exit air duct attachment point to additional radiator.

Figure 8. Upper exit air duct attachment points to additional radiator.

8. Locate exit air duct attachment hooks on the left and right charge air coolers or additional radiators (Figures 7 and 8).

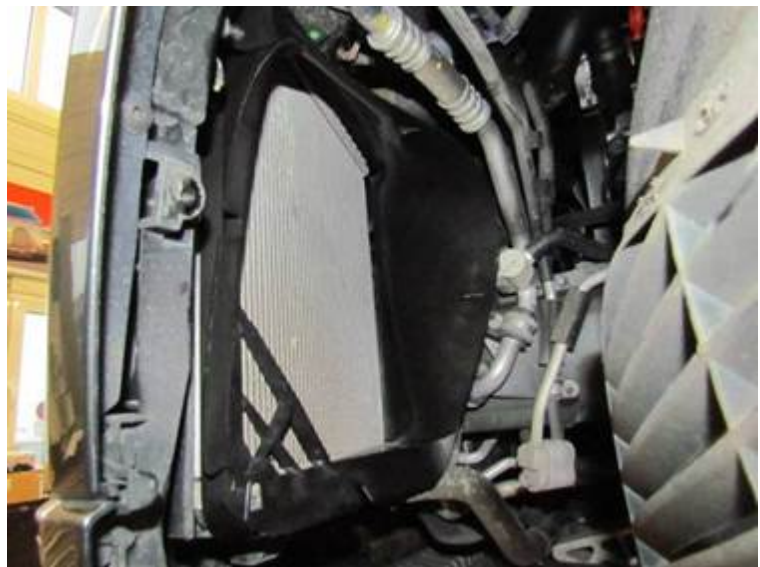
Figure 9. Exit air duct installed.

9. Affix left and right exit air ducts (Figure 9).
