# Technical Service Bulletin

## 96 False warning by lane change assistant (Audi Side Assist)

96 13 62 2033782/1 May 28, 2013.

Model(s)	Year	VIN Range	Vehicle-Specific Equipment
2013	A4 allroad	000001- 156231	Audi Side Assist

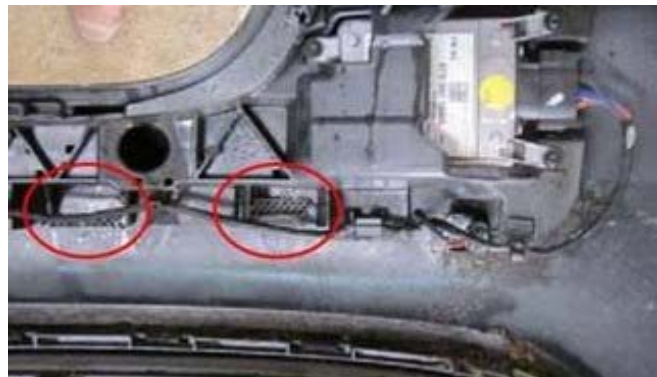
3. Perform a visual inspection of the plastic mounting brackets for the J769 and J770 control units. It is possible the plastic weld has come loose or is broken apart from the rear bumper cover (Figure 5).

**Figure 5.** Bumper bracket weld locations with broken welds.

4. Replace the rear bumper cover assembly if the bracket is loose (Figure 6).

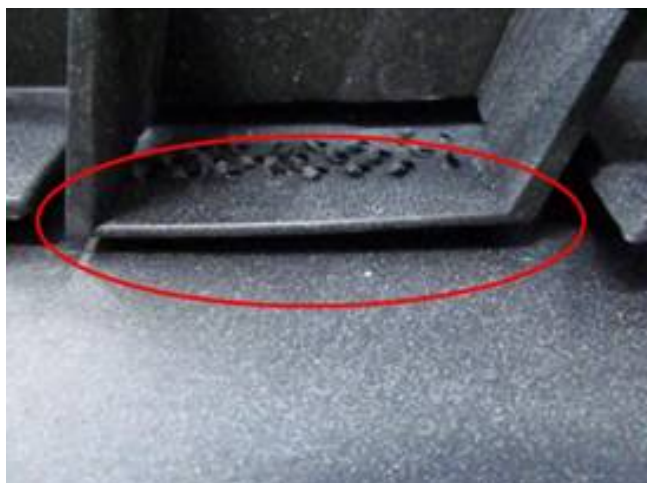
**Figure 6.** Loose bracket.

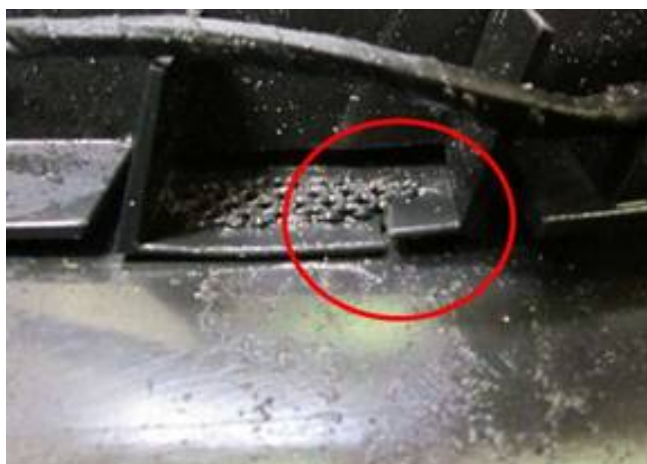
**Figure 7.** Broken bracket.

5. Replace the rear bumper cover assembly if the bracket is broken (Figure 7).
