Technical Service Bulletin

96 Rattle/clunk from front of vehicle while driving

96 13 58 2033812/1 May 7, 2013.

Model(s)	Year	VIN Range	Vehicle-Specific Equipment
A6/A7	2012-2014	All	Homelink

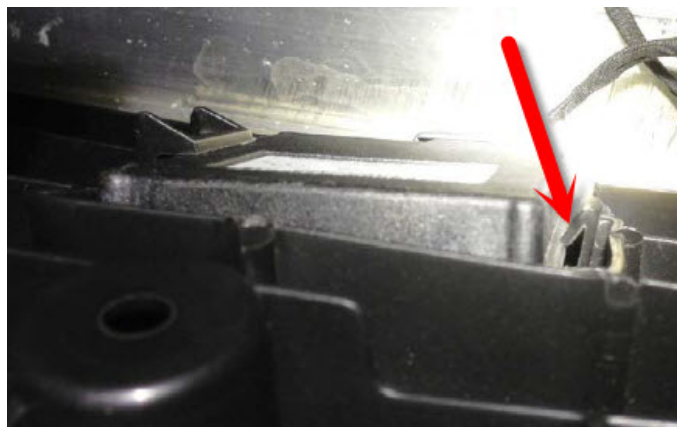
The locking tab for the Homelink control module does not securely hold the module in place (Figure 1), which causes it to come loose and bang against various support structures at the front of the vehicle (Figure 2).

Figure 1. Homelink control module tab not secure.

1. Reinstall the Homelink control module into factory location.
2. Using clip **3D0971838E**, trim extra support bracket highlighted in red as shown in the illustration at right (Figure 3).

3. Install the modified clip behind the locking tab to secure it in place (Figure 4).

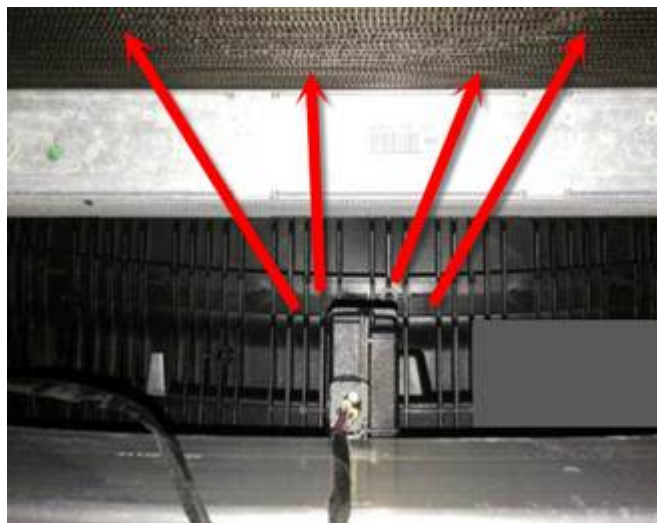
Figure 2. Loose Homelink module hitting AC condenser.

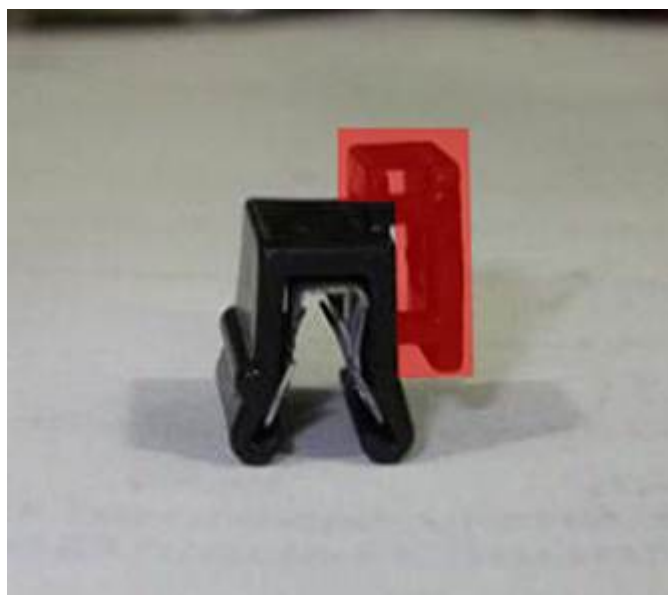
Figure 3. Retaining clip with highlighted section to be removed.

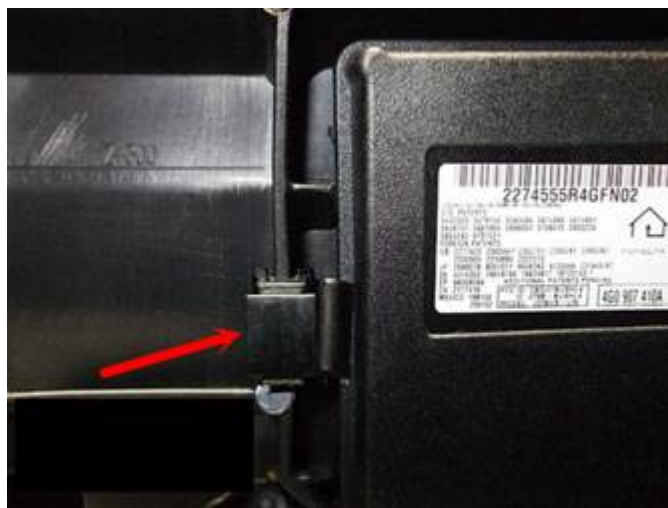
Figure 4. Modified clip installed behind locking tab.
