Technical Service Bulletin

PSS 96 Lane Change Assistant "Sensors Blocked" warning in DIS

96 13 60 2033943/1 May 23, 2013.

Model(s)	Year	VIN Range	Vehicle-Specific Equipment
A4/S4	2013	All	Lane Change Assistant
allroad	2013		
A5/S5/RS 5	2013

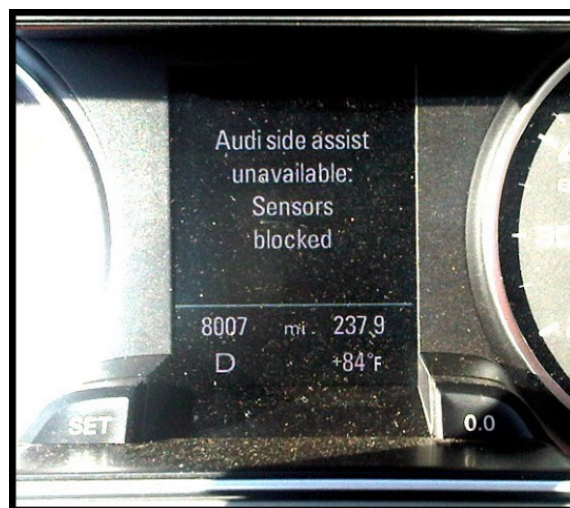
- Audi Lane Change Assistant (Side Assist) deactivates or is sporadically inoperative when the vehicle is driven in slow-moving, stop-and-go traffic or when it is driven for long periods of time on open roads that have no traffic.
- A warning message is seen in the instrument cluster driver information system stating "Audi side assist unavailable: Sensors blocked".

Figure 1. Audi Side Assist warning in DIS

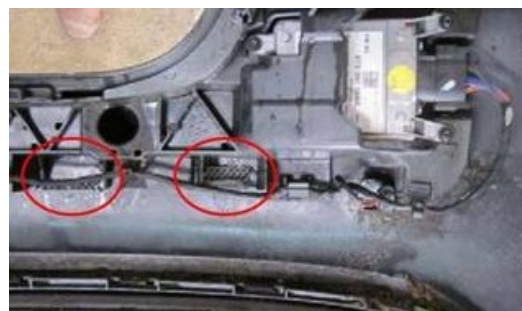
- Audi Lane Change Assistant can be activated without issue.
- No obstructions can be found.
- One or both of the following DTCs is stored in the Lane Change Assistance control module, J769 (address word 3C):
 - **DTC C1114F3** (Lane change assistance control module Restricted view Sporadic)
 - **DTC C1115F5** (Lane change assistance control module 2 Restricted view Sporadic)
- No damage is found to the rear bumper area, inside and outside (Figure 2) (If any damage is found, it is not covered under warranty).

Figure 2. Mounting bracket for one of the ECUs.

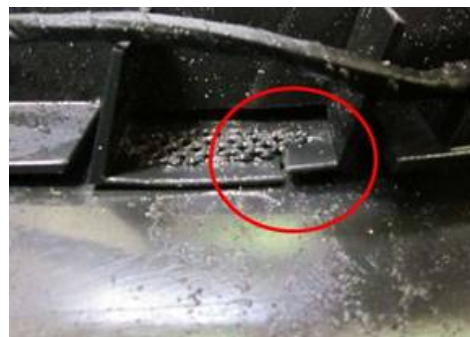
Figure 3. Mounting bracket broken

- The control unit mounting brackets are securely fastened to the lower rear bumper, and they are not loose or broken (Figures 3 and 4).
If a loose bracket is found, repair as necessary using the ElsaWeb Repair Manual. Submit a separate warranty claim, as this TSB does not cover this repair.

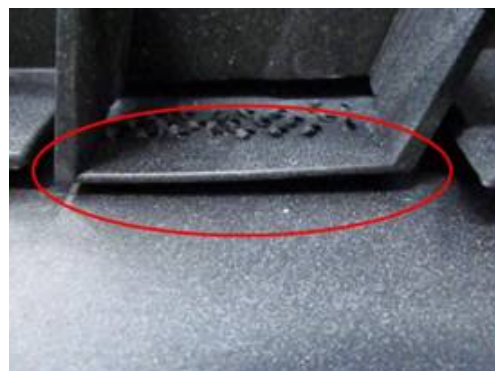
Figure 4. Mounting bracket loose
