#### 96 Homelink controls pressed into roof assembly

96 13 66 2033802/2 June 27, 2013. Supersedes Technical Service Bulletin Group 96 number 13-57 dated May 2, 2013 for reasons listed below.

Model(s)	Year	VIN Range	Vehicle-Specific Equipment
A6/A7	2012-2014	All	Homelink

**Technical Service Bulletin**

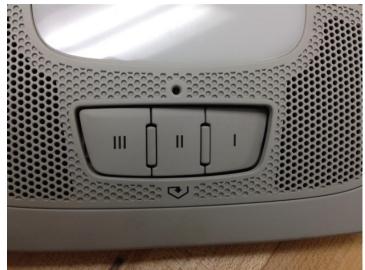
Customer states the Homelink controls are pressed into the interior light assembly (Figure 1).

*Figure 1.* Homelink buttons pressed into the interior light assembly.

Clips holding the Homelink buttons in place are too weak.

- For vehicles built before VIN DN148000, replace only the interior light assembly.
- For vehicles built after VIN DN148000, replace both the interior light assembly and the Homelink controls. Retain all parts from the repair, as they will be requested by the Warranty Parts Return Center.
