# Technical Service Bulletin

## 96 Lane Change Assistant sporadically inoperative

96 13 74 2034000/2 September 11, 2013. Supersedes Technical Service Bulletin Group 96 number 13-63 dated May 29, 2013 for reasons listed below.

Model(s)	Year	VIN Range	Vehicle-Specific Equipment
A6/A7	2012-2012	All	Lane Change Assistant
A6/A7	2013	000001 - 139171	Lane Change Assistant
A8	2011-2012	All	Lane Change Assistant
A8	2013	000001 - 031491	Lane Change Assistant

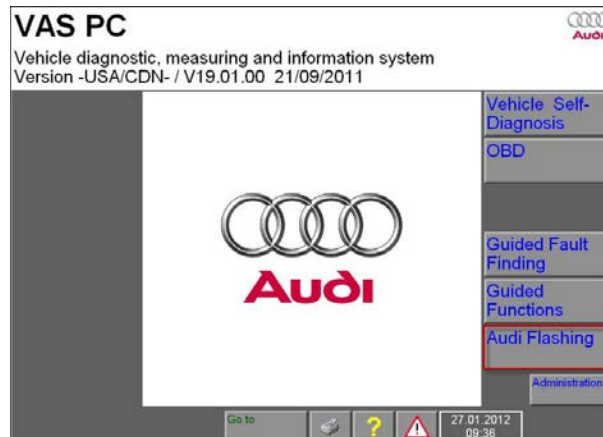
- Turn off any appliances with high electromagnetic radiation (such as mobile phones).
  - If communication with a module cannot be properly established, appropriate repairs must be made before attempting SVM. If the tester cannot communicate with a module, the tester cannot flash software onto the module.
5. Enter the SVM code into the User Test Plan by selecting the **Audi Flashing** option at the main tester screen, unless otherwise directed by the TSB or TAC Helpline.

Figure 2. Audi Flashing.
