# Technical Service Bulletin

## 96 False warning by lane change assistant (Audi Side Assist)

96 13 76 2030583/3 September 23, 2013. Supersedes Technical Service Bulletin Group 96 number 13-56 dated May 2, 2013 for reasons listed below.

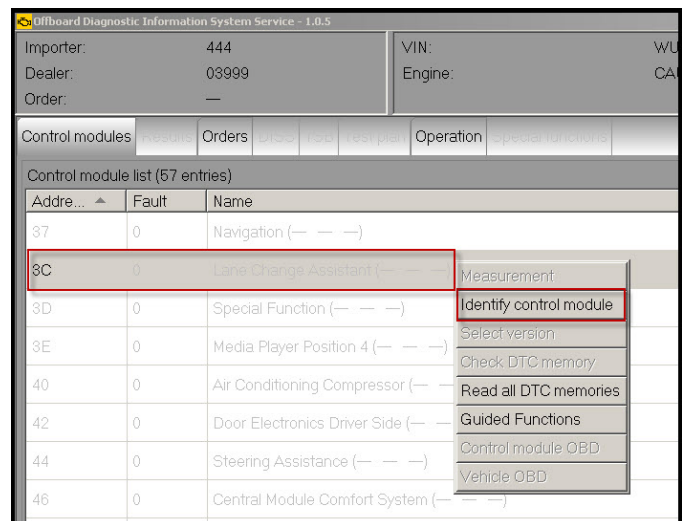
Figure 1. 3C Lane Change Assistant is greyed out until "Identify control module" is selected

Start Diagnosis -> Fill out Engine Information from drop down menu -> Uncheck option for "Guided Fault Finding" --> Select Tab "Control module list" --> Scroll down list to "3C Lane Change Assistant" (ECU option will be greyed out) -> Right click on "3C Lane Change Assistant" and select "Identify control module" (Figure 1).

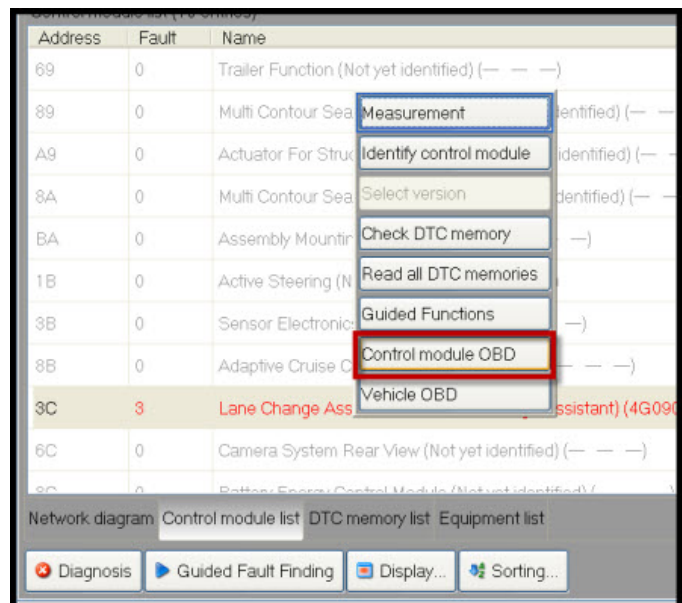
Figure 2. Software part number is identified as "VW/Audi part number" using ODIS

Once the information has populated, right-click on "3C Lane Change Assistant" and select "Control Module ODB" (Figure 2).

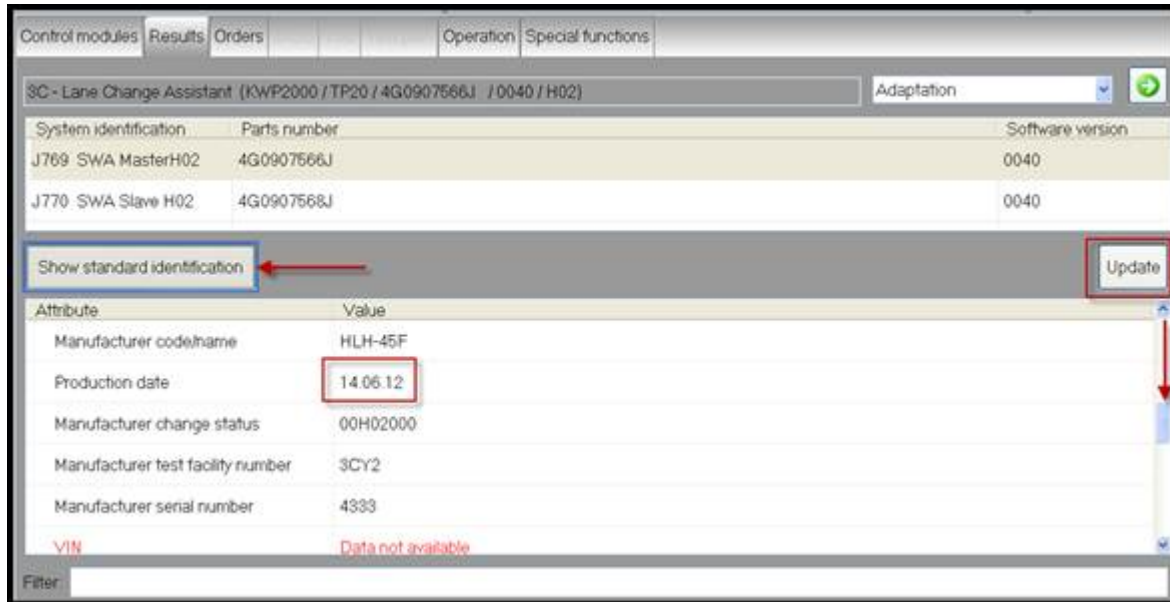
**Figure 3.** Control Module OBD screen showing part information and production date.

Under the Results tab, click on the button “Show Advanced Identification” (Figure 3), and then select the “Update” button on the right.

Click on the “SWA MasterH0X” at the top and then scroll down in the lower half of the screen until the “Production date” field (“X” can be any number, i.e. “SWA MasterH02” and will represent the hardware version of the ECU).
