Technical Service Bulletin

96 Lane Change Assistant "Sensors Blocked" warning in DIS (DTC C1114F3 and C1115F5)

96 13 79 2035047/3 December 5, 2013. Supersedes Technical Service Bulletin Group 96 number 13-77 dated September 23, 2013 for reasons listed below.

Model(s)	Year	VIN Range	Vehicle-Specific Equipment
A4	2013-2014	All	Audi Side Assist
A5	2013-2014		
A5 CAB	2013-2014		
allroad	2013-2014		
Q5	2013-2014

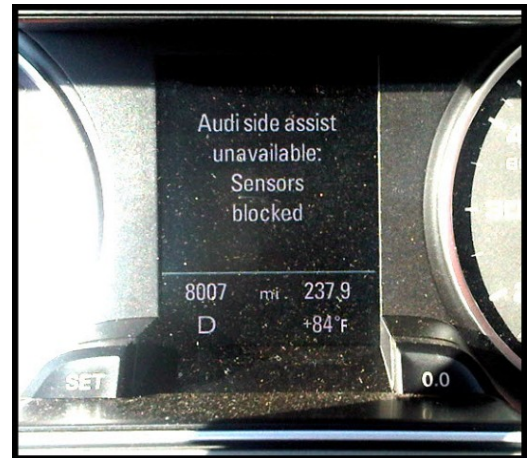
- Audi Lane Change Assistant deactivates or is sporadically inoperative when the vehicle is driven in slow-moving stop-and-go traffic, especially on roads with multiple lanes.
- The message “Audi side assist unavailable: Sensors blocked” appears in the driver information system (Figure 1).

Figure 1. Audi Side Assist warning in DIS

The software parameter update below will optimize the appearance of the “sensors blocked” message when the vehicle is driven in heavy stop-and-go traffic at low speeds. The updated parameter set will not remove the condition completely, as it is considered normal. The condition and the behavior of the system should be explained to the customer to prevent unnecessary repairs in the future.

- Follow all instructions in the attached TSB, 2011732: *00 Software Version Management (SVM), operating instructions.*
- Update the Lane Change Assistant, J769, using the SVM code as listed in the table below if necessary. The A4 allroad is the only vehicle that can receive a software update. The other models only receive an updated parameter set.

2. Calibrate the Audi Lane Change Assistant using the instructions listed in the Elsa Repair Manual: *Repair Manual >> Electrical System >> Electrical Equipment >> 96 Interior Lights, Switches >> Diagnosis and Testing >> Lane Change Assistance Control Module, Calibrating.*

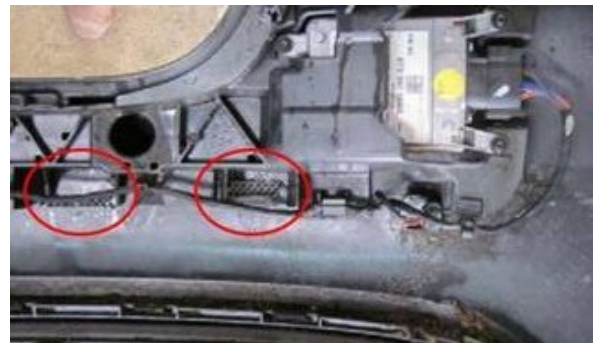
- One or both of the following DTCs is stored in the Lane Change Assistance control module, J769 (address word 3C):
 - **DTC C1114F3** (Lane change assistance control module Restricted view Sporadic)
 - **DTC C1115F5** (Lane change assistance control module 2 Restricted view Sporadic)
- Audi Lane Change Assistant can be activated without issue.
- No obstructions can be found on the outside or inside of bumper.
- No re-work of the bumper can be found (paint re-spray).
- The control module mounting brackets are securely fastened to the lower rear bumper, and no damage is found on the inside or on the outside rear bumper area (Figure 2).
(If any damage is found, it is not covered under warranty.)

Figure 2. Mounting bracket for one of the ECUs.

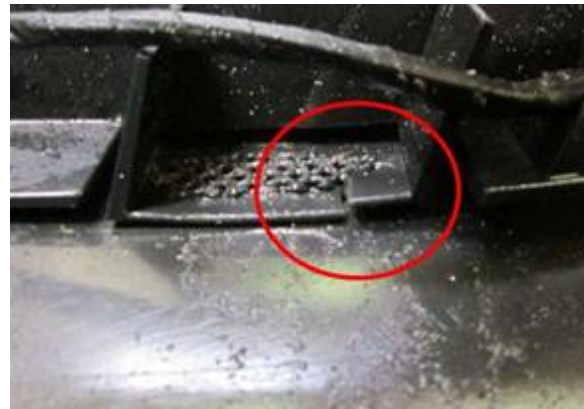
- The control module mounting brackets are not broken or loose (Figure 3 and Figure 4).
(If any damage is found, it is not covered under warranty.)

Figure 3. Broken mounting bracket

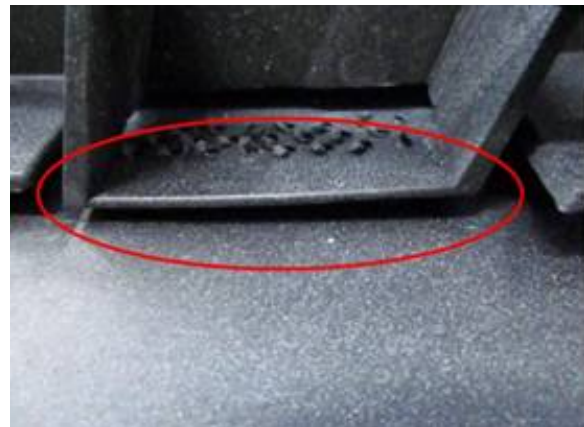
Figure 4. Loose mounting bracket.

Tip: If a loose bracket is found, repair as necessary using the Elsa Repair Manual. Submit a separate warranty claim, as this TSB does not cover this repair.
