Technical Service Bulletin

97 Alarm horn does not work or turns on without cause

97 13 36 2034322/1 July 10, 2013.

Model(s)	Year	VIN Range	Vehicle-Specific Equipment
A4	2012-2013	All	Not Applicable
A6	2012-2013		
A7	2010-2013

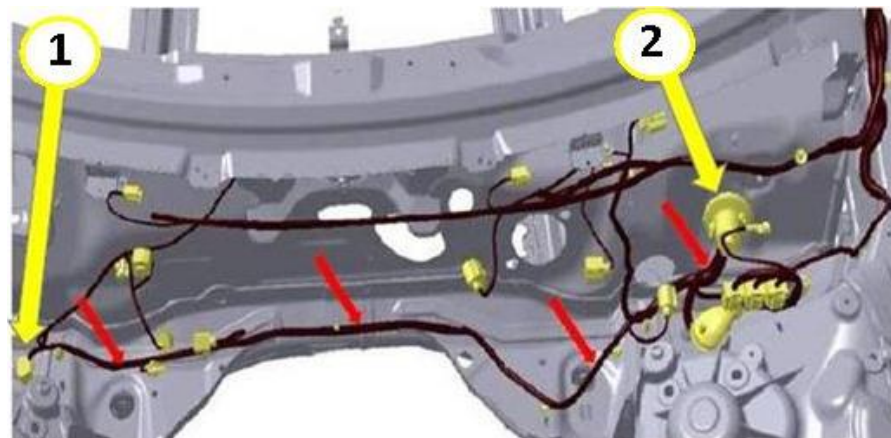
The horn, cables, and grommet are located in the plenum chamber. The grommet is located on the bulkhead in the plenum chamber (Figures 1 and 2).

Figure 1. A6 (C7) and A7 horn plug (1), grommet on bulkhead/plenum chamber (2), and cable routing (red arrows).

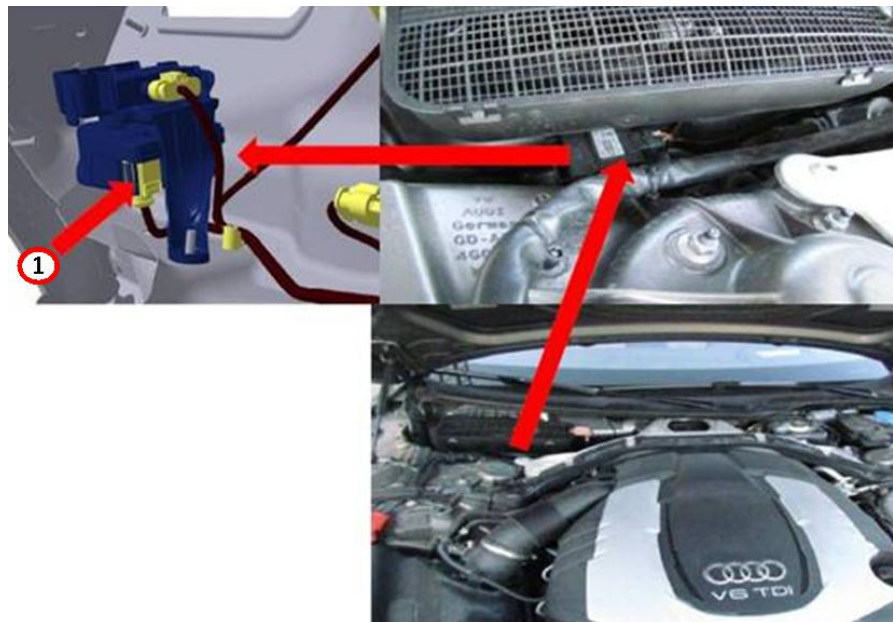
Figure 2. A6 (C7) and A7 horn position (1).

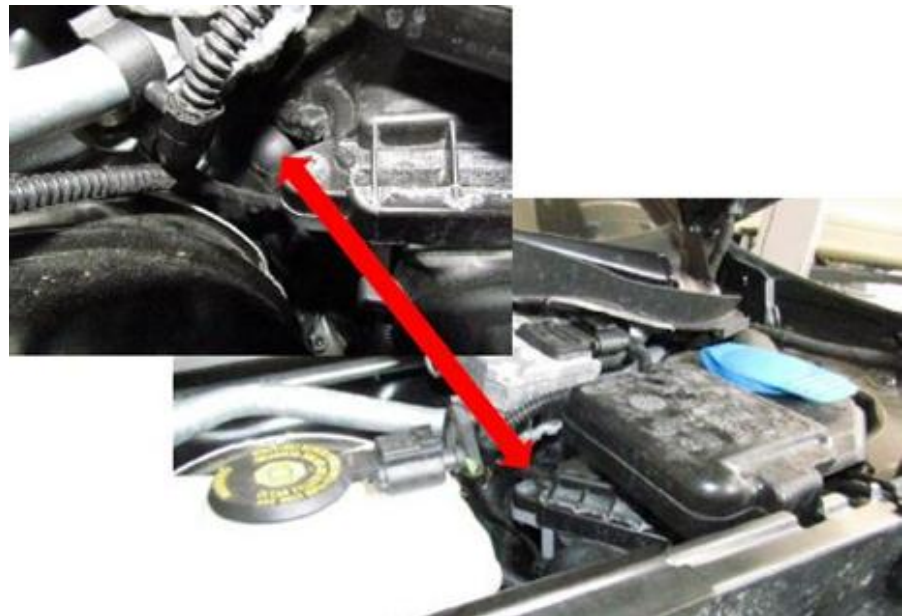
The horn, cables, and grommet are located in the plenum chamber. The cable routing is similar to that on the A6 (C7) and A7, but the grommet is located on the E-box and not on the bulkhead (Figures 3 and 4).

Figure 3. A4 grommet location.

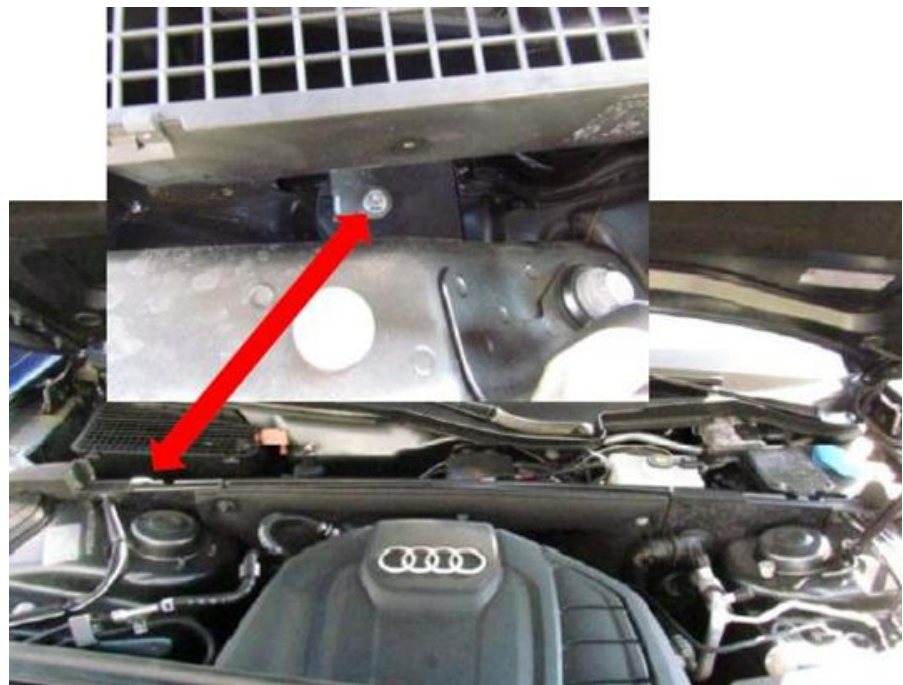
Figure 4. A4 horn position.

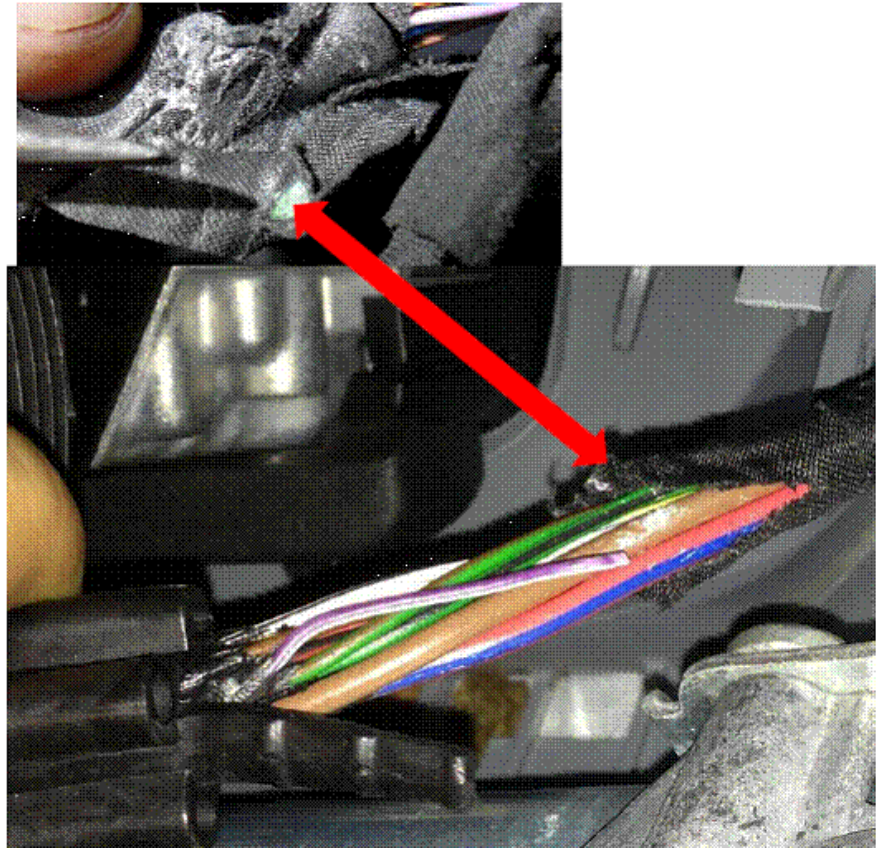
The wiring harness insulation for the alarm horn can be damaged during the vehicle production assembly. Because the cable is routed through the plenum chamber, water can enter into the cable via the damaged insulation. The water causes the alarm to activate for no reason or it causes the alarm horn to not work.

4. Examine the inside of the webbing for a white/green or red/green imprint. This imprint is a result of the production assembly damage to the wire insulation and of the corrosion caused by water ingress (Figure 5).

Figure 5. Color imprint on inside of webbing indicates point of damage.

5. Using the wiring repair kit **VAS 1978 B**, repair the damaged section as needed.
