# Service Bulletin

Bulletin No.: 08-08-67-013H

**Subject:** Snap, Pop, Creak or Rattle Noise from Lift Off Roof Panel While Driving  
(Verify Condition and Perform Appropriate Repairs)

**Models:** 2005-2013 Chevrolet Corvette  
Equipped with Removable Clear Roof Panel RPO CC3, Removable Sun Roof Panel  
RPO CF7 or Dual Removable Roof Panels RPO C2L

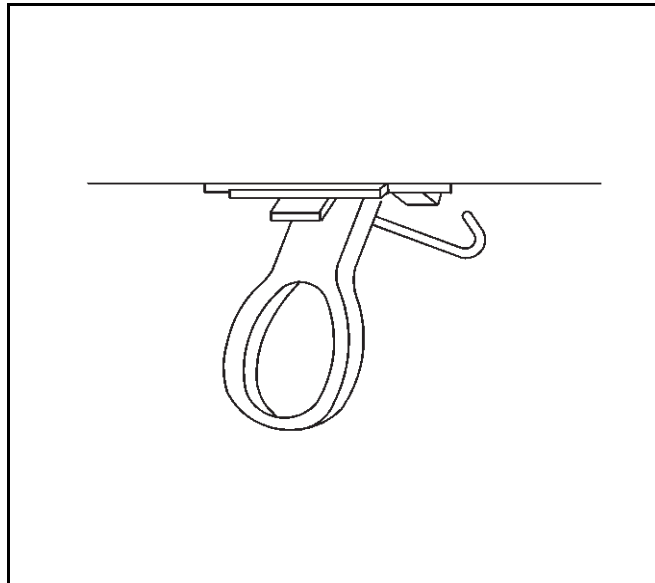
167241

- Insufficient clearance between the lift off roof panel and the leading edge of the rear roof bow.
- Possible crack at the rear edge of the lift off roof panel.
- Insufficient tension on the roof rear latching mechanism.

1. Verify there is sufficient gap, and that the lift off roof panel is not hitting the leading edge of the rear roof bow. If this condition exists, adjust the roof panel. Refer to Roof Lift Off Panel Adjustment in SI.
2. Inspect the rear edge of the lift off roof panel for cracks or chips. If a roof panel is dropped, or has been set down hard on the rear edge, it may crack the edge and cause a noise.

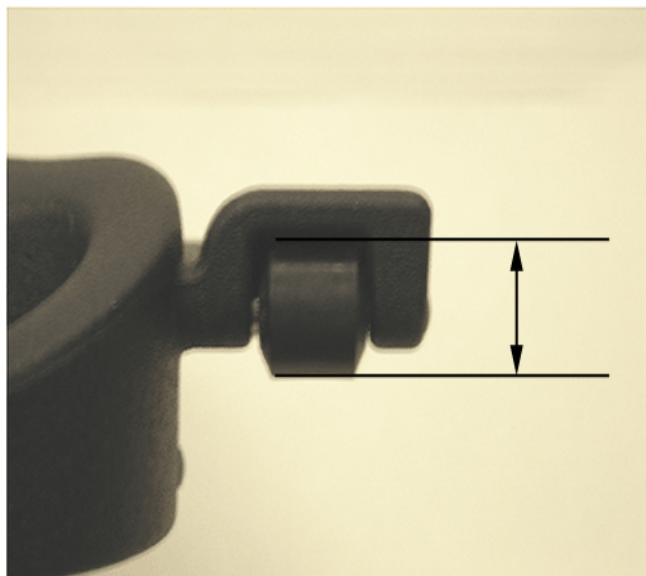
2236147

- If the roller is round and will spin on its axis (as shown above), they are early design handles and should be replaced. Replace the left and right front lift off roof panel handles with the current handle design parts noted previously, **and include the lubrication steps below.** Refer to Roof Lift Off Panel Front Latch Handle Replacement in SI.

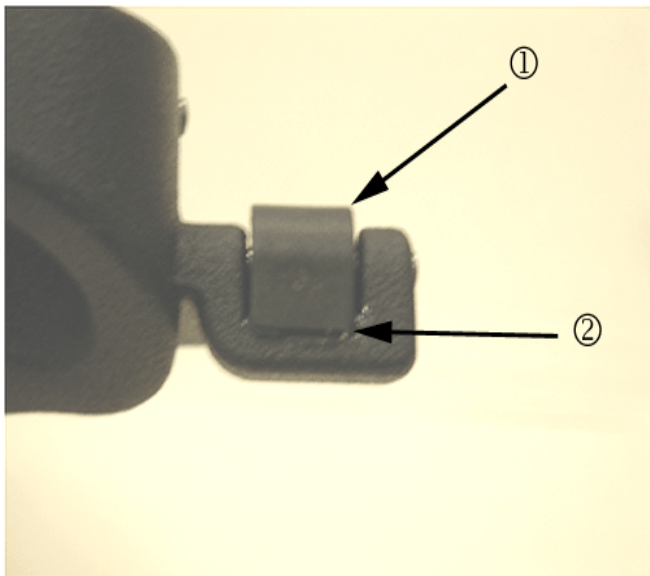
2236148

- If the roller is rounder on the contact side (1), and is flat and secured on the latch side (2), they are current design and DO NOT need replacement.

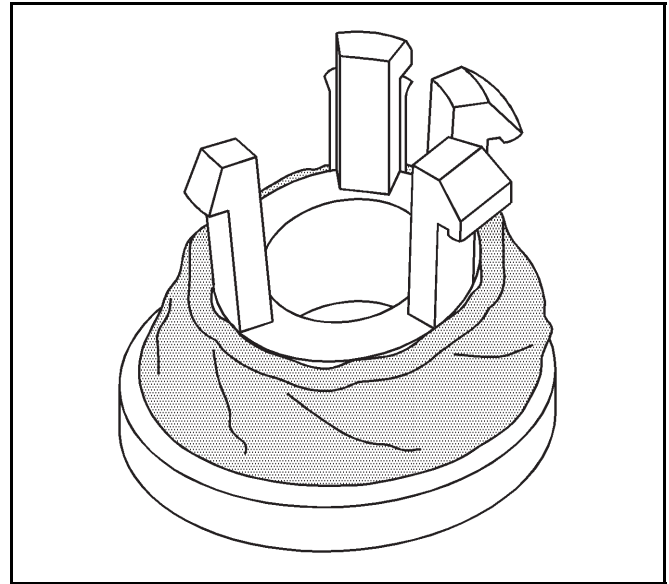
1935499

**Note:** The flocking is designed to insulate the cone when roof movement occurs.

- 3.3. Also verify that the inserts have an 8 mm (0.31 in) wide wrap of flocking tape toward the top of the cone, as shown above. If the flocking tape is worn or is missing, repair following the latest version of Corporate Bulletin Number 05-08-59-003.

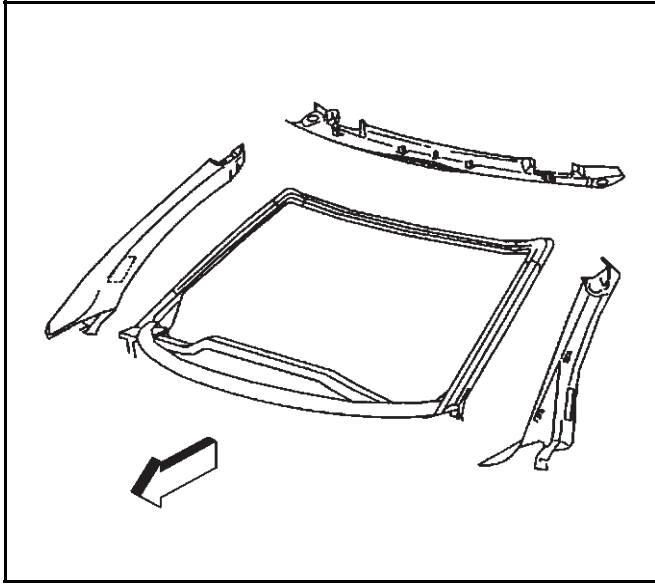
71178

The windshield side garnish moldings may be causing the noise.

The windshield upper garnish molding guides or the windshield header wiring harness may be causing the noise.

1. Remove the upper and both side windshield garnish moldings. Refer to Windshield Upper Garnish Molding Replacement in SI.
2. Follow the latest version of Corporate Bulletin Number 05-08-59-003 to add flocking tape to the "A" pillar garnish moldings.
