# Service Bulletin

Bulletin No.: 09-07-30-001F

**Subject:** Transmission Shudder or Bucking Feel (Follow Procedure Outlined Below)

**Models:** 2009 Cadillac Escalade  
2008-2009 Chevrolet Tahoe  
2008-2009 GMC Yukon  
Equipped with 2 Mode Hybrid Automatic Transmission (RPO M99)  
Built Prior to Serial Date 8010017028

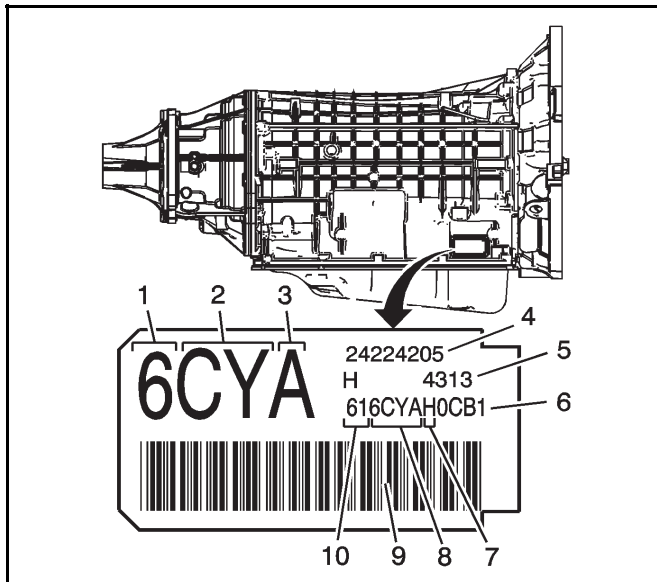
1963763

Refer to the illustration above to locate the sequential serial number (6).

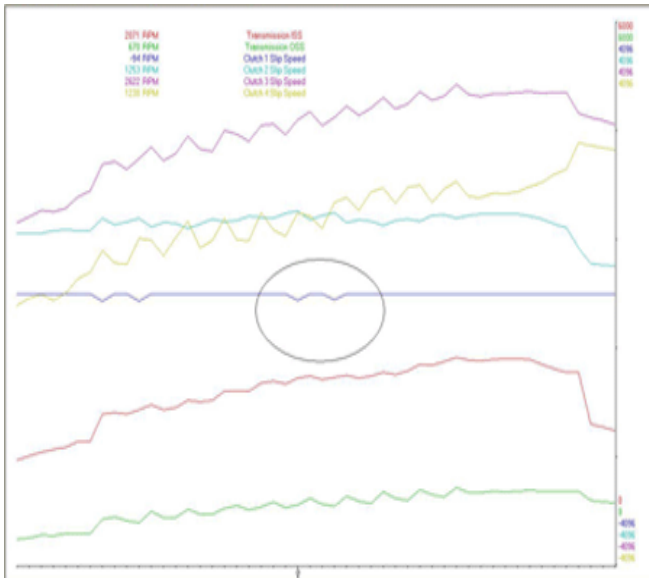
2535182

To verify the concern is caused by the orifice, monitor the Hybrid Low 1-2 clutch slip speed (clutch 1 on the scan tool). Normal clutch slip speed should be 0 rpm. If the slip speed varies either positive or negative slip rpm, or causes other clutch slip speeds to read erratic, the orifice is most likely restricted (see scan tool screen shot below showing variation of the clutch 1 slip speed (circled area). Normal reading would have a flat line (0 rpm).

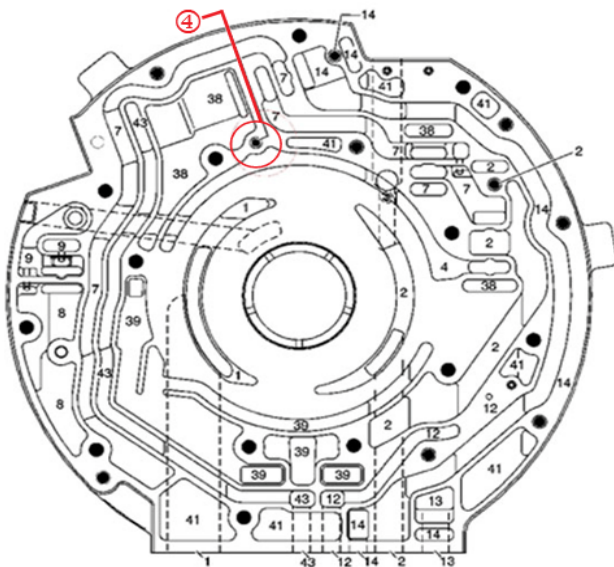
2707874

This condition may be caused by a restricted line pressure decrease orifice.

3. Remove and discard the orifice cup plug in the pump cover. The location is shown above (callout #4).
