Service Bulletin

Bulletin No.: 10-06-01-003C

Subject: Diagnostic Information on Internal Engine Noise or Damage After Oil Filter Replacement

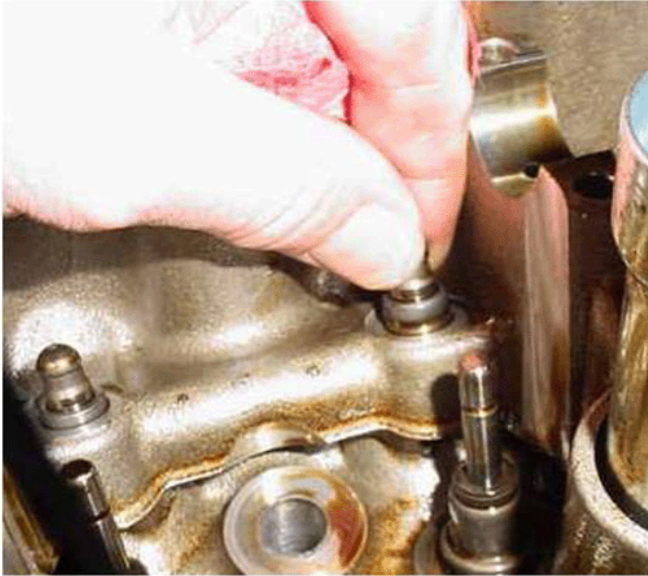
2479378

1. Does the noise only come from one bank location (intake or exhaust lifters area)?
2. If the noise is in the one bank location, then the oil galley lubrication hole may be obstructed with foreign material.

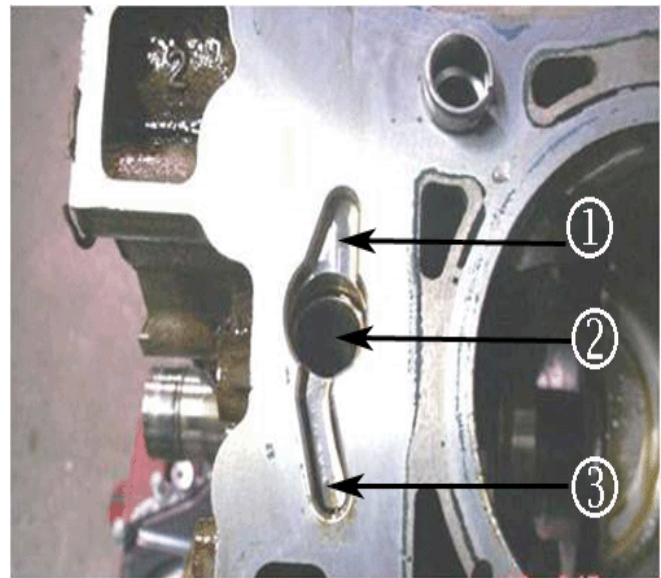
2479454

5. (A) Bank 1 (2, 4, 6) Reference 1—Intake oil galley for lifters, Reference 2—Camshaft Actuator (Phaser) Oil Galley, Reference 3- Exhaust Oil Galley for Lifters.

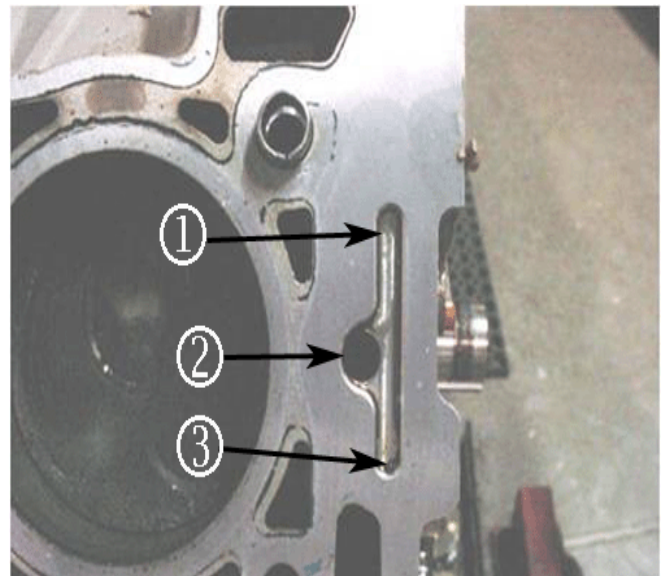
2479431

- (B) Bank 2 (1, 3, 5) Reference 1—Intake oil galley for lifters, Reference 2—Camshaft Actuator (Phaser) Oil Galley, Reference 3- Exhaust Oil Galley for Lifters.

An obstruction to oil flow is present at the engine block deck passage under the head gasket for lifter oil pressure. The passage is the location in the front engine block deck. The oiling passage can be identified as a hole with eye brows cut to each side. See figures above.

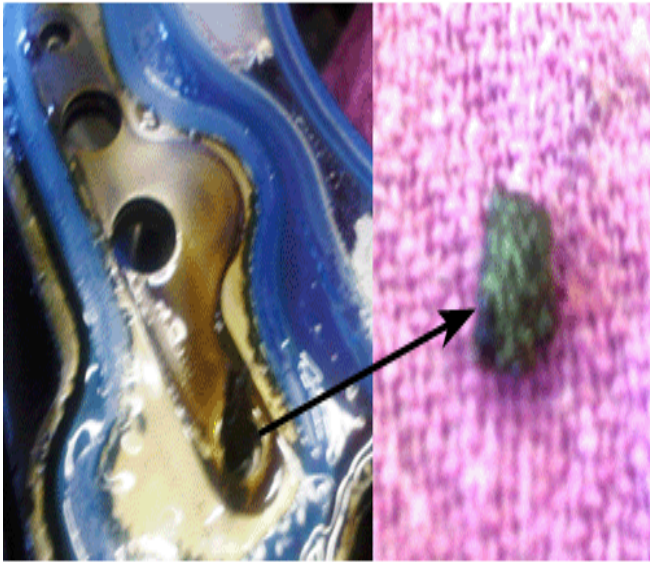
2479441

6. One example of obstruction is shown above. Filter media material plugging the 2 mm lubrication passage hole creating aeration in the exhaust lifter oil galley. The obstruction can be filter media material or an orange silicone rubber material. The above example is filter media.
7. Engine oil passages will have to be cleaned of aftermarket filter media debris or orange silicone rubber.

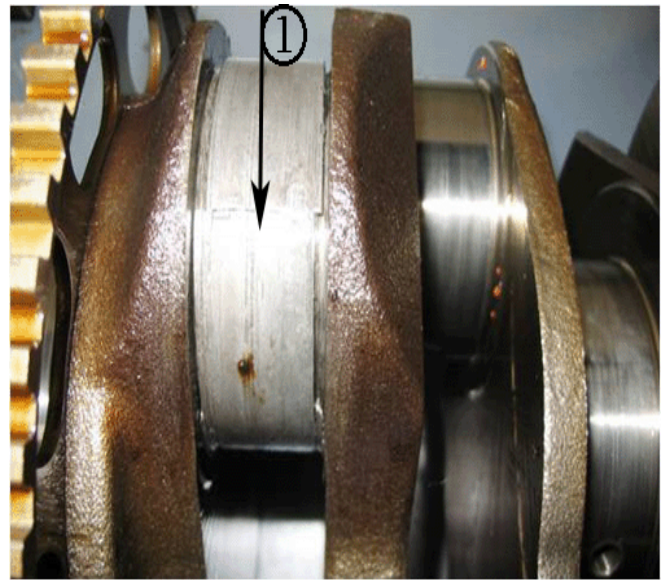
2479435

Rod bearing welded to crankshaft (1).

Repair as necessary to remove filter media/debris from oil galleys and piston squirter sprayer in the cylinder head. Repair and/or replace damaged engine components as necessary.

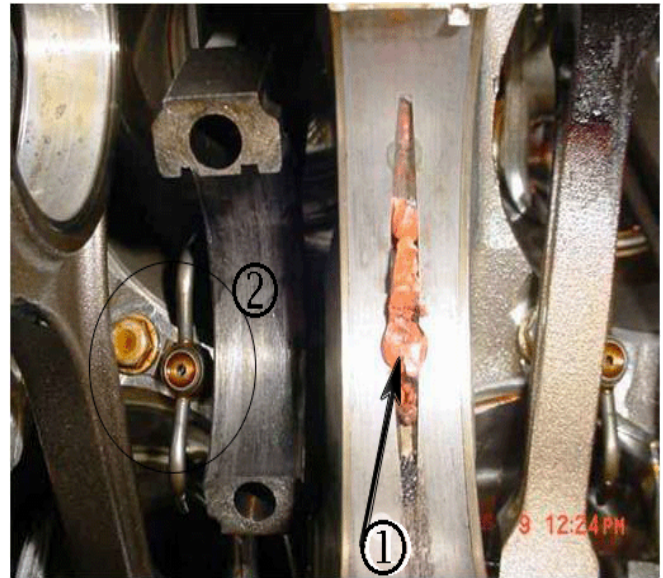
2479437

Orange silicone rubber obstructing the oil flow to the main and rod bearings in the engine block webbing (1).

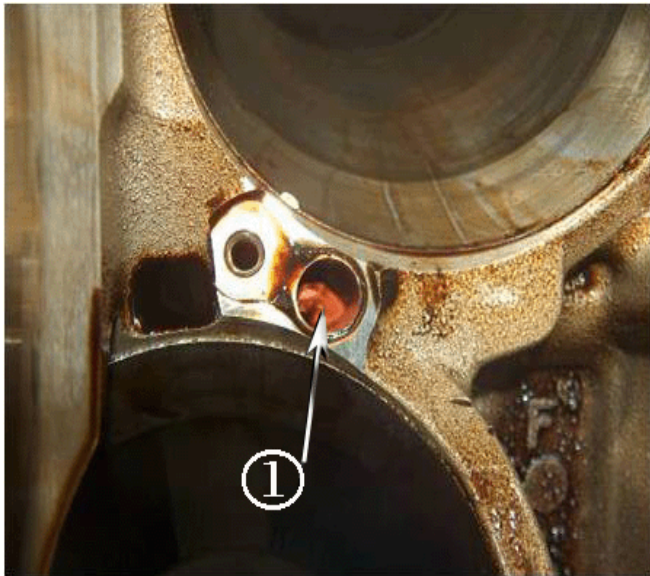
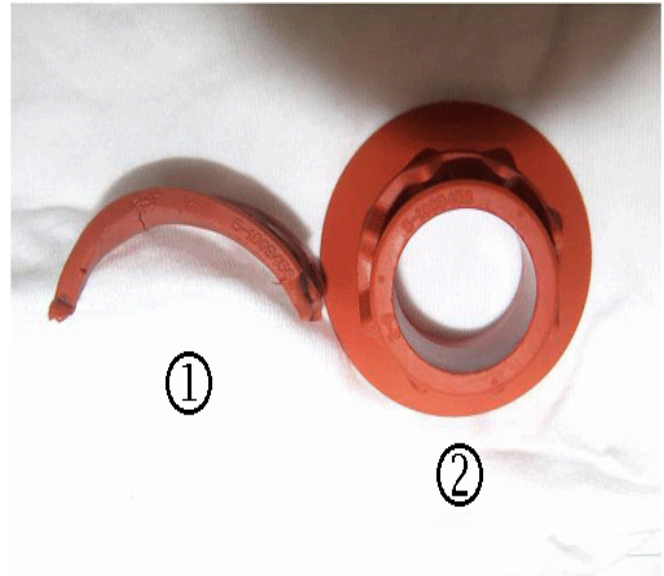
Silicone rubber found in main and rod bearing and in the piston skirt squirter (sprayers) (1).

Sprayer is removed to show obstruction material.

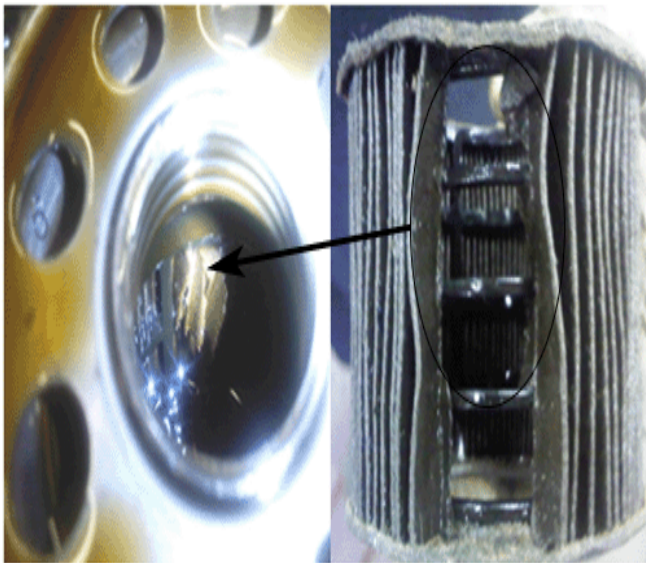
2493733

First do a general inspection for possible source. With the metal can cut off, you can see detail of media failure.
