Bulletin No.: 10-06-01-008J

# Service Bulletin

**Subject:** Engine Oil Consumption on Aluminum Block/Iron Block Engines with Active Fuel Management (AFM) (Install AFM Oil Deflector and Clean Carbon from Cylinder and/or Install Updated Valve Cover)

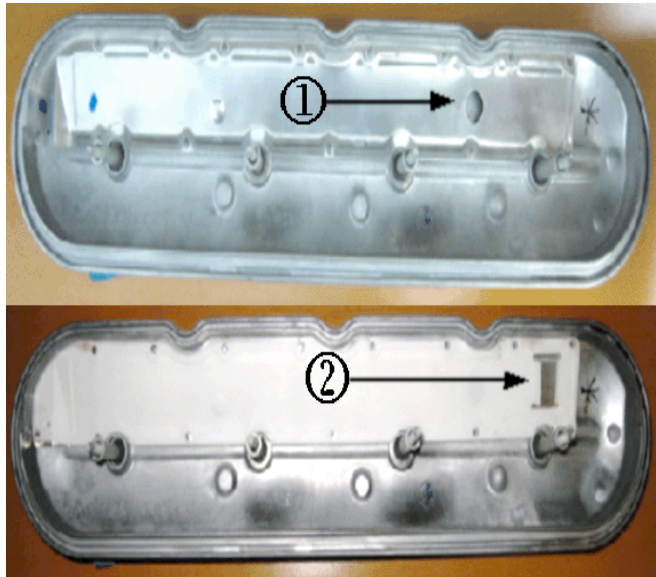
2740641

1) Old Design

2) New Design

PCV pullover or an overactive lifter can cause oil to be pulled through the PCV system even at low vehicle mileage. A correctly functioning PCV system will only leave a film of oil in the intake manifold. Inspect the intake manifold to see if there is any oil puddling in the bottom. If there is you will need to replace the left valve cover. Two new left rocker arm covers have been released for trucks and vans. Technicians should replace the left rocker arm cover with GM P/N 12570427 for 2007-2008 or GM P/N 12642655 for 2009-2011. Refer to the Parts Information below for the Camaro. This rocker arm cover has a relocated PCV drain hole that prevents oil from entering the intake manifold. Refer to Valve Rocker Arm Cover Replacement - Left Side in SI.
