Tech Tips

TT 20-12-03 Date: December 23, 2012

2011-2013 Jetta Sedan, Jetta Sportwagen Equipped With TDI Engine – Fuel Gauge Does Not Read Full after Fueling

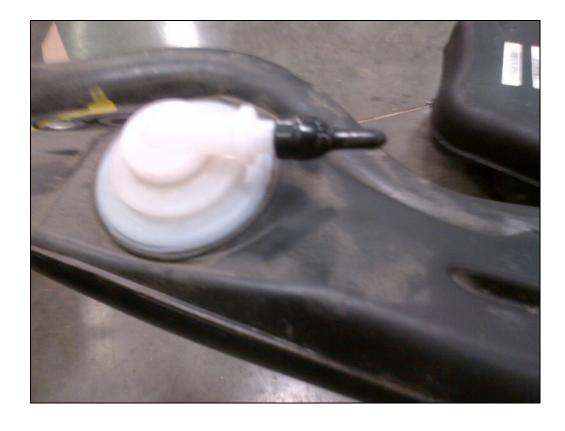
When diagnosing a customer concern of fuel gauge not reading full after fueling, start by checking for the presence of a cover over the fuel tank vent as shown in the picture below. Vent is located on filler neck and can be inspected by removing fuel door assembly. If cover is found over vent, inspect for damage to fuel tank and replace tank if needed. Ensure cover is not present on replacement fuel tank. If fuel tank is not damaged, remove cover over fuel tank vent and retest for customer concern. If cover is not present over vent, continue with normal diagnosis.
