# M-TIPS

UNIQUE REPAIR INFORMATION FOR  
MAZDA TECHNICIANS

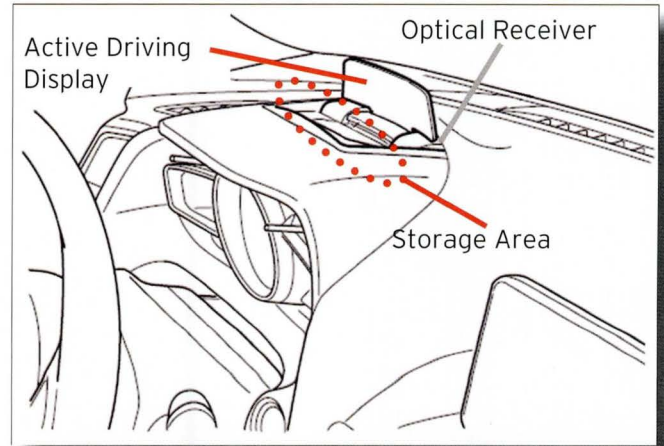
Some customers may claim that it is impossible or difficult to view the Active Driving Display, even if the position of the display is adjusted through the Settings screen. This is caused by an incorrectly learned zero-point (closed position) of the Active Driving Display. The main reason this happens is because an object (e.g. gloves, paper, etc.) was placed in the storage area where the mirror and optical receiver are housed.

If an object is detected (i.e., jammed) when the Active Driving Display closes after switching the ignition OFF, the system determines this as abnormal and stops the closing operation, leaving the Active Driving Display in an open position. When the engine is started the next time, correction of the zero-point is automatically performed. If the object is still in the storage area during the correction, the system learns the incorrect position as the zero-point. As a result, the zero-point position largely deviates from the standard position; therefore, it becomes impossible to view the Active Driving Display from the normal view position.

- **Do not** turn off the ignition switch with objects placed in the storage area of the Active Driving Display. It will cause incorrect learning of the zero-point (closed position).
- **Do not** force open or close the Active Driving Display manually. If an object is jammed, remove the object, and NEVER force the Active Driving Display closed.

Start the engine again to automatically correct and learn the zero-point.

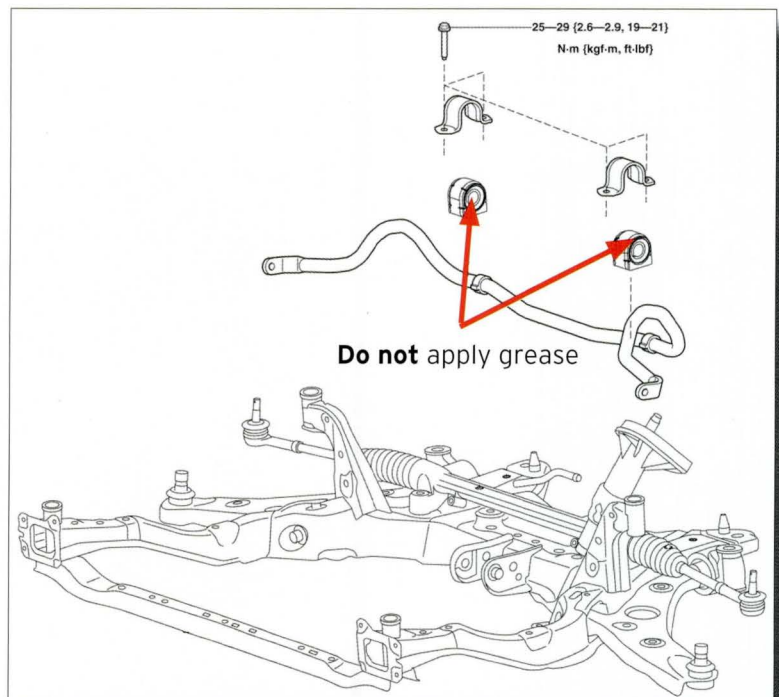
Grip-type bushings are installed on both front and rear stabilizers to reduce noise.

**Do not** apply grease on the bushings. If grease is applied, a squeak-type noise may occur.

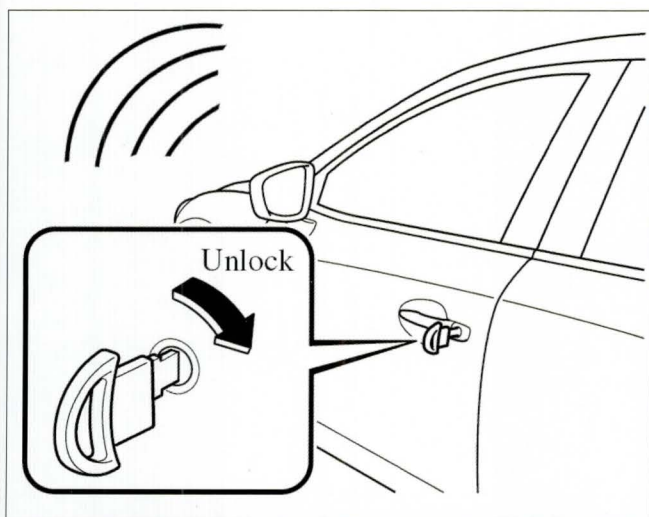
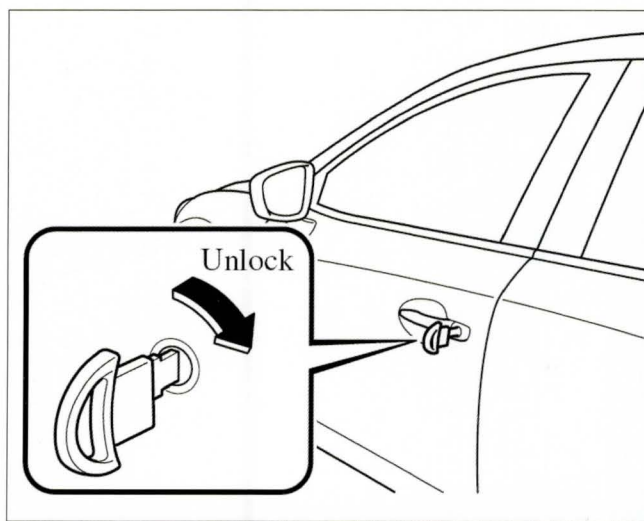
The theft-deterrent system operation condition has been changed on vehicles produced on and after May 8, 2013. These vehicles are equipped with rear BCM part number KD45-67-5Y0G or later.

If the front door key cylinder is unlocked by the mechanical key while the theft-deterrent system is in "armed" mode (stand-by), the system changes to "alert" mode and the theft-deterrent system operates (i.e., alarm goes off).

If the front door key cylinder is unlocked by the mechanical key while the theft-deterrent system is disarmed (i.e., "stand-by" mode is cancelled), the alarm does not go off. Other operating conditions are the same.

Rear BCM with P/N KD45-67-5Y0A through KD45-67-5Y0F supersedes to KD45-67-5Y0G. Therefore, the alarm operating condition will change if the rear BCM is replaced on vehicles built on and before May 7, 2013. Customers will need to be notified of this change. Do not perform any warranty repairs related to this change.

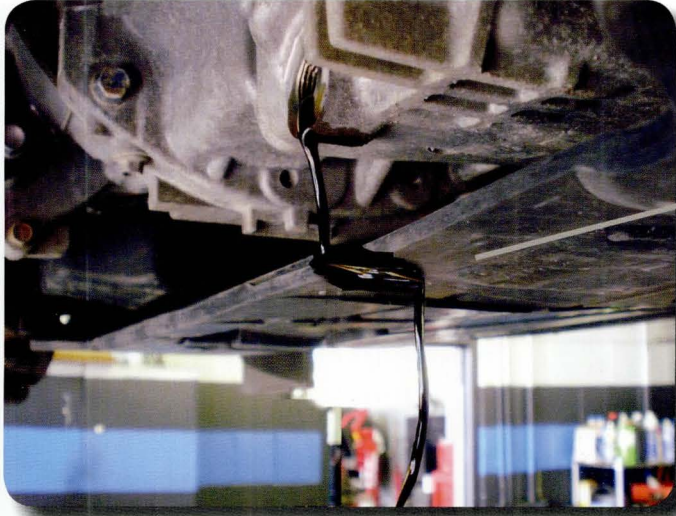
When draining motor oil, the oil flows in a steady stream after removing the drain plug. Just before the drain ends, the oil flow changes direction. On some vehicles, such as the 2012 Mazda3, this change may cause the motor oil to land on the engine undercover, creating an oily mess. Valuable time is wasted for engine undercover cleanup.

Engine undercover cleanup is necessary.

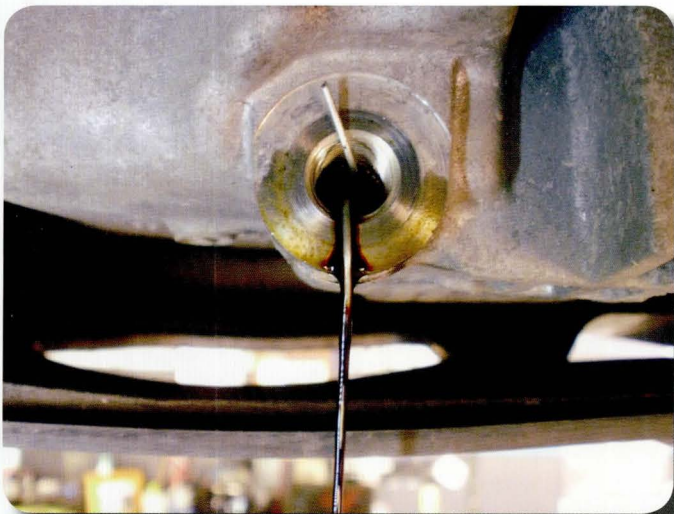
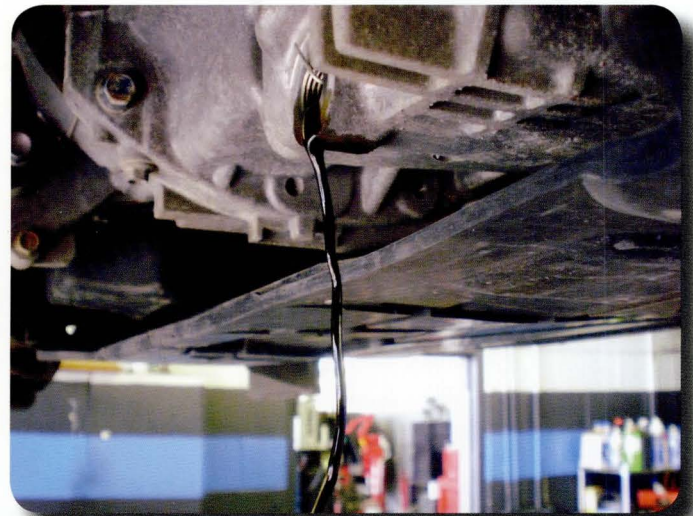
Mechanic's wire installed.

Mechanic's wire guides oil flow away from engine undercover and avoids an oily mess.

This oily mess can be avoided by using a mechanic's wire (approx. 9 inches) to guide the oil flow away from the engine undercover. Install the mechanic's wire just before draining ends.

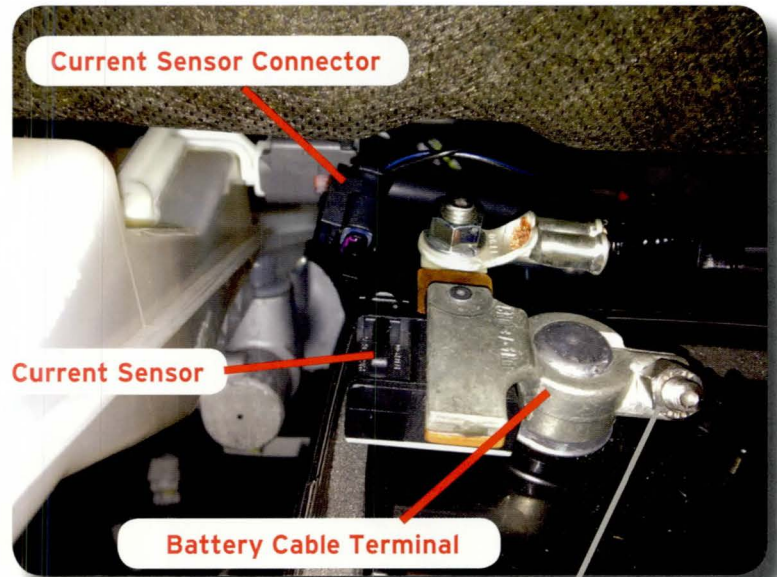
If a Q-85/T-110 battery requires removal or terminal disconnect, use the following Workshop Manual procedures. DTC(s) may be stored in the PCM memory if these procedures are not performed.

Step	Action
1	Record audio memory.
2	Switch the ignition OFF.
3	Disconnect the current sensor connector from the current sensor.
4	Disconnect the negative battery cable terminal.

Step	Action
1	Connect the negative battery cable terminal.
2	Connect the current sensor connector to the current sensor.
3	Switch the ignition ON.
4	Perform the power window system initial setting.
5	Perform the sunroof system initial setting.
6	Set clock.
7	Set audio memory.
8	Perform the tire pressure monitoring system (TPMS) initialization.

Torque: 36-53 in lbf (4-6 N m)
