SERVICE BULLETIN

APPLICABILITY: 2012-13MY Impreza 2.0L Models
2013MY XV Crosstrek

NUMBER: 12-157-13

SUBJECT: Rattle or Buzzing Sound from “A” Pillar Trim

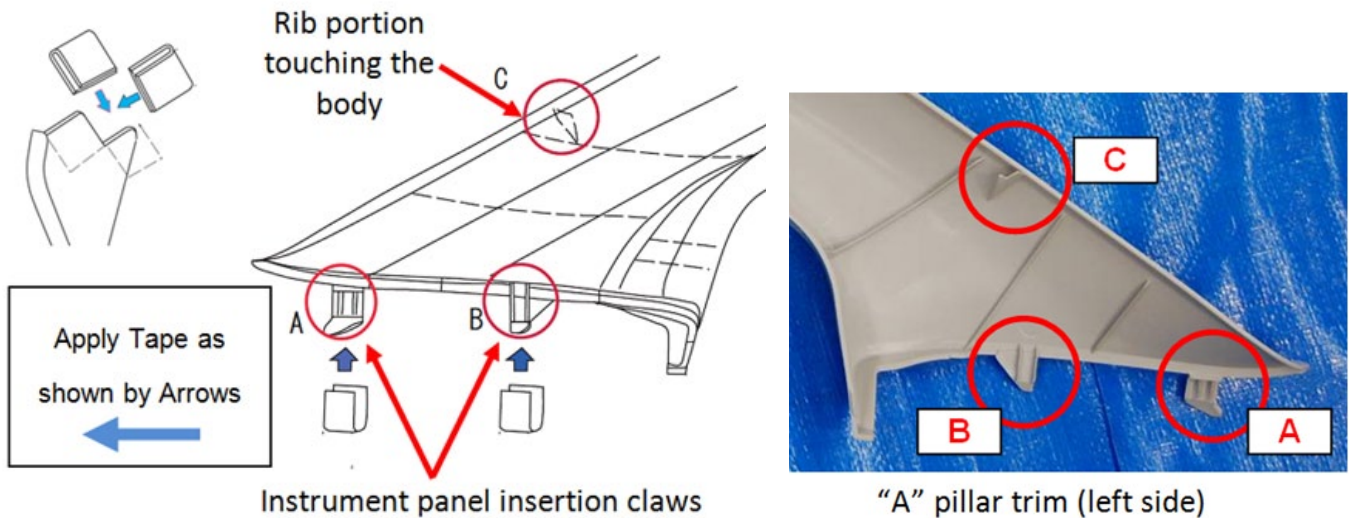
This bulletin provides a repair procedure to address a customer concern of a rattle or buzzing-type sound coming from the lower portion of the “A” pillar trim while driving over bumpy or rough road surfaces. The lower insertion claws and / or the trim’s support rib may be coming in contact with the vehicle body causing the sound.

- With the “A” pillar trim at room temperature, clean the 3 areas shown in the illustration below (A, B, and C) with rubbing alcohol applied to a clean shop cloth then allow to dry before installing the non-woven material.
