Service Bulletin

Bulletin No.: 13-08-43-002

Subject: Information on Windshield Multifunction Sensor Mount Bracket Cover Replacement

Models: 2014 Cadillac ATS, XTS

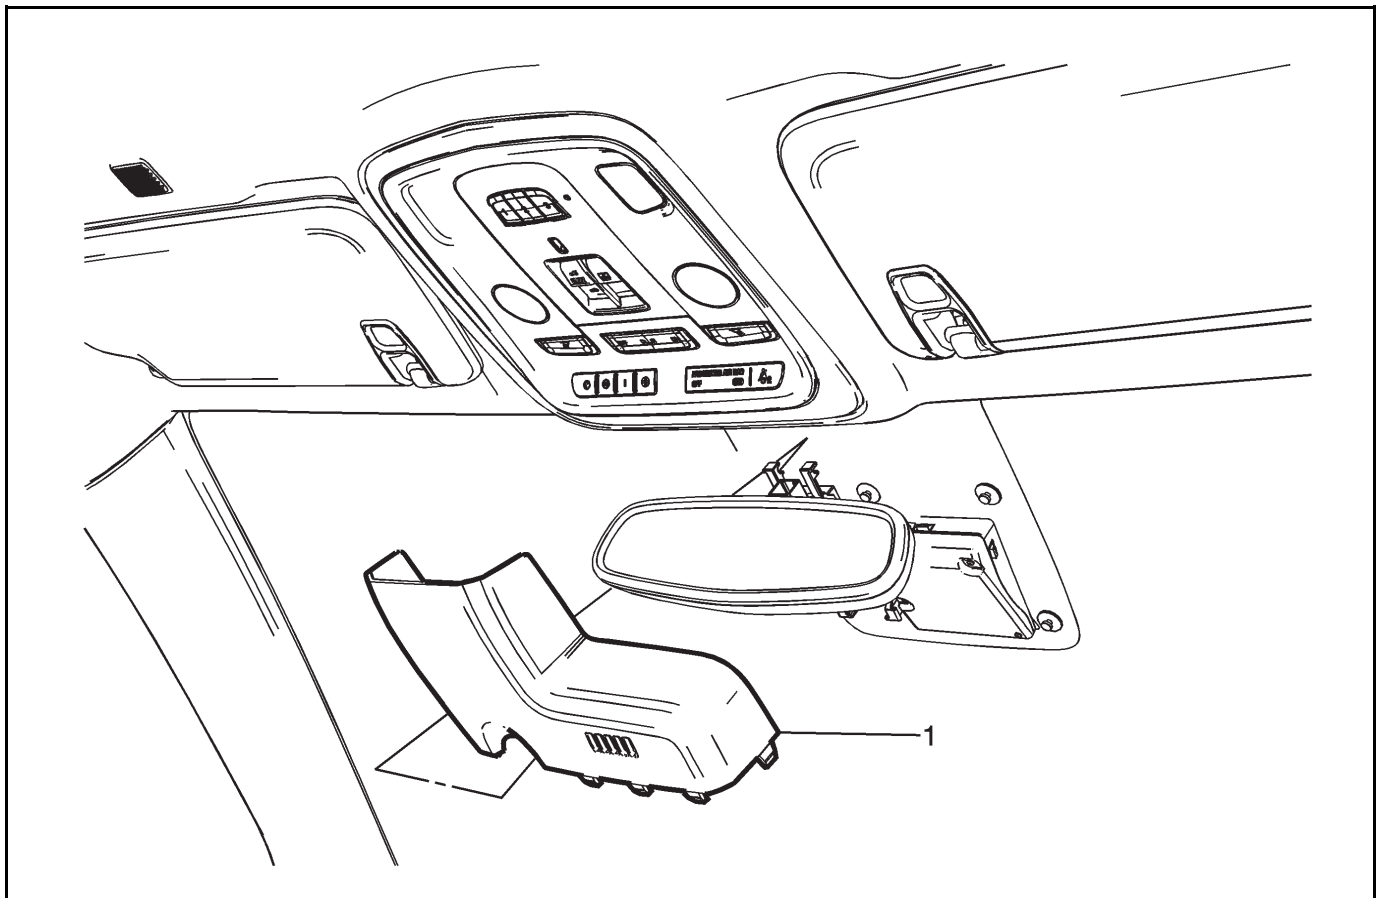
2760577

When technicians are replacing the windshield multifunction sensor mount bracket cover due to the tabs not retaining the cover firmly in place, they are submitting the wrong labor operation for the repair being done.

Replace the windshield multifunction sensor mount bracket cover (1), in the illustration above, following the windshield multifunction sensor mount bracket cover replacement in SI and submit the labor operation listed in the warranty information below.
