Recall Bulletin

PRODUCT SAFETY RECALL

SUBJECT: Harsh Transmission Shift, Engine Stall, Engine May Not Start, MIL or Service Engine Soon Lamp

MODELS: 2005-2008 Pontiac Vibe
Two Wheel Drive Equipped with 1.8L MFI Engine (LV6)

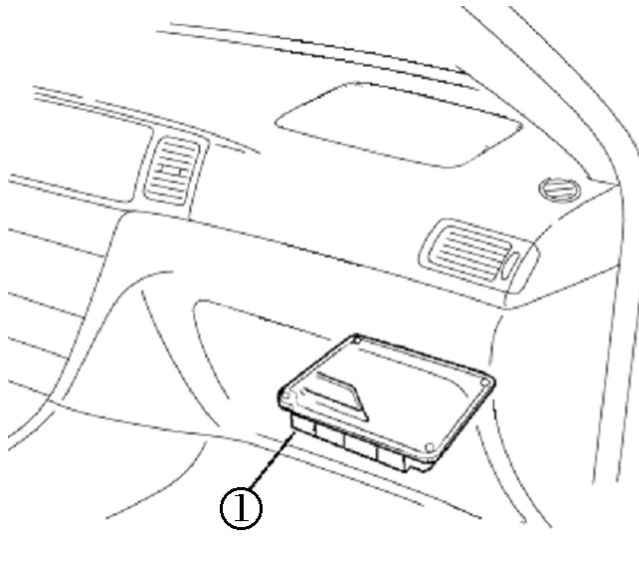
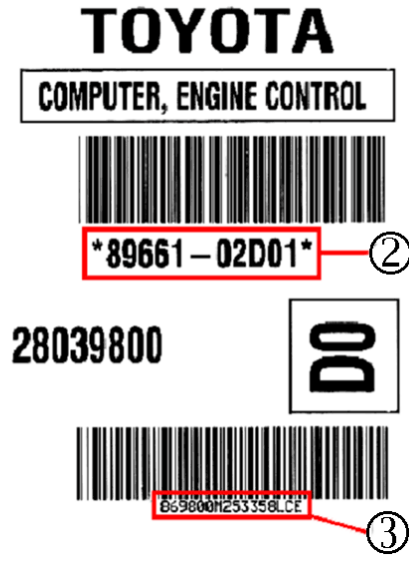
2530675

1. Locate the PCM (1) under the glove box compartment.
2. Record the part number (2) and the lot number (3) on the repair order.

3. Confirm the PCM part number to determine the required action using the table below.

4. Confirm the LOT number, if required. Determine the 9th through 12th digits as shown in the following example:

- If the LOT number is 7227 or higher, no further repair action is required. FOR CALIFORNIA VEHICLES ONLY: Install a Recall Identification Label and complete a "Proof of Correction" certificate upon recall completion.

- If the LOT number is 7226 or lower, replace the PCM. Refer to *PCM Replacement* in this bulletin.
