Service Bulletin

SPECIAL COVERAGE

SUBJECT: Special Coverage Adjustment – Driver Door Switch Short Circuit

**MODELS: 2006-2007 Buick Rainier
2006 Chevrolet TrailBlazer EXT
2006-2007 Chevrolet TrailBlazer
2006 GMC Envoy XL
2006-2007 GMC Envoy**

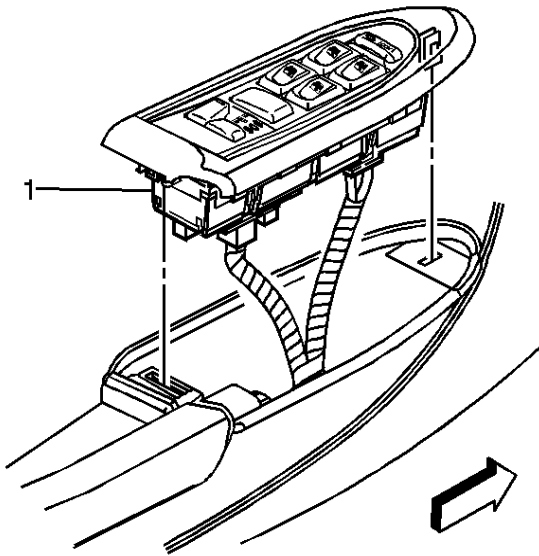
690976

1. Determine if the driver side door lock and side window switch requires replacement using diagnostic information in SI.
 - If the driver side door lock and side window switch requires replacement, proceed to Step 2.
 - If the driver side door lock and side window switch does NOT need to be replaced, determine cause of vehicle condition. Additional diagnostic time and repairs are NOT covered under this field action bulletin. Assign payment through warranty, goodwill or customer pay.

2. Remove the driver side door lock and side window switch. Refer to *Door Lock and Side Window Switch Replacement - Driver Side* in SI.
3. Install a new driver side door lock and side window switch. Refer to *Door Lock and Side Window Switch Replacement - Driver Side* in SI.
