Recall Bulletin

PRODUCT SAFETY RECALL

SUBJECT: Power Window Master Switch Failure

MODELS: 2009 Pontiac Vibe

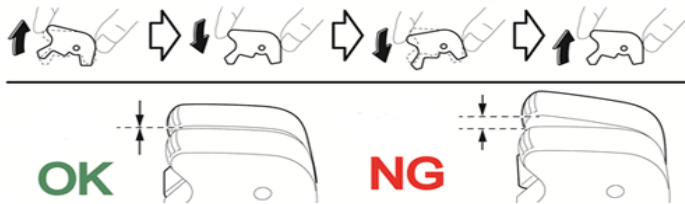
3021149

2. Check all switches (1) that do not have AUTO function (2) for the catching condition.

OK-Good
NG-No Good

3. Operate each switch in the up direction, and then slowly return the switch using two fingers.

4. Operate each switch in the down direction, and then slowly return the switch using two fingers.

- If none of the switches are catching, proceed to the Check Resistance of the Switches procedure in the bulletin.
- If one or more of the switches are catching, replace the accessory switch circuit board. For removal, refer to steps 1-4 of the Check Resistance of the Switches procedure in this bulletin. For installation, refer to the Switch Reassembly procedure in this bulletin. DO NOT reuse the screws that have been removed, new one-way screws MUST be used.

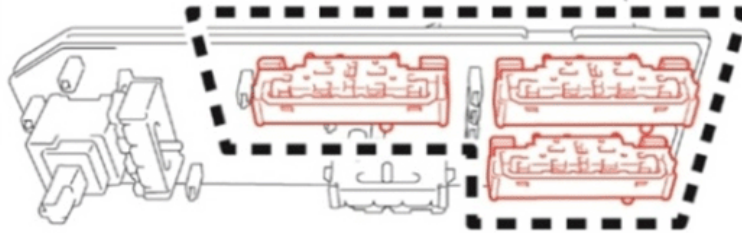
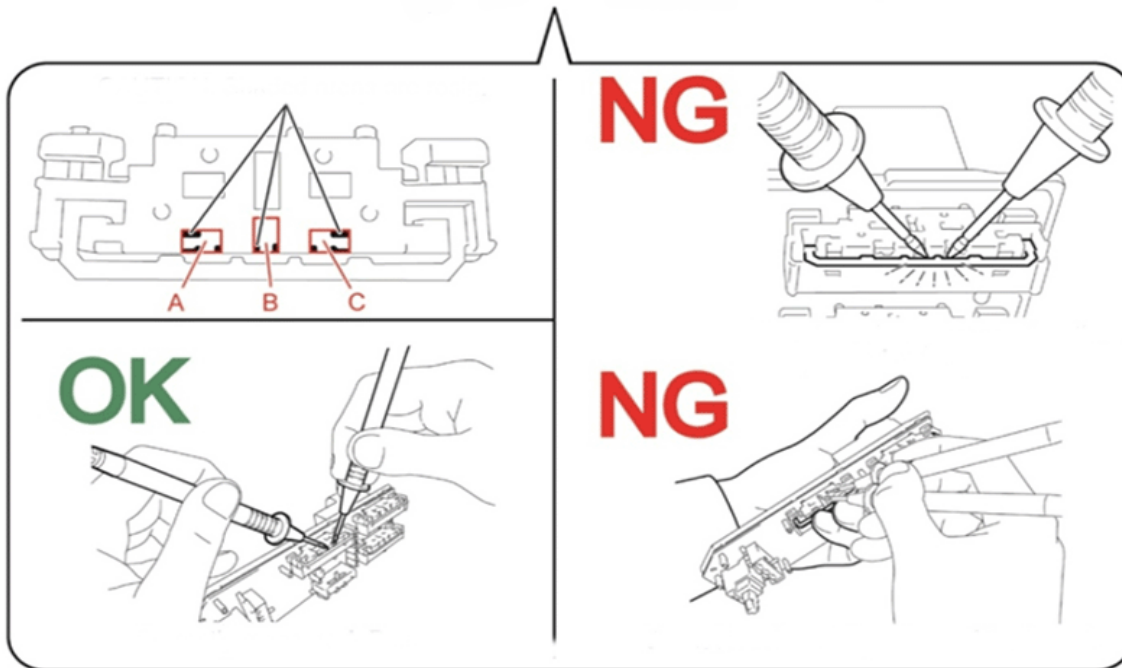
3021162

OK-Good
NG-No Good

9. Measure the resistance between points A-B and points B-C.

- If the resistance value for ALL switches is infinite, fill the switches with grease. Refer to the Grease Application procedure in this bulletin.
- If one or more resistance value IS NOT infinite, replace the accessory switch circuit board. Refer to the Switch Reassembly procedure in this bulletin.

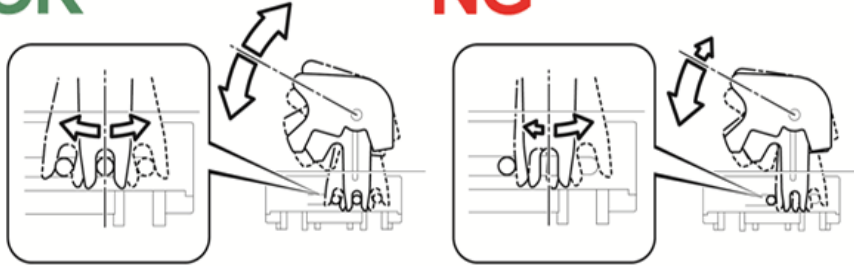
3021212

OK-Good
NG-No Good

4. While holding the circuit board in the switch case, check the operation of the switches. The movement up/down and lock/unlock position should be equal in both directions.
 - If movement is equal in ALL switches, the circuit board is positioned correctly. Proceed to step 5.
 - If movement in one or more switch IS NOT equal, one or more switch pin is misaligned. Repeat steps 2-4.

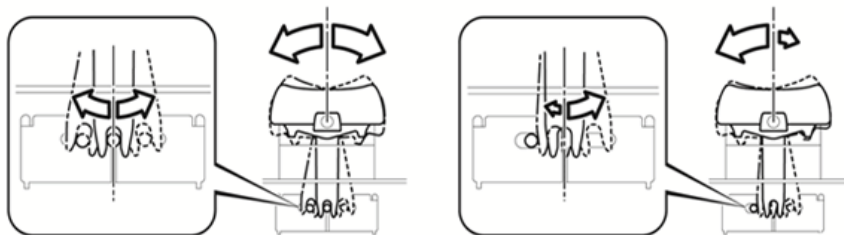
3021213

OK-Good
NG-No Good
