# Recall Bulletin

## PRODUCT SAFETY RECALL

**SUBJECT:** Power Window Master Switch Failure

**MODELS:** 2009 Pontiac Vibe

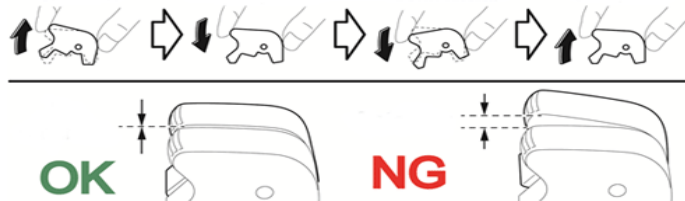
3021149

2. Check all switches (1) that do not have AUTO function (2) for the catching condition.

OK-Good  
 NG-No Good

4. Operate each switch in the down direction, and then slowly return the switch using two fingers.
  - If none of the switches are catching, proceed to the Check Resistance of the Switches procedure in the bulletin.
  - If one or more of the switches are catching, replace the accessory switch circuit board. For removal, refer to steps 1-4 of the Check Resistance of the Switches procedure in this bulletin. For installation, refer to the Switch Reassembly procedure in this bulletin. DO NOT reuse the screws that have been removed, new one-way screws MUST be used.

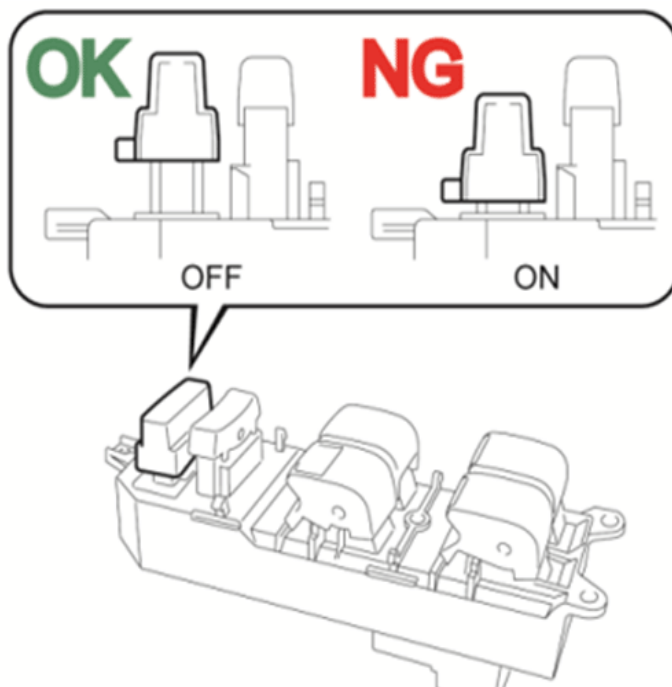
3021150

OK-Good  
NG-No Good

1. Turn the window lock switch to the OFF position.
2. Pull the button up to remove it from the switch assembly.

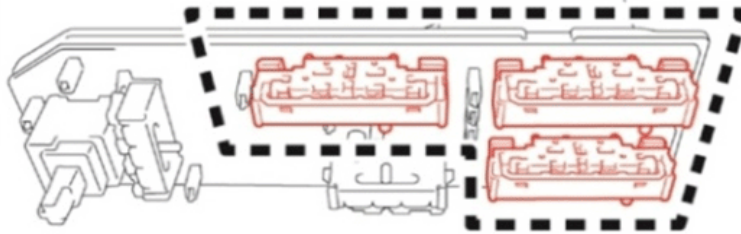
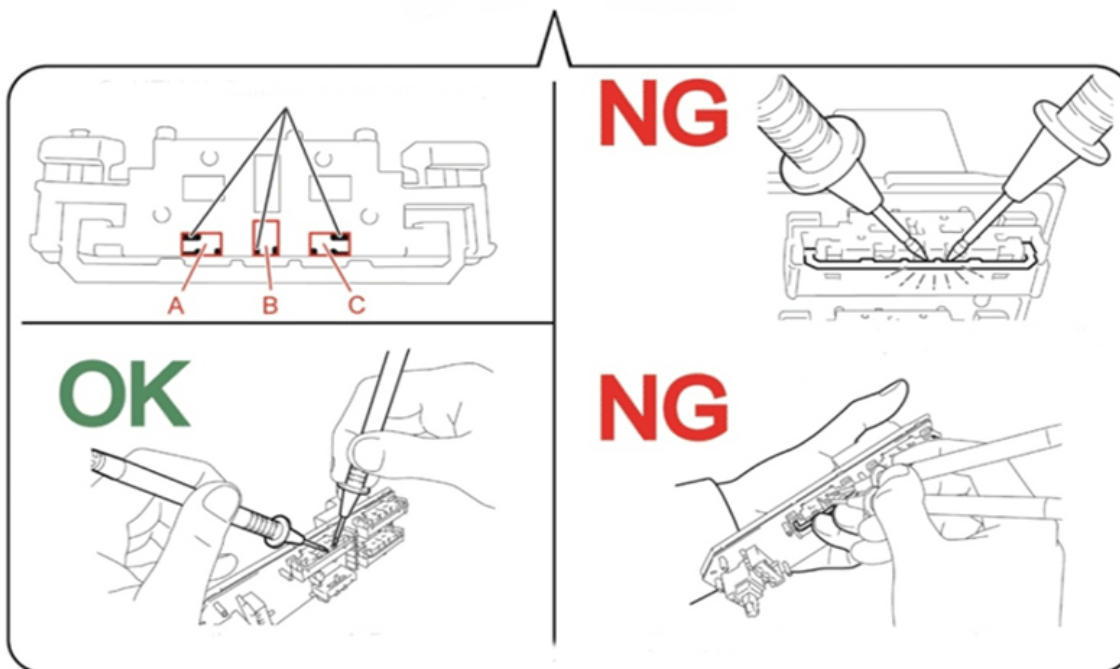
3021162

OK-Good  
NG-No Good

9. Measure the resistance between points A-B and points B-C.

- If the resistance value for ALL switches is infinite, fill the switches with grease. Refer to the Grease Application procedure in this bulletin.
- If one or more resistance value IS NOT infinite, replace the accessory switch circuit board. Refer to the Switch Reassembly procedure in this bulletin.

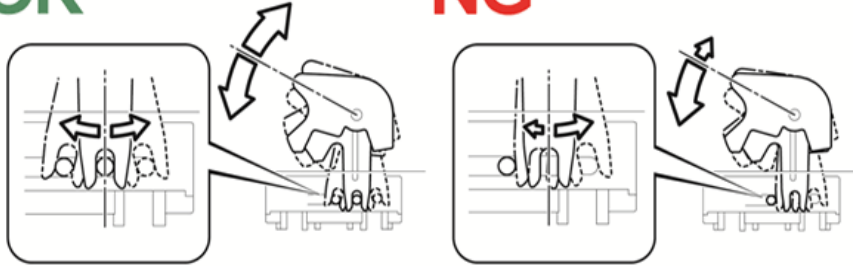
3021212

OK-Good  
NG-No Good

4. While holding the circuit board in the switch case, check the operation of the switches. The movement up/down and lock/unlock position should be equal in both directions.
  - If movement is equal in ALL switches, the circuit board is positioned correctly. Proceed to step 5.
  - If movement in one or more switch IS NOT equal, one or more switch pin is misaligned. Repeat steps 2-4.

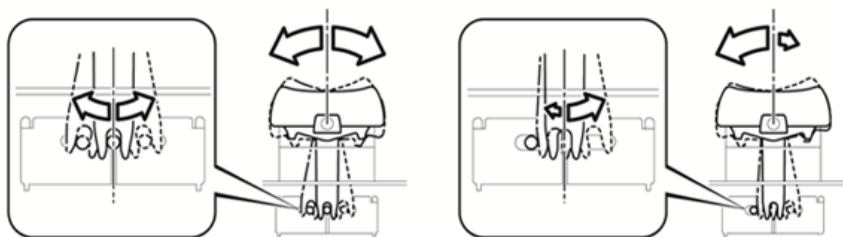
3021213

OK-Good  
NG-No Good
