Service Bulletin

SUBJECT: Service Update for Inventory and Customer Vehicles
Rattle or Clunk Noise During Turns or Driving Over Bumps
Expires with Base Warranty

MODELS: 2012 Chevrolet Sonic

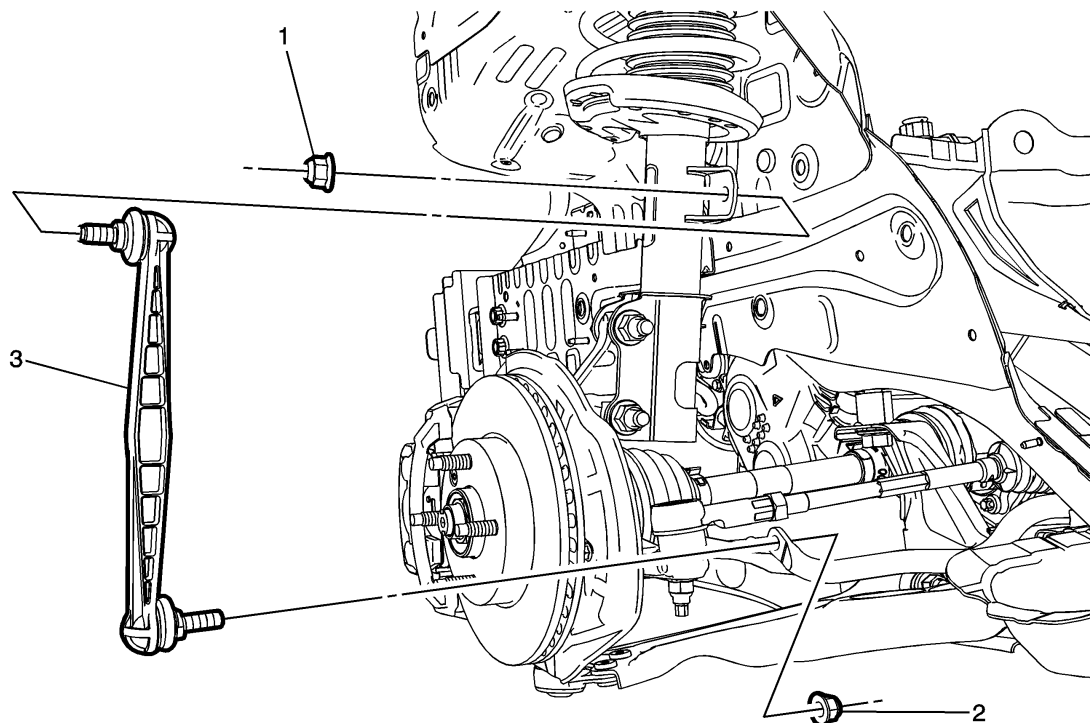
2497993

This bulletin provides a service procedure to replace the stabilizer bar link on **certain** 2012 model year Chevrolet Sonic vehicles. These vehicles may have been built with stabilizer bars which may have lower ball joint boots that are subject to water and dirt intrusion. As a result, contamination within the boot may cause the joint to loosen due to rust, causing wear between the ball stud and socket. If this condition were to occur, the occupants of the vehicle may hear a rattle or clunk noise during turns or when driving over bumps.

1. Remove front driver and passenger side stabilizer shaft links. Refer to *Stabilizer Shaft Link Replacement* in SI.
2. Install a new front driver and passenger side stabilizer shaft link. Refer to *Stabilizer Shaft Link Replacement* in SI.
