Recall Bulletin

PRODUCT SAFETY RECALL

SUBJECT: Brake Vacuum Micro Switch

MODELS: 2011–2012 Chevrolet Cruze
Equipped with 1.4L DOHC Turbo Engine (LUJ) and 6T40 FWD Automatic Transmission (MH8)

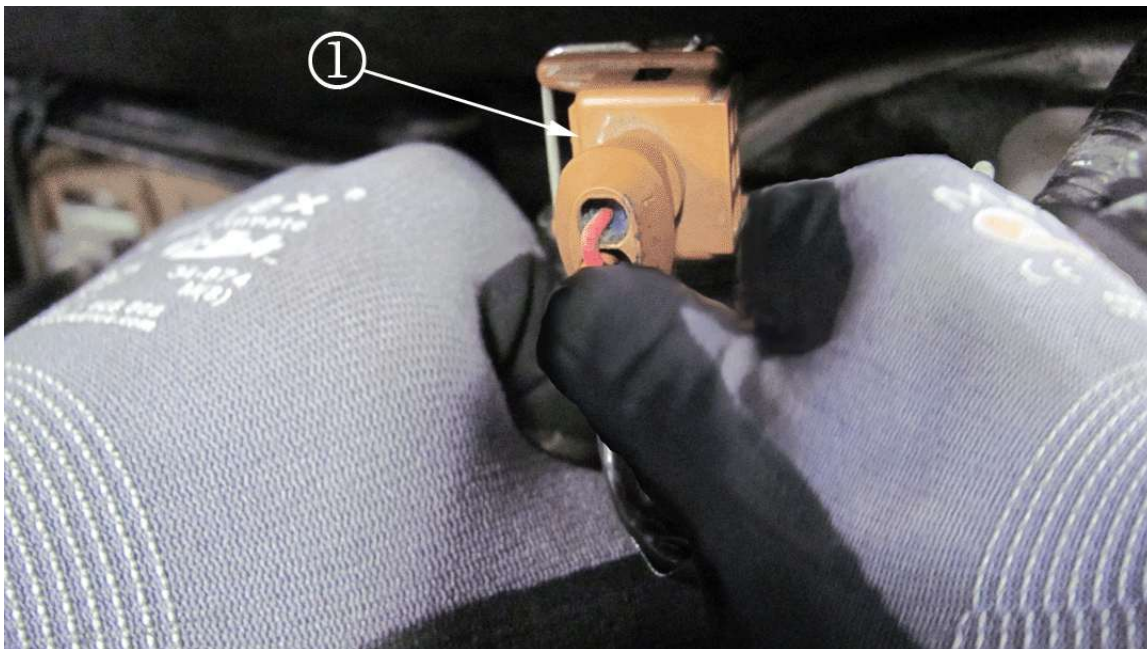
3610402

Note: Hold the micro switch by the switch body to avoid damaging the switch or displacing lubricant on the switch. The switch body has a guide on one side. Align the guide into the groove.

14. Install the new switch into the electric vacuum pump switch housing using a small flat-blade screwdriver and your hand. The switch will produce a “click” noise when installed correctly.
