Service Bulletin

SUBJECT: Service Update for Inventory and Customer Vehicles
Product Enhancements – Interior Trim
Expires with Base Warranty

MODELS: 2013 Cadillac XTS

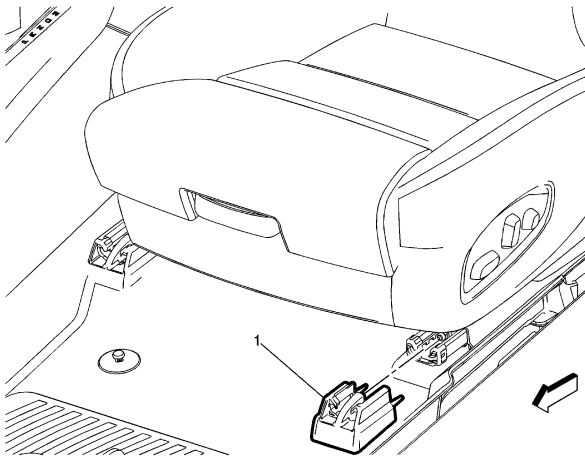
2755689

- Replace the driver and front passenger seat track cover. The cover may not be fully secure.
- Inspect and, if necessary, replace the driver and/or passenger side center (B) pillar trim panels. The trim panels may not be secure.
- Inspect and, if necessary, reseal the front console cup holder. The holder may not be seated properly.
- Modify the 5 windshield defroster grille front plastic tabs. The tabs may not have a large enough interference fit and could cause a buzz or rattle sound.
- Inspect and, if necessary, repair or replace the IP storage compartment. The bin by the driver's left knee may be noisy or not open properly.
- Inspect and, if necessary, replace the floor console storage bin latch. The console may not open.
- Inspect, and if necessary, replace the windshield multifunction sensor mount bracket cover. The retention features may be damaged.

1. Remove the driver and passenger seat outer track front covers (1). Refer to *Front Seat Track Cover Replacement* in SI.
2. Install new driver and passenger seat outer track front covers (1). Refer to *Front Seat Track Cover Replacement* in SI.
