Service Bulletin

SUBJECT: Service Update for Inventory and Customer Vehicles
Product Enhancements – Interior Trim
Expires with Base Warranty

MODELS: 2013 Cadillac XTS

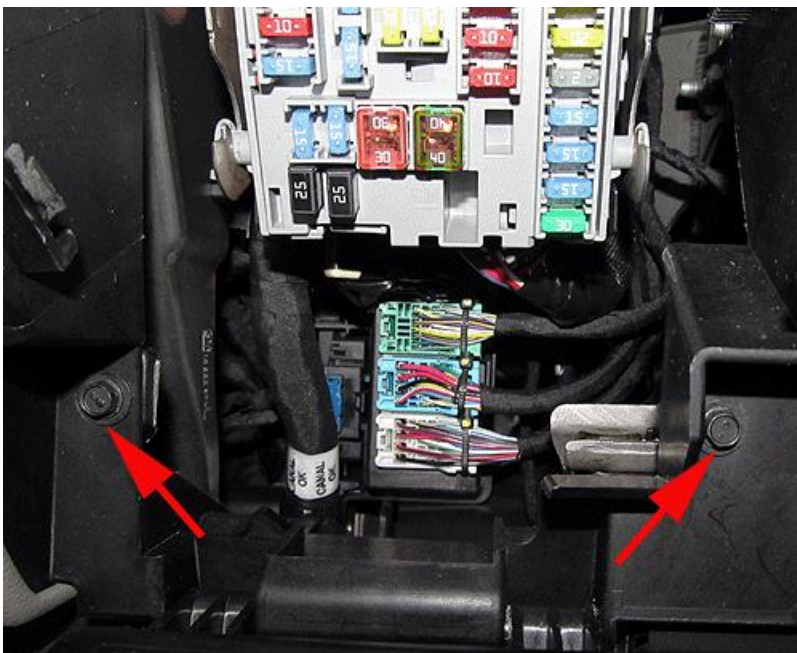
3258653

IP Storage Compartment Door Binds or Opens Very Slowly

1. Open bin door with release tabs.
2. Loosen two screws.

3. While pulling downward on left side, tighten the left screw first and then tighten the right screw.

Note: If the bin door is still slow, then repeat steps 2-3, but add an upward push at the bottom right side BEFORE tightening the right screw. Replace the IP storage compartment if the adjustment does not correct the condition. Refer to *Instrument Panel Knee Bolster Replacement* in SI.

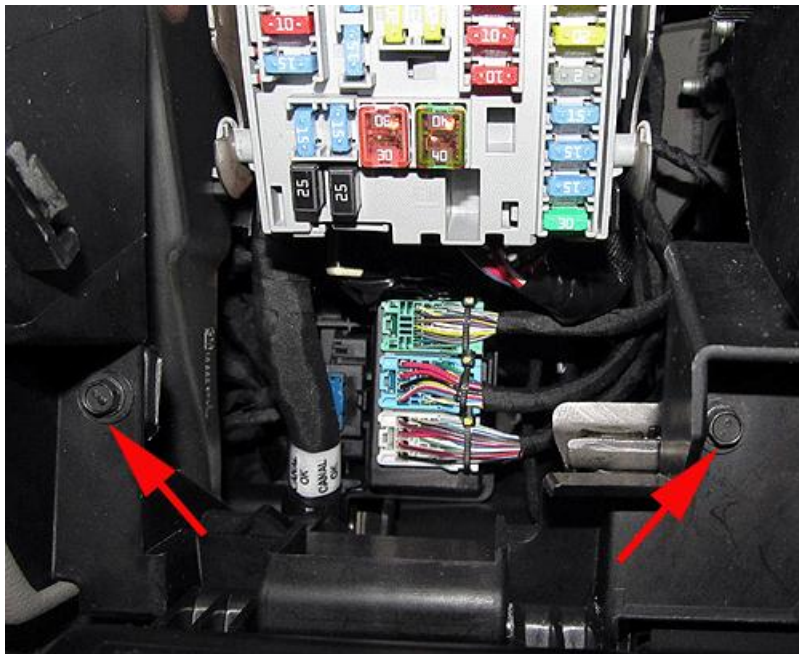
IP Storage Compartment Door Opens Very Fast and/or Creates Zip Noise

1. Open bin door with release tabs.
2. Ensure pinion gear is seated.
3. Loosen two screws.
4. While pulling downward on the right side, tighten the right screw first and then the left screw.

Note: Replace the IP storage compartment if the adjustment does not correct the condition. Refer to *Instrument Panel Knee Bolster Replacement* in SI.
