Service Bulletin

**SUBJECT: Service Update for Inventory and Customer Vehicles
Inspect Seat Memory Switch Retention, if Equipped, and Replace Outside
Door Handles and Outside Door Handle Cables
Expires with Base Warranty**

MODELS: 2013 Cadillac XTS

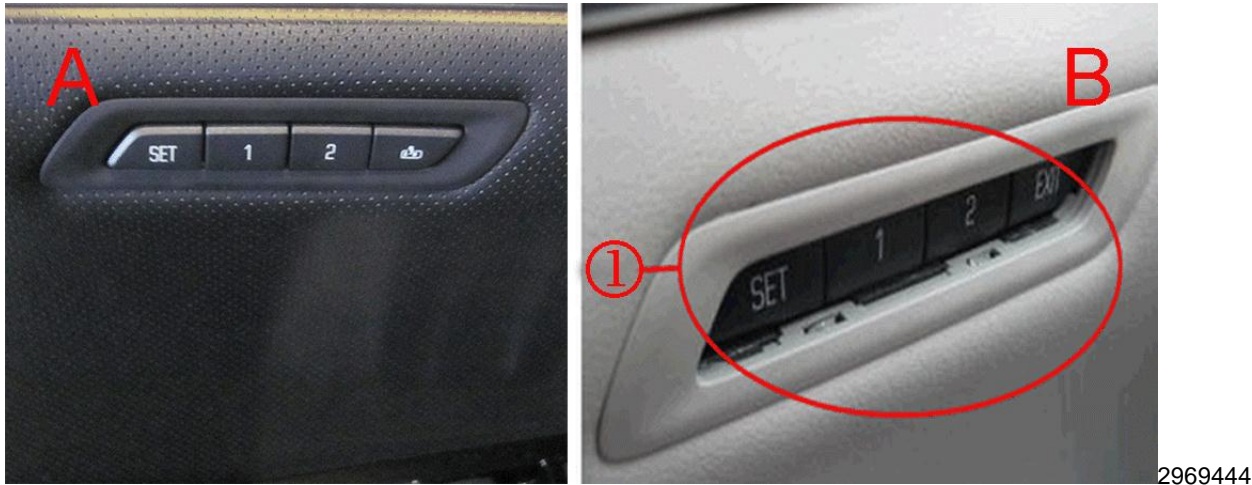
(A) Good driver seat memory seat switch. (B) Driver seat memory seat switch requires repair. The buttons (1) are pushed into the door trim panel.

Note: The cause of this condition may be insufficient retention of the seat switch snap features to the switch bracket. Reposition the memory seat switch bracket and add an adhesive back shim stock. Refer to Steps 3-9.

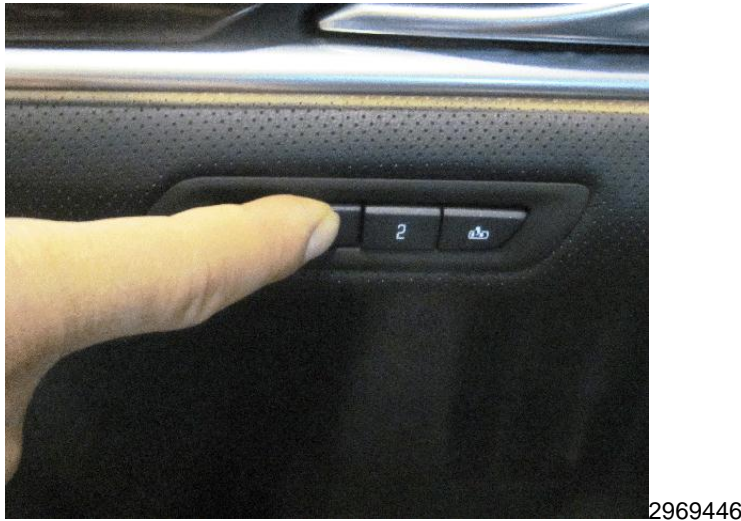
2. Inspect the driver seat memory seat switch buttons to determine if the switch buttons (1) are pushed into the door trim panel.
 - 2.1 Visually inspect condition of the driver seat memory seat switch buttons (1).

2.2 Firmly depress the driver seat memory seat switch buttons.

- If the driver seat memory seat switch buttons are not pushed into the door trim panel, no further action with the driver seat memory seat switch is required. Proceed to *Front and Rear Side Door Outside Handle Cable Replacement and Outside Door Handle Replacement* in this bulletin.
- If the driver seat memory seat switch buttons are pushed into the door trim panel, proceed to the next step.
