# Recall Bulletin

**SUBJECT: Rear Suspension Bolts May Not Be To Proper Torque Specification**

**MODELS: 2013 Chevrolet Malibu**

GM Recall #13008

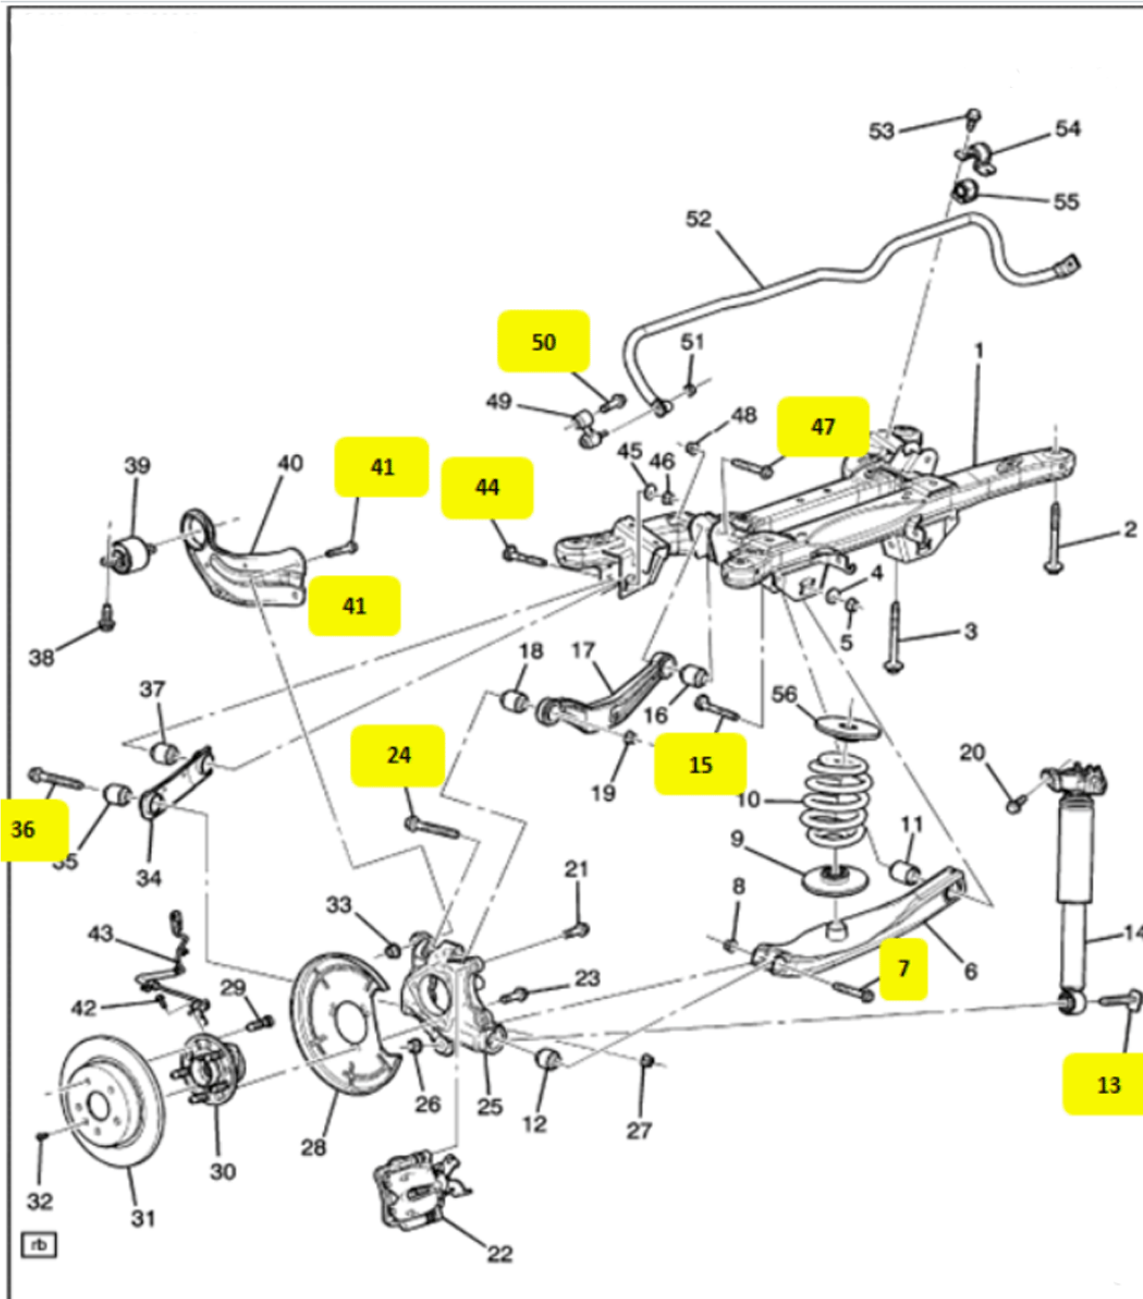
### Fastener Location Overview

General Motors has decided that a defect, which relates to motor vehicle safety, exists in **certain** 2013 model year Chevrolet Malibu vehicles. These vehicles may have been built with one or more rear suspension bolts that were not tightened to the specified torque. The effect will vary depending on which bolt is involved and the progression of the condition. Initially, noise and a minor handling effect may be noticed. As the condition progresses, sudden changes in the vehicle handling could occur and the driver may not be able to control the vehicle, particularly at higher speeds, which could result in a crash without prior warning.

FLO Illustration Number.	Bolt Reuse	Bolt Name	Bolt P/N.	Nut P/N	Static Specification Min (Nm)
13	No	Rear Shock Absorber to Knuckle	<b>11611099</b>		170 Nm
50	Yes	Rear Stab Bar Shaft Link	<b>11518630</b>		50 Nm
44	No	Rear Suspension Link Inner	13219181	<b>11094488</b>	100 Nm
36	No	Rear Suspension Link Outer	<b>11561300</b>		130 Nm
15	No	Rear Suspension Lower Control Arm Inner	13219184	<b>11094488</b>	100 Nm
7	No	Rear Suspension Lower Control Arm Outer	<b>11609607</b>		90 Nm
41	No	Rear Suspension Trailing Arm to Knuckle	<b>11589355</b>		160 Nm
Opposite to 41	No	Rear Suspension Trailing Arm to Knuckle	<b>11589355</b>		160 Nm
47	No	Rear Suspension Upper Control Arm Inner	11589279	<b>11516078</b>	80 Nm
24	No	Rear Suspension Upper Control Arm Outer	<b>11611105</b>		190 Nm

3. Perform a static torque inspection on the 20 rear suspension fasteners listed in the *Static Torque Specification Table* in this bulletin.
    - Ensure the 20 fasteners meet the minimum static torque specification provided in the table. Refer to the table to determine if torque must be applied to the bolt or nut.

- Replace ALL fasteners that do NOT meet the minimum torque specification with a new fastener. The fastener part number is provided in the *Parts Information* section of the bulletin.
