# Service Bulletin

**SUBJECT:** Service Update for Inventory and Customer Vehicles  
Turbo-to-Exhaust Manifold Joint May Relax  
Expires with Base Warranty

**MODELS:** 2013 Cadillac ATS  
2013 Chevrolet Malibu  
Equipped with 2.0L Engine (LTG)

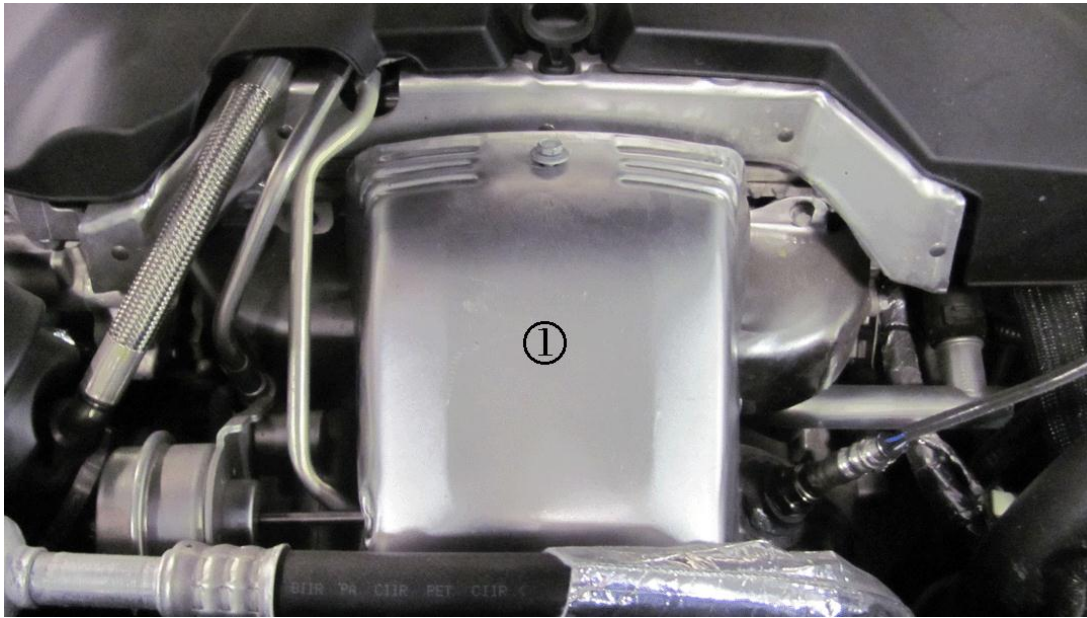
3268362

2. Locate the turbocharger exhaust heat shield (1).

3. Remove the turbocharger exhaust heat shield. Refer to *Exhaust Manifold Heat Shield Replacement (LTG)* in SI.
