Service Bulletin

SUBJECT: Service Update for Inventory and Customer Vehicles
Turbo-to-Exhaust Manifold Joint May Relax
Expires with Base Warranty

MODELS: 2013 Cadillac ATS
2013 Chevrolet Malibu
Equipped with 2.0L Engine (LTG)

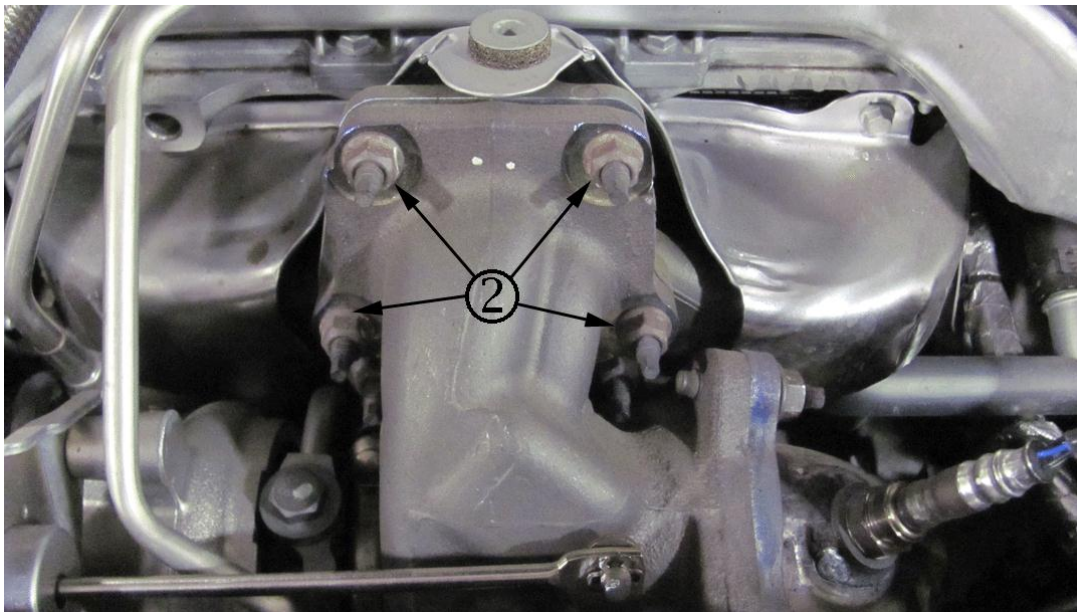
This bulletin provides a service procedure to tighten all 4 exhaust manifold bolts on **certain** 2013 model year Cadillac ATS and Chevrolet Malibu vehicles, equipped with a 2.0L engine (LTG). The ring gasket may be pinched between the flanges on the inside diameter of the joint leading to a visible gap. As the pinched part of that gasket relaxes, clamp load is lost at that stud location.

4. Loosen the four turbocharger-to-exhaust manifold nuts (2).
5. Tighten the four turbocharger-to-exhaust manifold nuts (2) to **30 Nm (22 lb-ft) + 90 degrees**.
6. Re-install the turbocharger exhaust heat shield. Refer to *Exhaust Manifold Heat Shield Replacement (LTG)* in SI.
