Program Bulletin

CUSTOMER SATISFACTION PROGRAM

SUBJECT: Windshield Water Leak

MODELS: 2012 Buick Verano

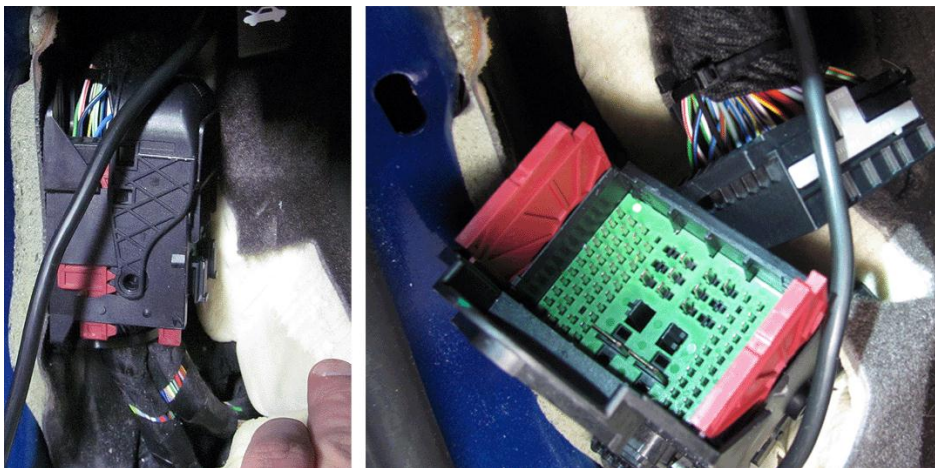
3350869

- 6.3 Inspect the connector for terminal damage.
- 6.4 Inspect the condition of the connector body.
 - If the connectors and terminals are NOT damaged and do NOT show signs of corrosion, connect and secure the connectors. Proceed to step 7.
 - If the connectors and/or terminals are damaged or show signs of corrosion, replace the damaged or corroded terminals. Refer to *Terminal Removal, Repairing Connector Terminals* and *X 200 Instrument Panel Harness to Body Harness* in SI. Proceed to step 7 after repairing the terminals.

6. Carefully inspect the condition of the instrument panel harness to body harness connector.
 - 6.1 Disconnect the negative battery cable. Refer to *Battery Negative Cable Disconnection and Connection* in SI.
 - 6.2 Disconnect the connector and inspect the connector for corrosion.
