Program Bulletin

CUSTOMER SATISFACTION PROGRAM

SUBJECT: Front Strut - Noise

MODELS: 2012-2013 Chevrolet Colorado

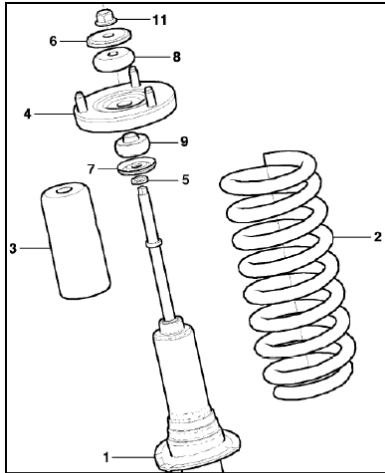
Figure 1

4. Remove the top mount plate. Ensure SI procedures are followed as the spring is under tension and injury could occur if incorrectly disassembled.
5. Refer to figure 1 - the lower bush (9) will be replaced as well as the spring seat isolator (not shown in figure 1). In addition, inspect the top mount bracket (4), cup washer (7), upper bush (8), and shocker absorber rod (1) for damage. Follow these guidelines to determine if these parts should be replaced:
 - Place a straight edge along the shocker absorber rod as shown in figure 4.
 - Measure the depth of wear on the shaft. If the wear is greater than 1mm, replace the shock absorber.
 - Inspect the steel washer (silver) that is pressed into the centre of the top mount bracket. If the washer has worn through to the black steel mount bracket, then replace the top mount bracket, refer figure 5.

- Inspect the upper bush (8), if the bush is out of shape or is damaged, replace the bush. In most cases it is expected that the upper bush can be reused. Do not replace it unless necessary.
- Inspect the cup washer (7) for distortion or other damage. Replace only if required.

3. Before removing the top mount bracket (refer figure 1, item 4), place alignment marks on the top mount bracket and spring using the outboard mounting bolt on the strut top bracket as a reference. Mark the bottom of the spring to shocker absorber as well. These marks should all be aligned as shown in figure 2 and 3.
