Service Bulletin

SUBJECT: Service Update for Inventory and Customer Vehicles
Transmission Fluid Leak
Expires with Base Warranty

MODELS: 2013 Cadillac SRX
Equipped with 6-Speed Automatic Transmission (6T70)

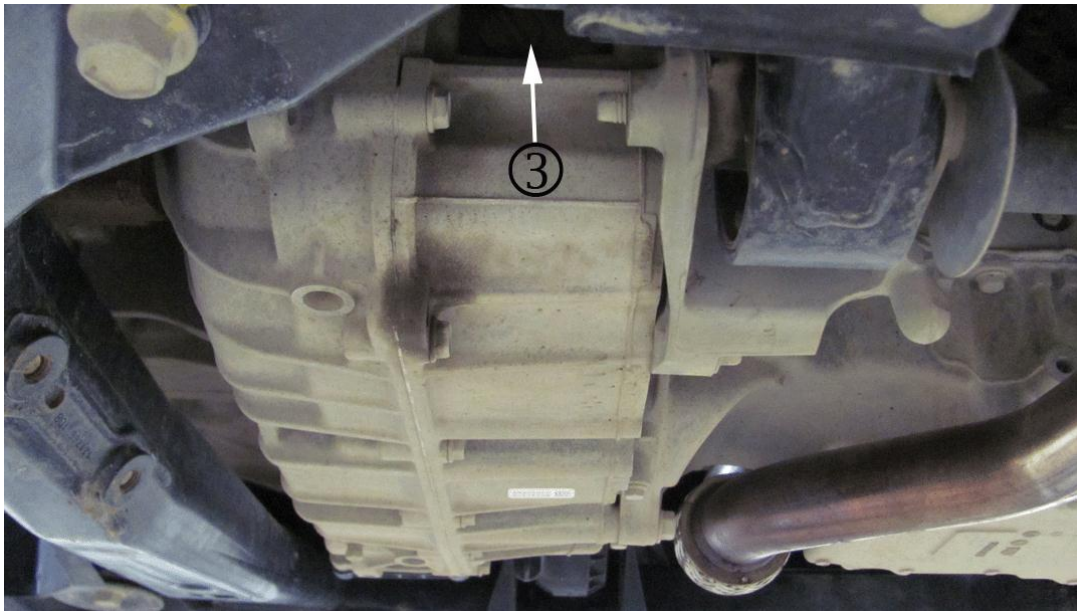
3337569

The torque converter housing may have a casting defect on the sealing flange that could prevent the molded rubber carrier gasket from fully seating on the flange. If the gasket is not fully seated, over time, a transmission fluid leak could develop.

The arrow in the photograph points to where the casting information is located on the torque converter housing. Use a flash light and mirror to obtain the Julian date and the mold casting number.

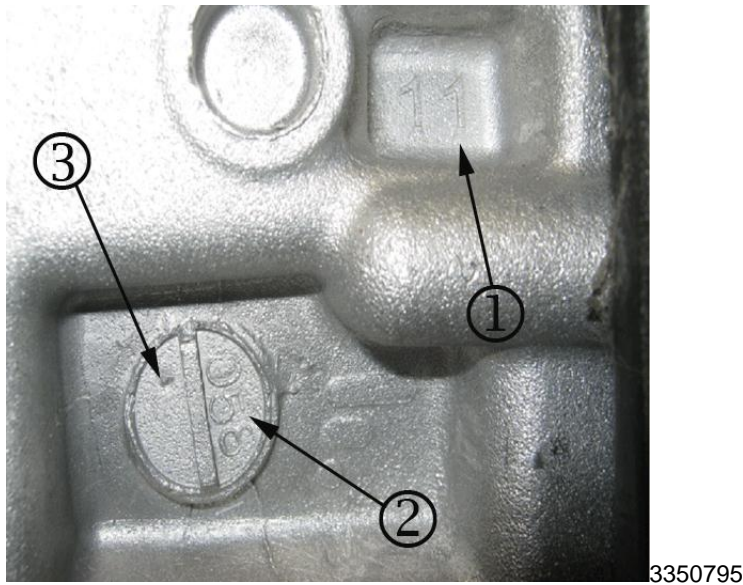
(1) Mold Casting Number Location (2) Julian Date Location (3) Shift Dot Location

3. Locate the casting information on the torque converter housing (1) (2).
 - 3.1 Locate the mold casting number (1).
 - If the mold casting number is NOT 11, no further action is required. Proceed to step 4.

- If the mold casting number is 11, determine the Julian date (2). Proceed to step 3.2.
 - 3.2. Locate the Julian date (2).
 - If the Julian date is 037 and has less than four shift dots (3), no further action is required. Proceed to step 4.

- If the Julian date is 037 and has four or more shift dots (3), replace the transmission assembly. Refer to *Transmission Replacement* in SI.
 - If the Julian date is 038 and has three or more shift dots (3), no further action is required. Proceed to step 4.

- If the Julian date is 038 and has less than three shift dots (3), replace the transmission assembly. Refer to *Transmission Replacement* in SI.
4. Lower the vehicle. Refer to *Lifting and Jacking the Vehicle* in SI.
