PRODUCT SAFETY RECALL

SUBJECT: Steering Wheel Fastener Inspection

MODELS: 2013 Buick Encore
Equipped with Heated Steering Wheel

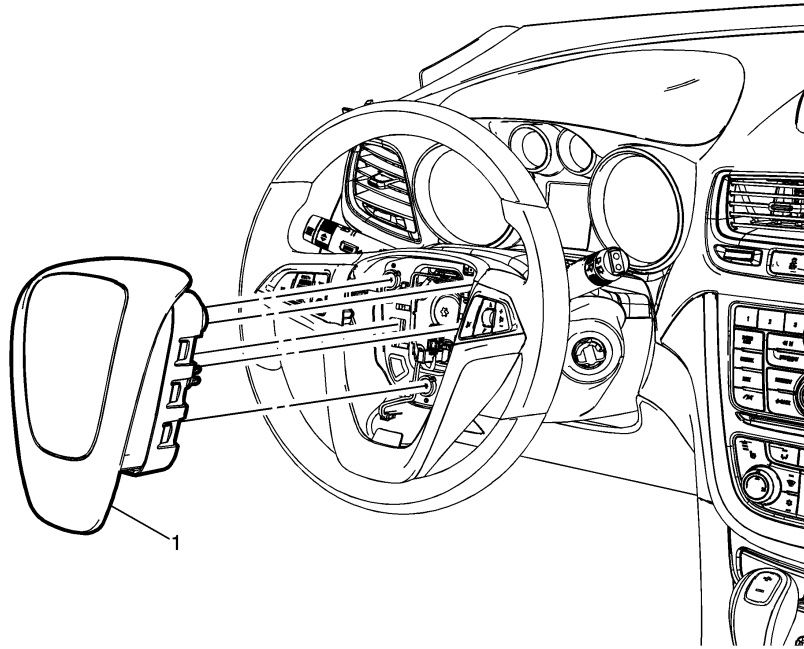
2779508

General Motors has decided that a defect, which relates to motor vehicle safety, exists in **certain** 2013 model year Buick Encore vehicles that are equipped with a heated steering wheel. The steering wheel fastener may not have been properly installed. If it was not installed properly, it could allow the steering wheel to come loose and/or separate from the steering column. If this were to happen while the vehicle was moving, the driver could lose the ability to steer the vehicle, potentially leading to a crash.

10. Inspect the hub area of the steering wheel for the attachment bolt (1).
 - If the attachment bolt (1) is NOT present, install a new attachment bolt, P/N 11610164. Tighten the bolt to **30 Nm (23 lb-ft)**. Proceed to Step 11 after installing the new attachment bolt.
 - If the attachment bolt is present, apply a torque of 25 N·m (18 lb-ft) and verify that the bolt does not rotate. If the bolt rotates, remove it and replace it with P/N 11610164. Tighten the bolt to **30 Nm (23 lb-ft)** using a torque wrench.
