Recall Bulletin

PRODUCT SAFETY RECALL

SUBJECT: Steering Wheel Fastener Inspection

MODELS: 2013 Buick Encore

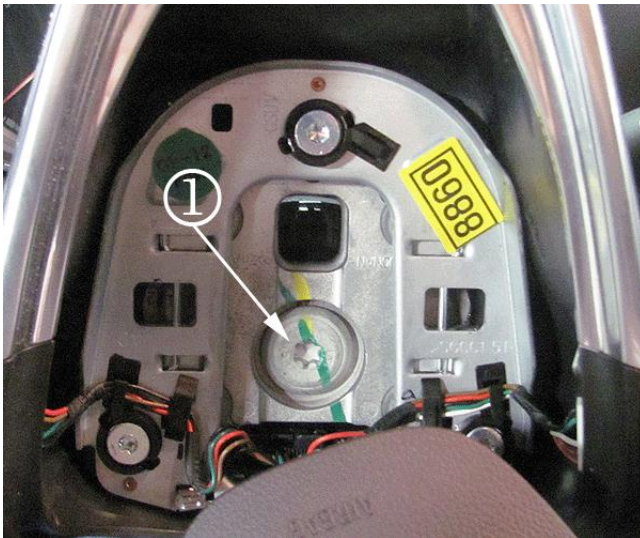
3352589

8. Push the spring fastener in the direction of the steering column to release the steering wheel inflator from the steering wheel.
9. Remove Driver Airbag Module (DAB). DO NOT disconnect the two yellow electrical connectors.

10. Inspect the hub area of the steering wheel for the attachment bolt (1).
 - If the attachment bolt (1) is NOT present, install a new attachment bolt, P/N 11610164. Tighten the bolt to **30 Nm (23 lb-ft)**. Proceed to Step 11 after installing the new attachment bolt.
 - If the attachment bolt is present, apply a torque of 25 N·m (18 lb-ft) and verify that the bolt does not rotate. If the bolt rotates, remove it and replace it with P/N 11610164. Tighten the bolt to **30 Nm (23 lb-ft)** using a torque wrench.
