# Service Bulletin

**SUBJECT:** Service Update for Inventory and Customer Vehicles  
Convertible Top Cosmetic Blemish  
Expires with Base Warranty

**MODELS:** 2013 Chevrolet Camaro Convertible

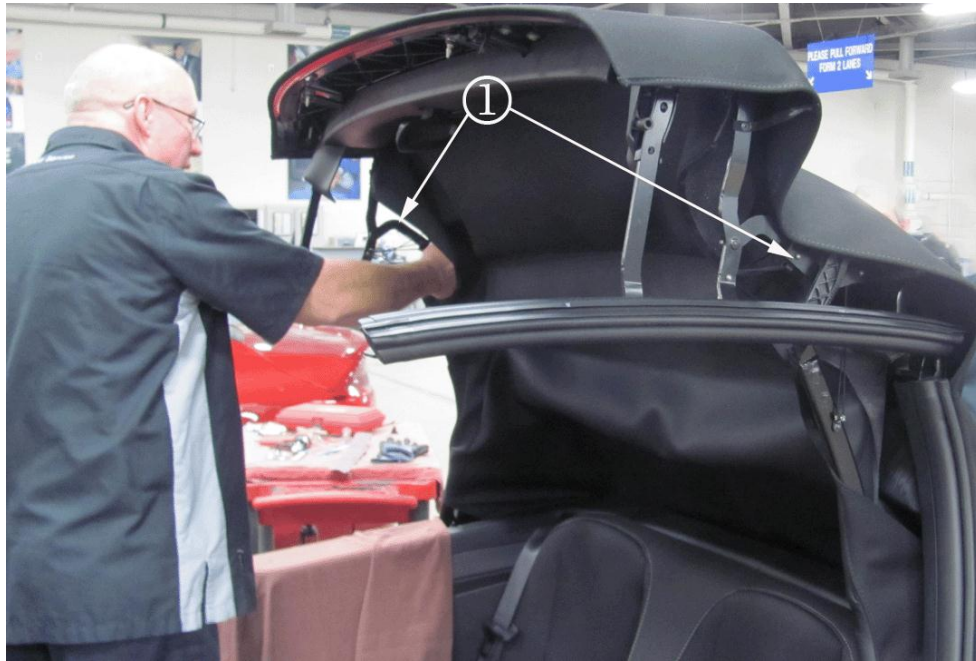
3402300

1. Open the convertible top to the half-open position.
2. Locate the convertible top control link (1).

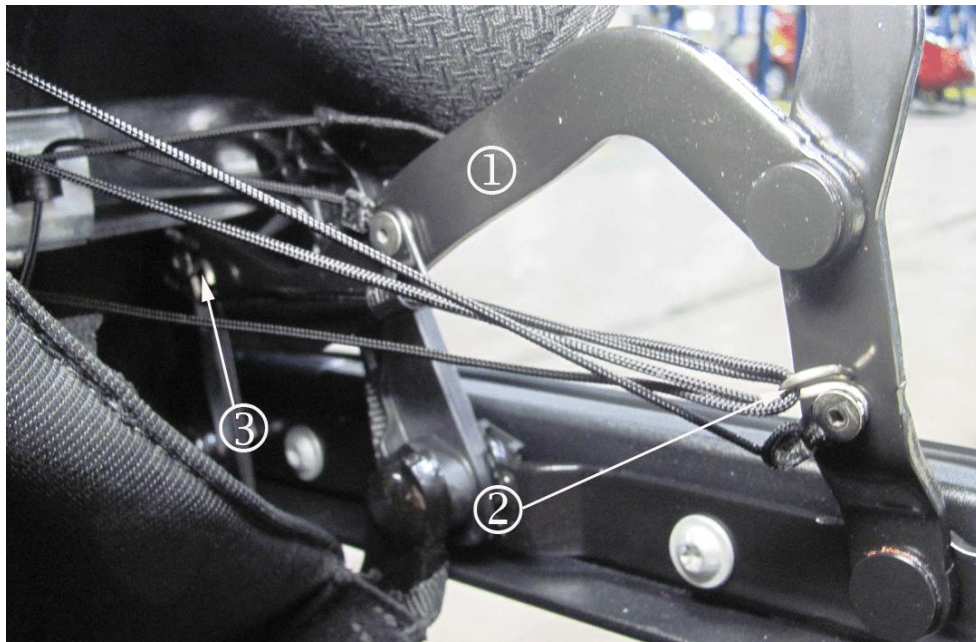
3402303

(1) Control Link (2) Control Link Front Eye Loop (3) Control Link Rear Eye Loop

3. Locate the control link rear eye loop (3). Refer to the inside of the control link to locate the rear eye loop.

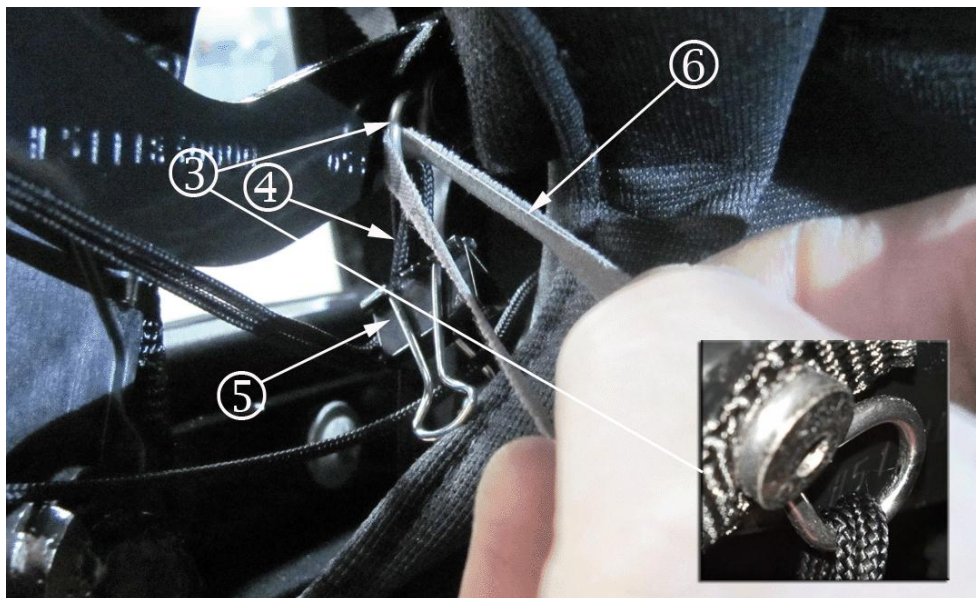
3402307

4. Pull down on the rear eye loop cord (4) and secure it with a binder clip (5) or equivalent to expose the inside surface of the rear eye loop.

**Note:** Only polish the control link rear eye loop. Do NOT polish the control link front eye loop.

5. Use a piece of 320 grit emery cloth (6) that is 5 mm (0.197 in) wide and 80 mm (3.15 in) long to polish the inside surface of the eye loop (3). Spend about 3 minutes polishing each rear eye loop (3) to ensure any burrs or rough edges have been removed.
