Service Bulletin

SUBJECT: Service Update for Inventory and Customer Vehicles
Software Enhancement Update
Expires with Base Warranty

MODELS: 2013 Chevrolet Sonic, Spark, Trax
Equipped with MyLink Radio (UF7)

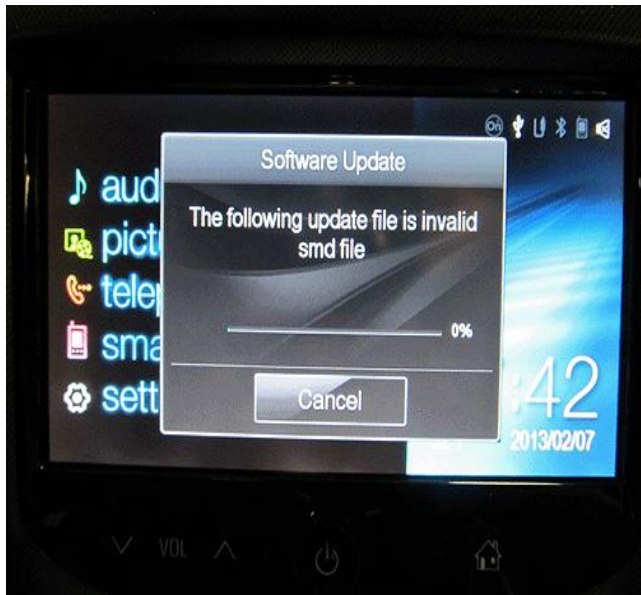
3286662

- 8. If you see the message as shown above “The following update file is Invalid SMD file,” continue to the next step. Otherwise, skip to Step 14.
