# Service Bulletin

**SUBJECT:** Service Update for Inventory and Customer Vehicles  
Software Enhancement Update  
Expires with Base Warranty

**MODELS:** 2013 Chevrolet Sonic, Spark, Trax  
Equipped with MyLink Radio (UF7)

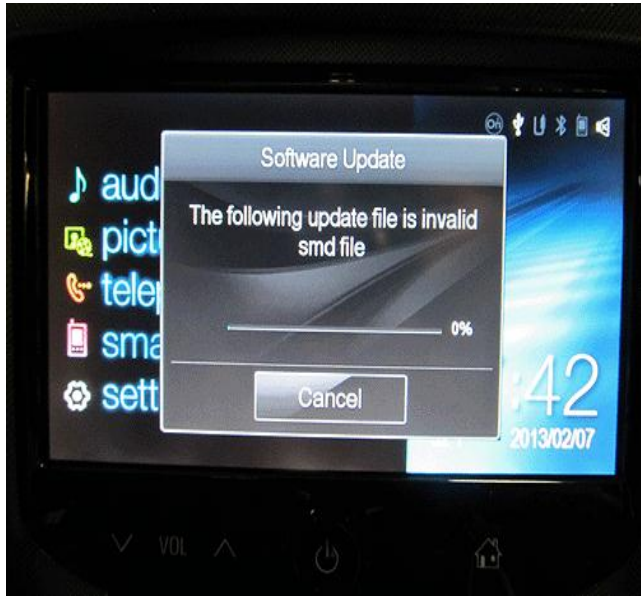
3286662

8. If you see the message as shown above “The following update file is Invalid SMD file,” continue to the next step. Otherwise, skip to Step 14.
